Reconstruction of the Kråknes landslide event, Alta.

Stina Mari Pettersen

GEO-3900 *Master's thesis in Geology, May 2021.*

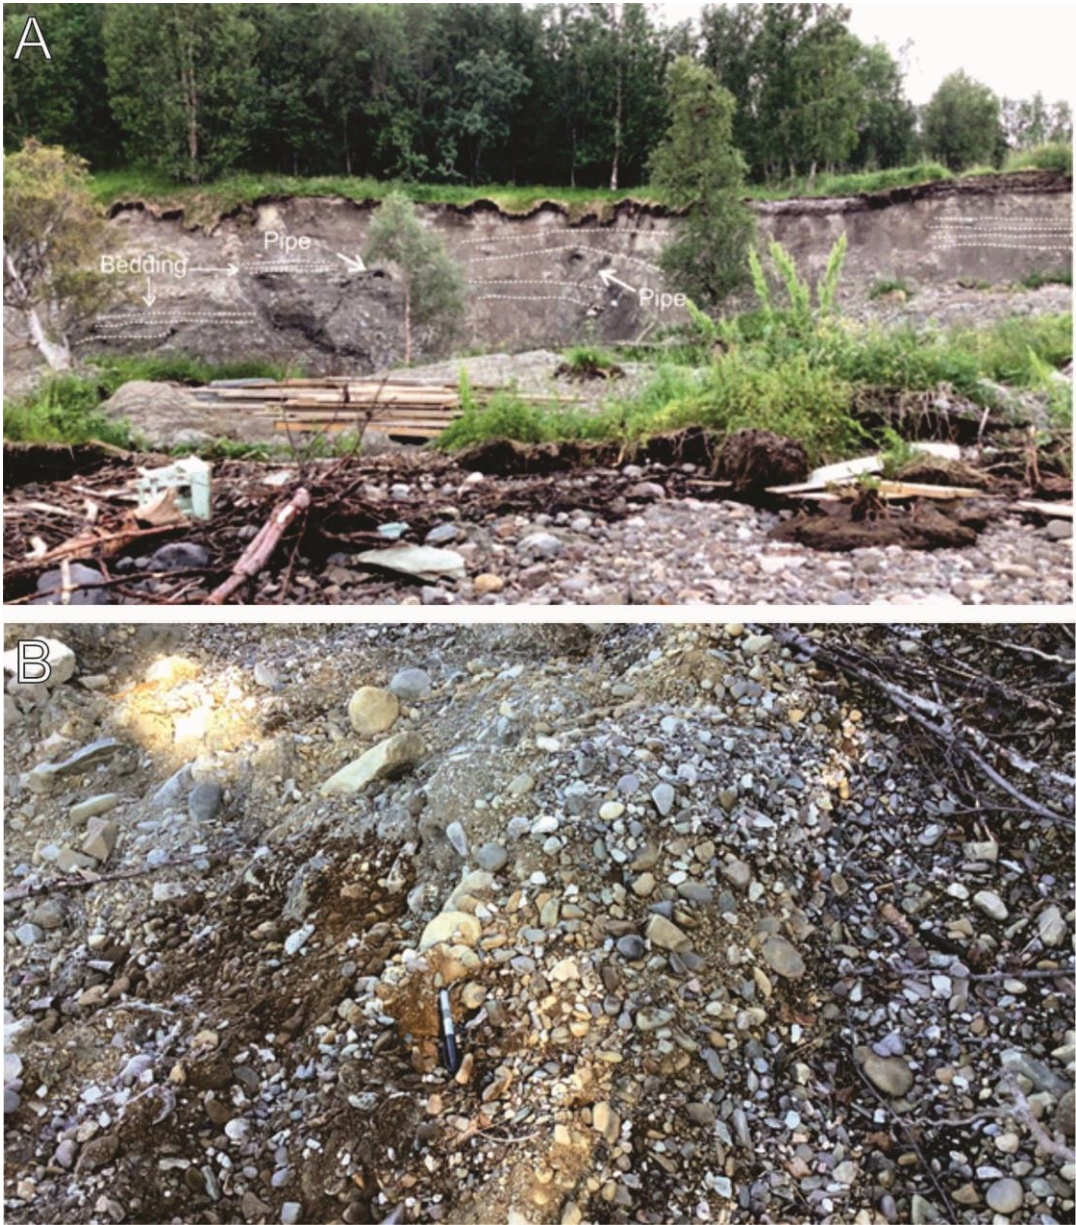
Figure 45 A) Back scarp with exposed bedding (white-dashed lines) and soil pipe structures. Vegetation and debris deposited below scarp. B) Landslide debris.

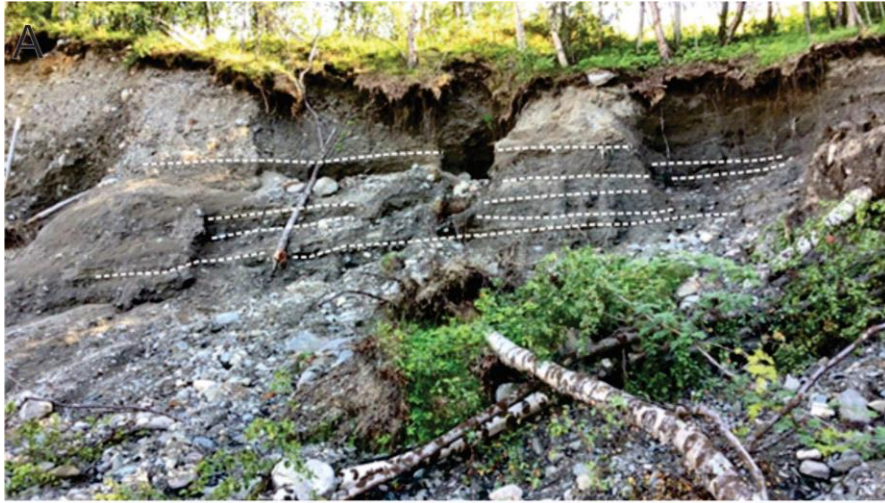
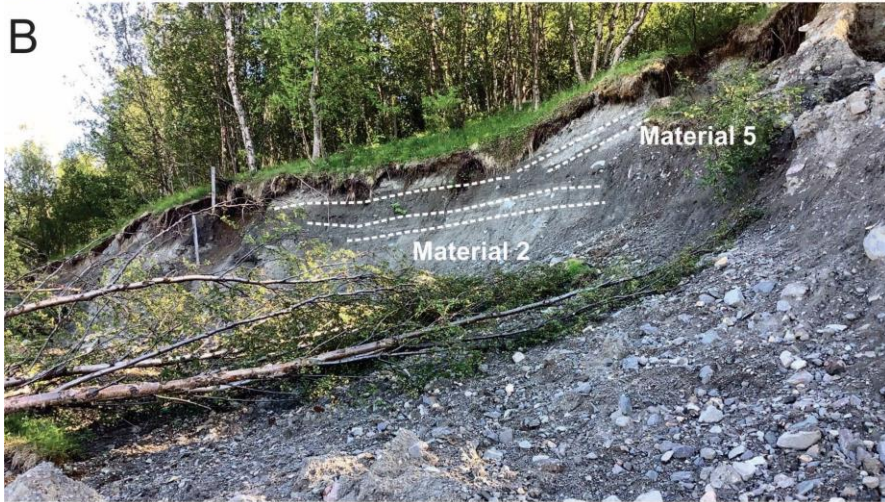
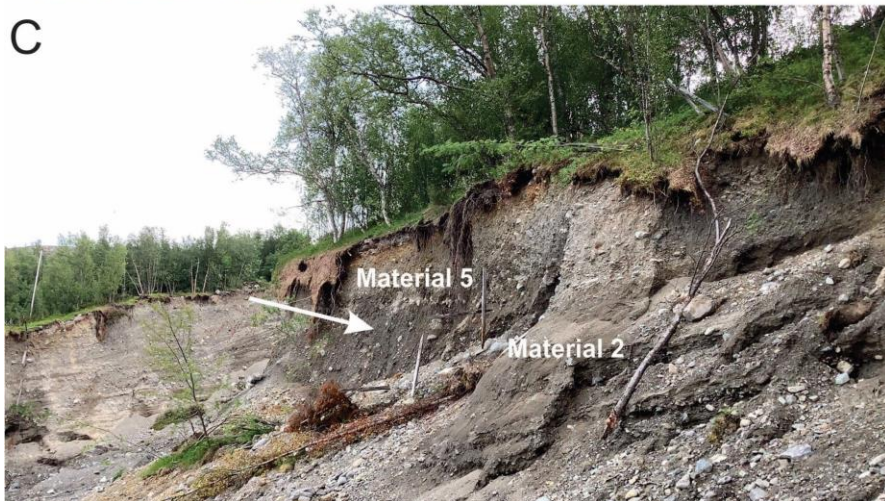
Figure 48 A) Outcrop 5 with beddings of material 2 and 5. B) Beddings of material 2 and 5 with an angular disconformity. C) The arrow points at a moist area within material 5 in outcrop 5.

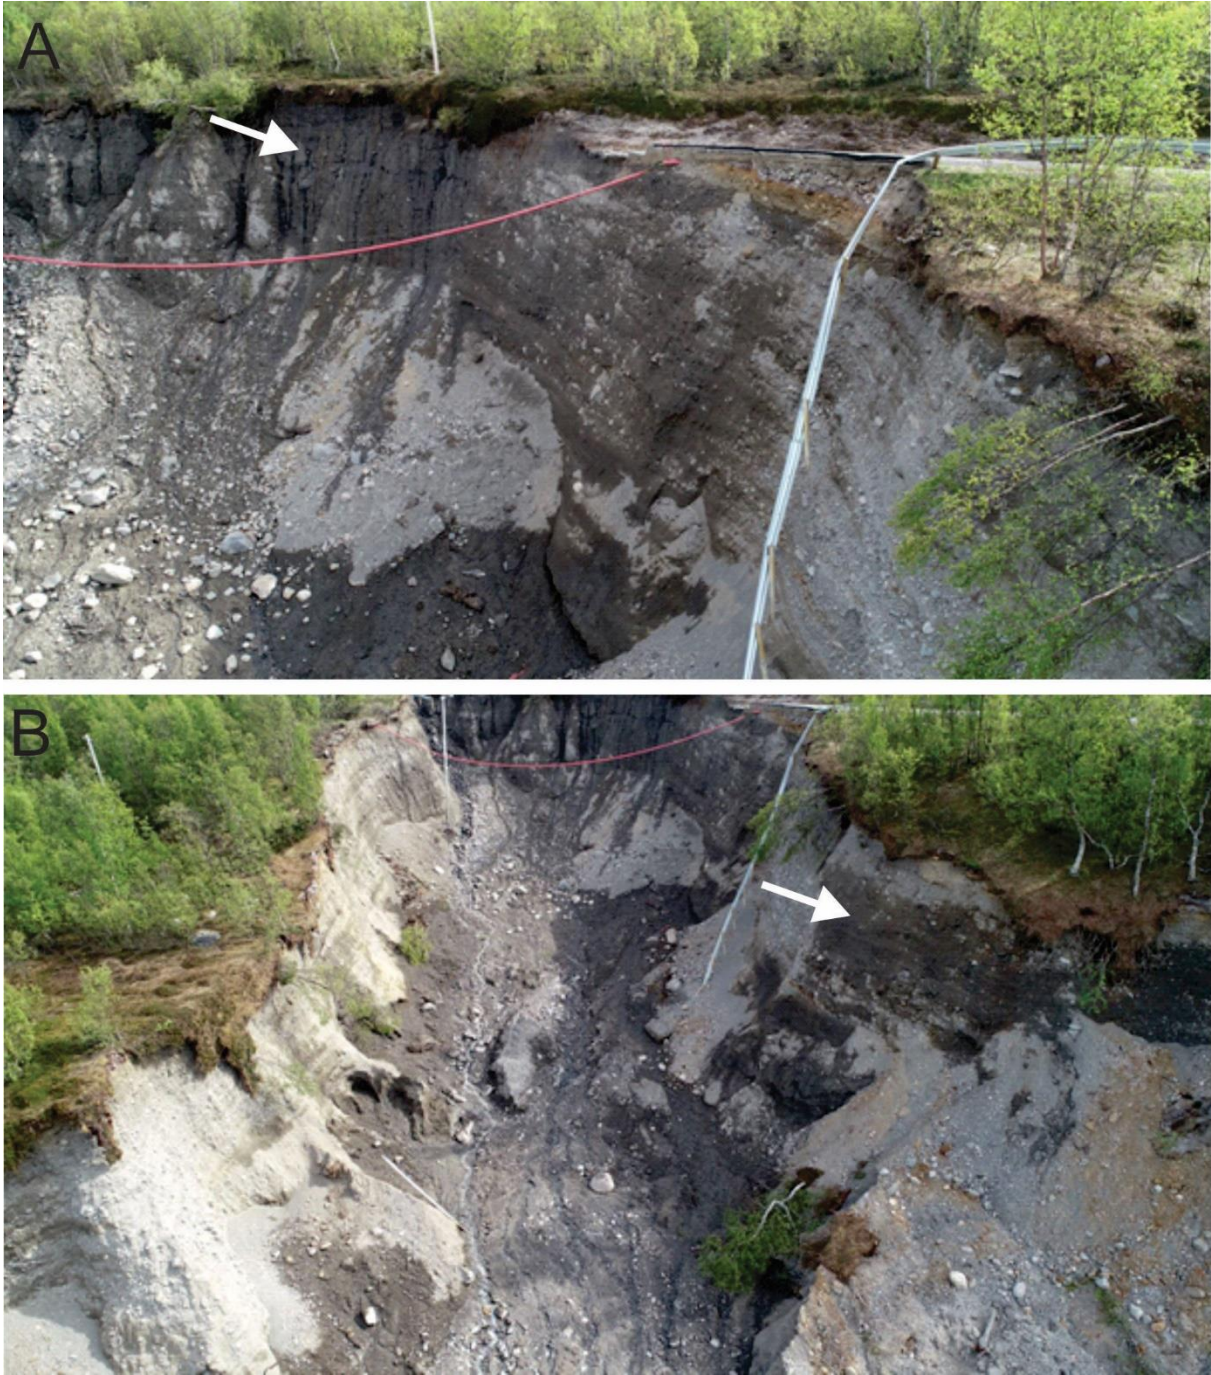
Figure 50 A) Landslide pit and back-scarp up to 40 m asl. Beddings of material 6. The arrow shows water seepage from the back-scarp. B) Braided water streams below the back scarp.

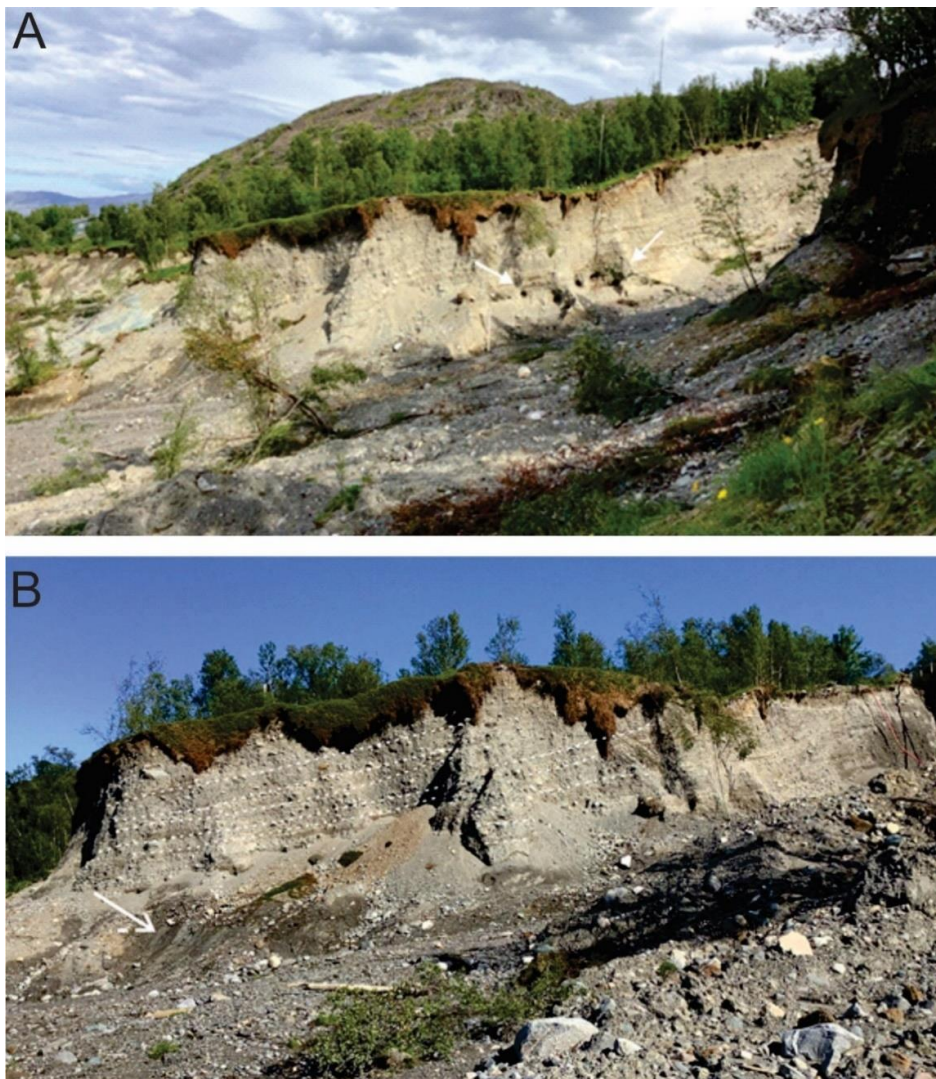
Figure 51 A) Back scarp in outcrop 8. Arrows point at soil pipes within the back scarp. B) Beddings of material 6. Arrow points at beddings of clay/silt.

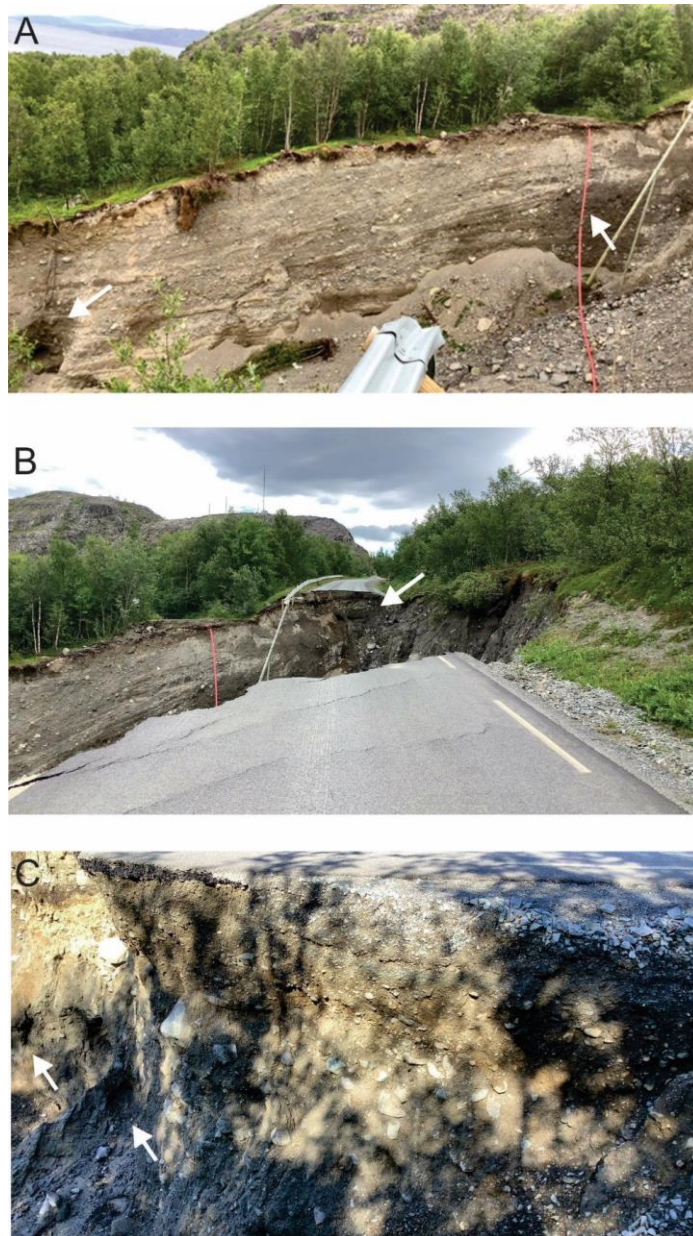
Figure 52 A) Seepage between beddings in outcrop 8. B) Back scarp beneath the former E6-road. The arrow shows moist gravel. C) Close up of moist gravel beneath the road. Arrows point at pipe-like structures.

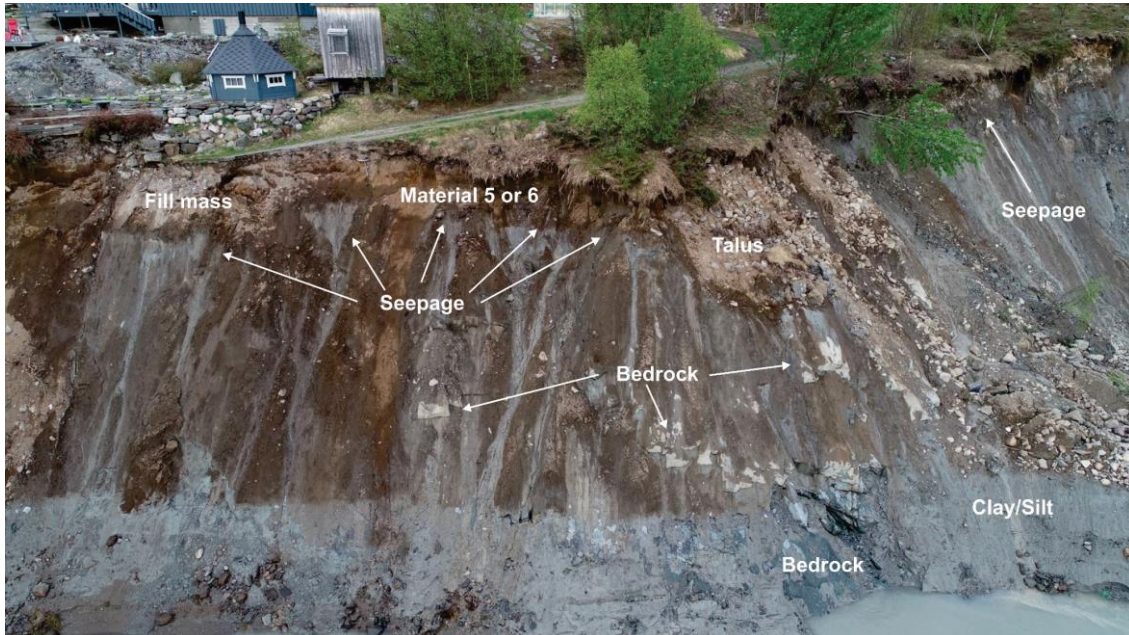
Figure 57 Outcrop 11 with the back scarp beneath the blue house. Water and sediments are seeping out between the bedrock and the soil. The yellow arrows show rock exposed in the scarp (Photo courtesy of Anders Bjordal, NVE).

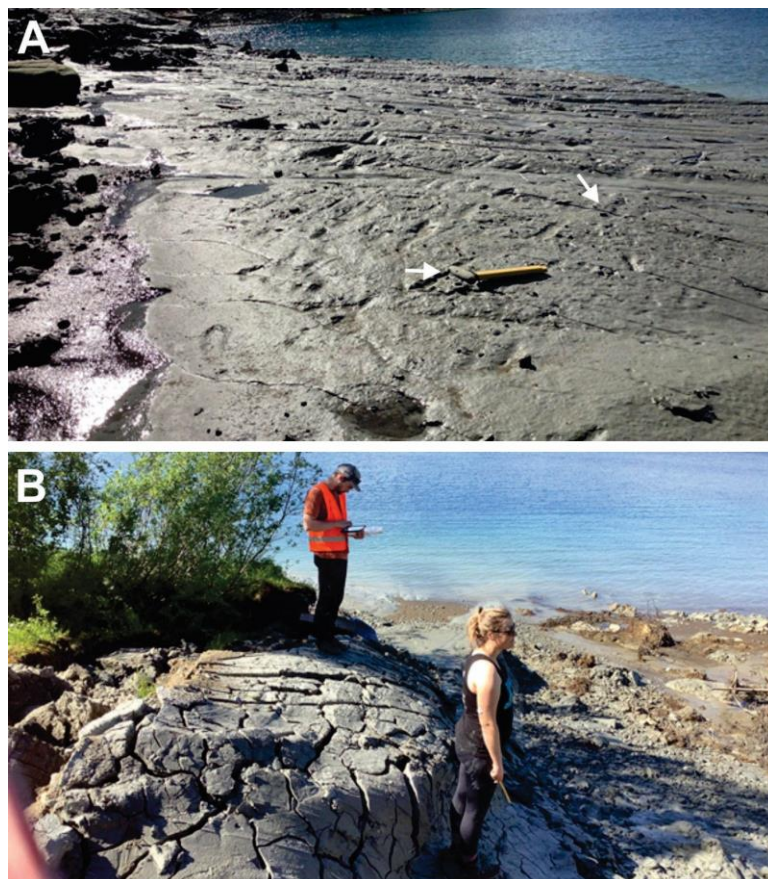
Figure 60 A) Clay surface with striations below scarp in outcrop 12. The arrows show rocks with their long side in the same orientation as the striations. B) A mass of clay with tension cracks.

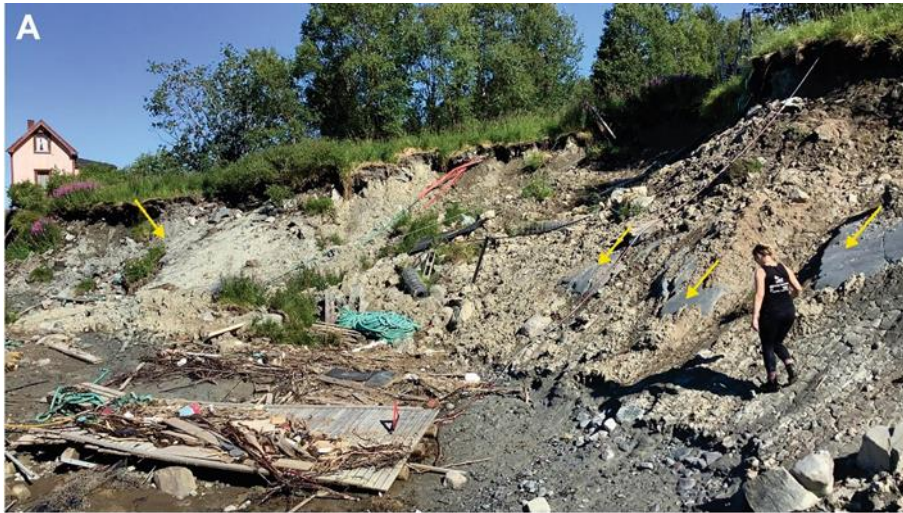
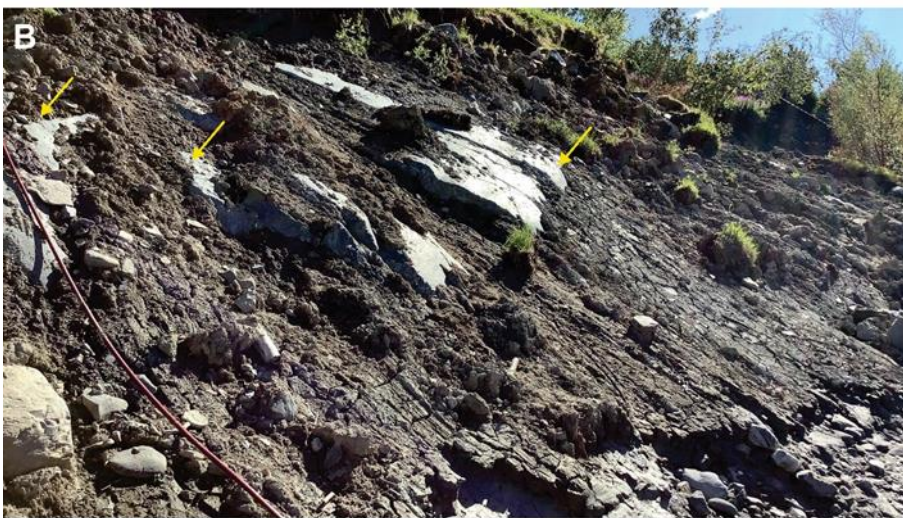
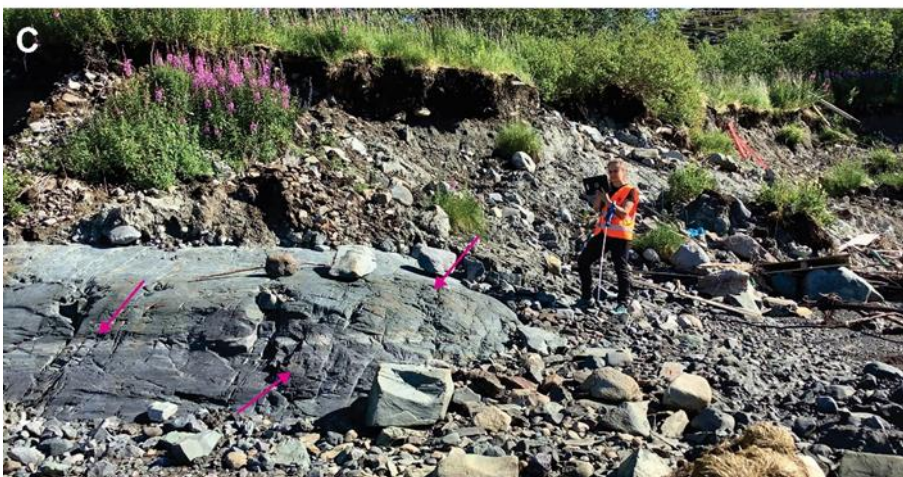
Figure 61 Outcrop 12 A) Yellow arrows show bedrock exposed in back-scarp. B) Close-up of bedrock in the scarp and desiccation cracks in material 7. C) Outcrop with fractured bedrock and possibly glacial striations. Pink arrows point at cracks.

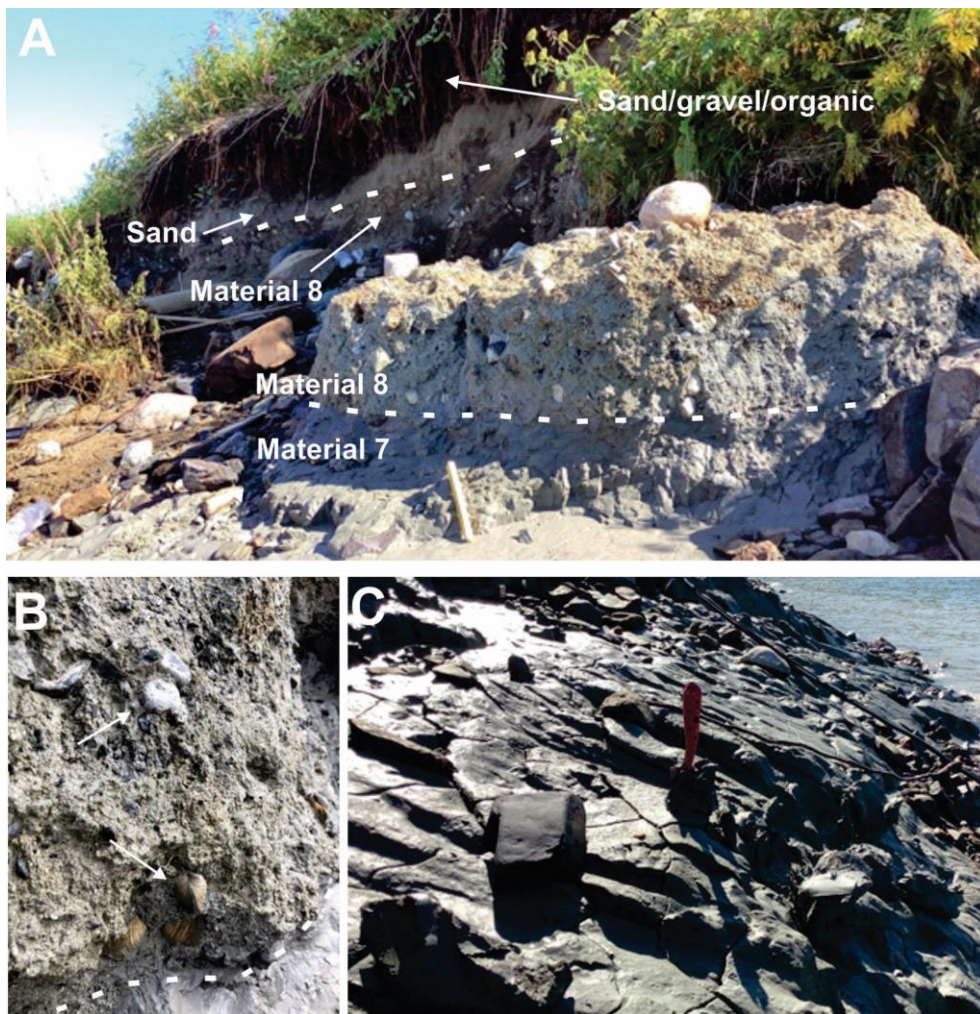
Figure 62 A) Back scarp in outcrop 13. B) Close up of material 8 with arrows pointing at shells and the stippled line is the boundary to material 7 below. C) Uneven surface of material 7.

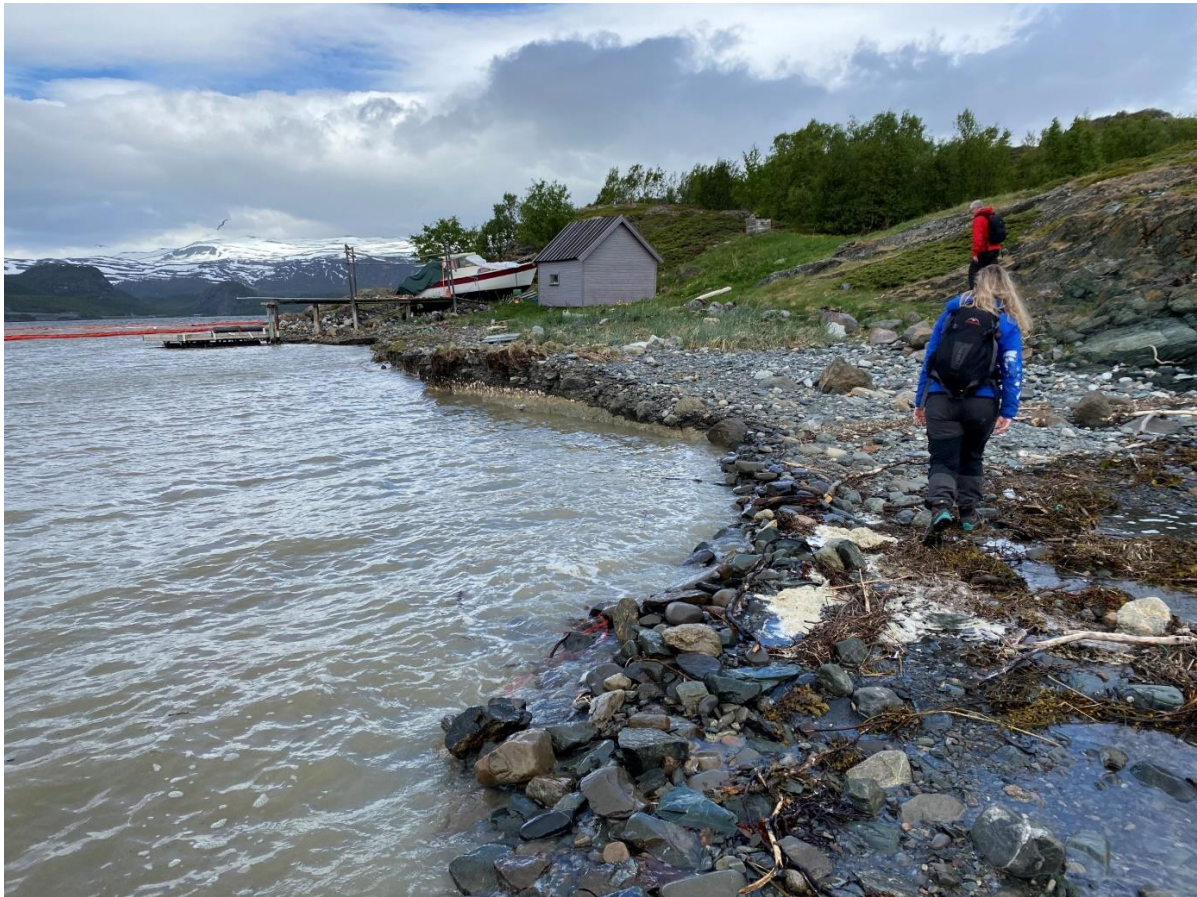
Figure 63 Dock and scarp along the shoreline in the northern part of the landslide area. The dock was destroyed because of the landslide. The picture is taken during high tide about 12 days after the landslide occurred.

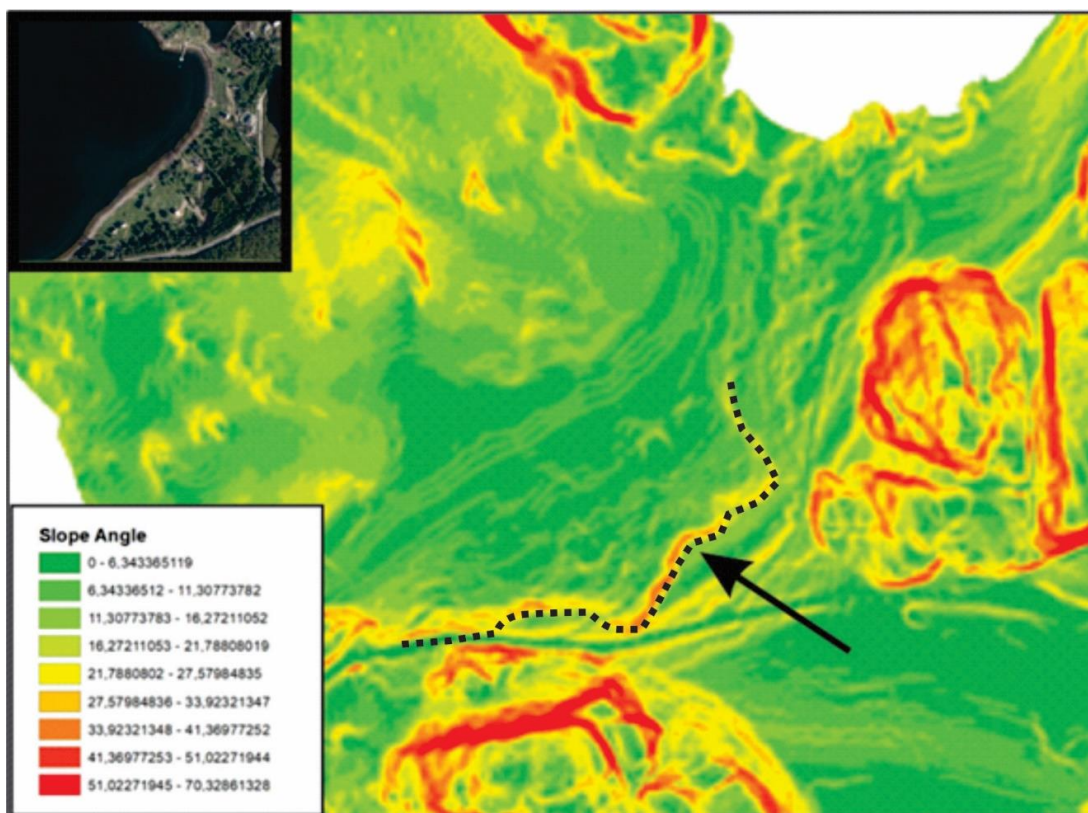
Figure 75 Arrow points at the scarp of a historic landslide event at Kråknes. The colors show the slope angles within the landslide area before the 2020 landslide event.

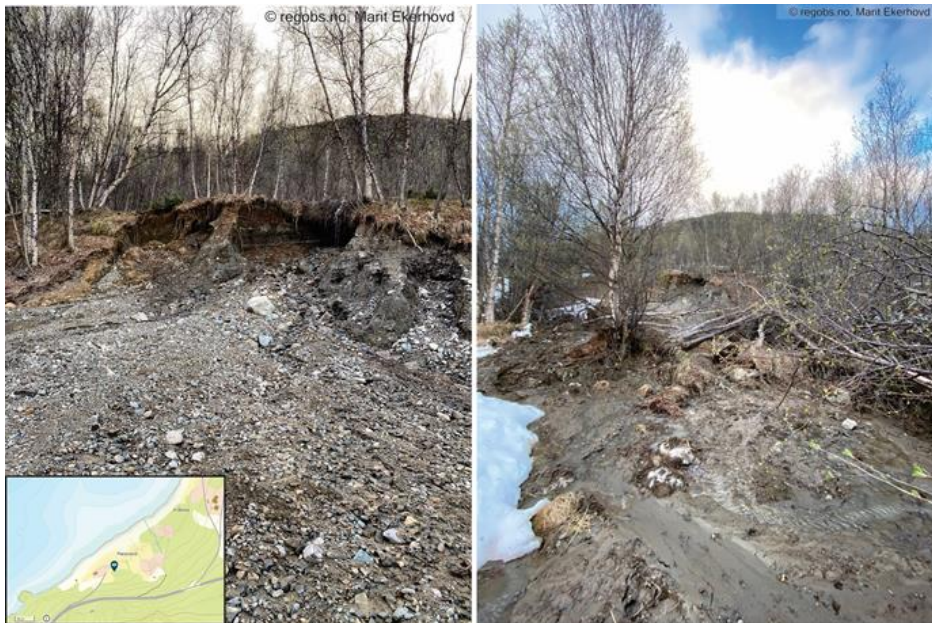
Figure 76 Small landslide event in the study area from May 29th. Photo courtesy of Marit Ekerhovd (Regobs.no, 2020)

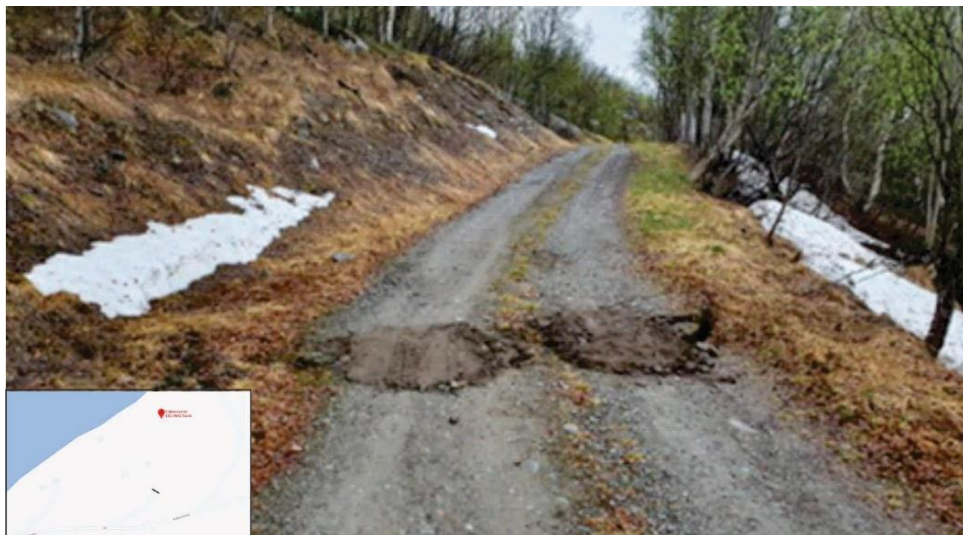
Figure 77 Fracture in the access road to Kråknes Road 450. The fracture is filled with sand. Photo courtesy of Egil Bakkeby (Gylland et al., 2021).

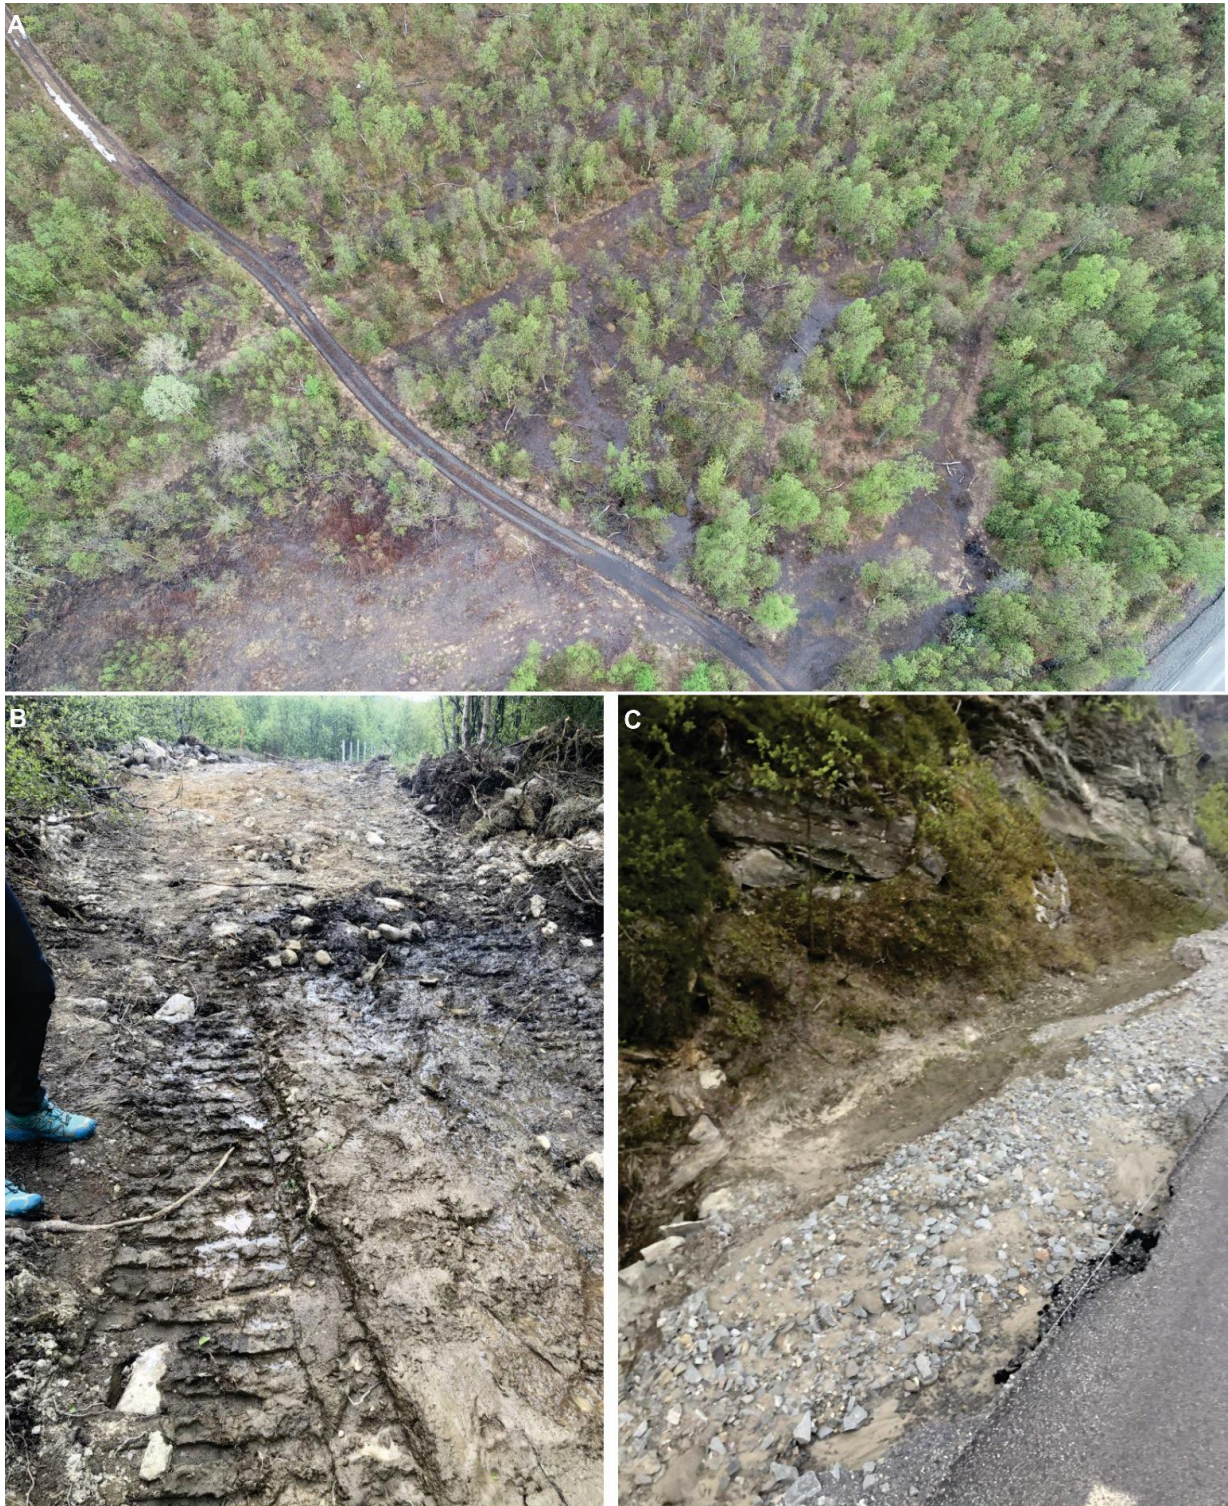
Figure 84 A) Wet area in Kråknesdalen above the Kråknes Road on June 7th, 2020(Photo courtesy of Anders Bjordal, NVE). B) Moist tractor road on July 28th, 2020. C) Erosion from water streams in the ditch along Kråknes Road on July 28th, 2020.

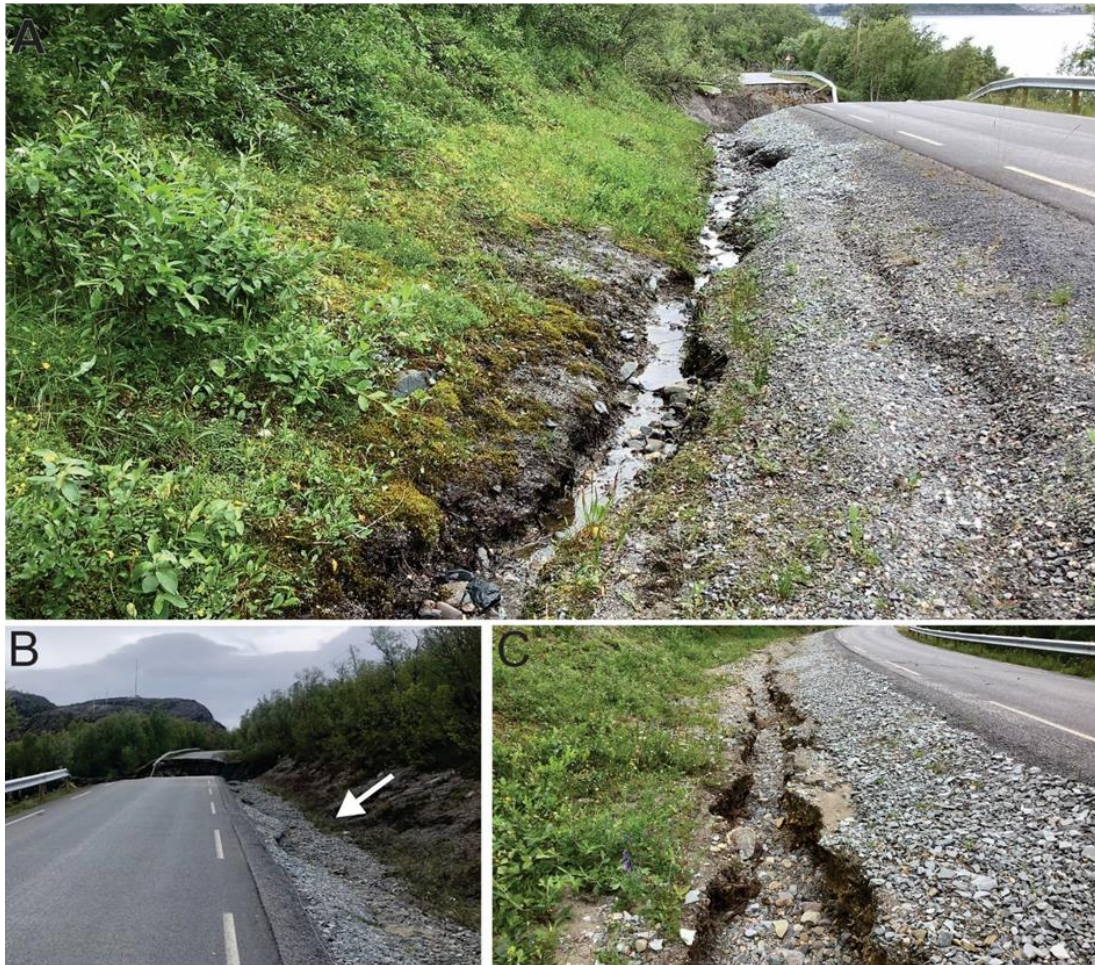
Figure 85 Eroded channels in the ditch system along the Kråknesroad north of the section B. B) Dry channels in the ditch south of section B. C) Close-up of dry channels.
