## An investigation into the causal factors of the Kråknes landslide

Torgrim Sandnes Master's thesis in Geology (GEO-39100), May 2021

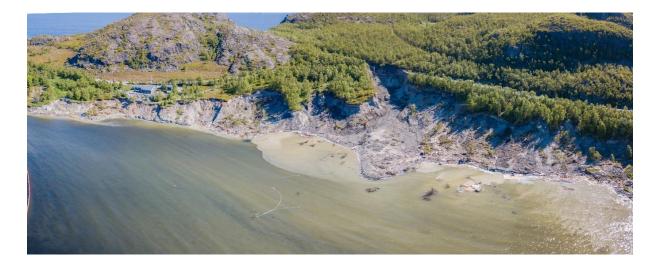
Figure 1: Photo of the Kråknes landslide, looking towards the north (Photo: Raymond Eilertsen 03.06.2020).

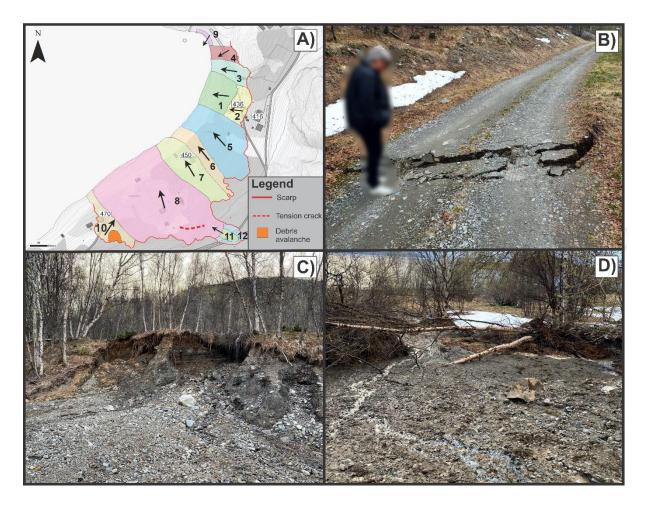
Figure 23: A) Overview map of Kråknes. B) Tension crack discovered on the 2nd of June (Photo: Jan Egil Bakkeby). C/D) Small landslide reported by locals on the 30th of May (Photo: Marit Ekerhovd).

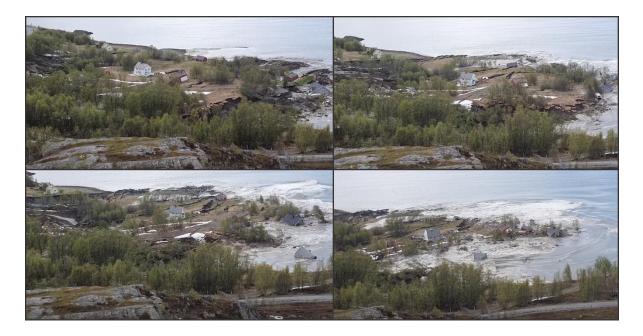
Figure 24: Snapshots of the southward progression of the Kråknes landslide captured on video. A large flake is observed sliding into the fjord. This flake corresponds to sequence 8 in . Source: (Larsen & Quist, 2020).

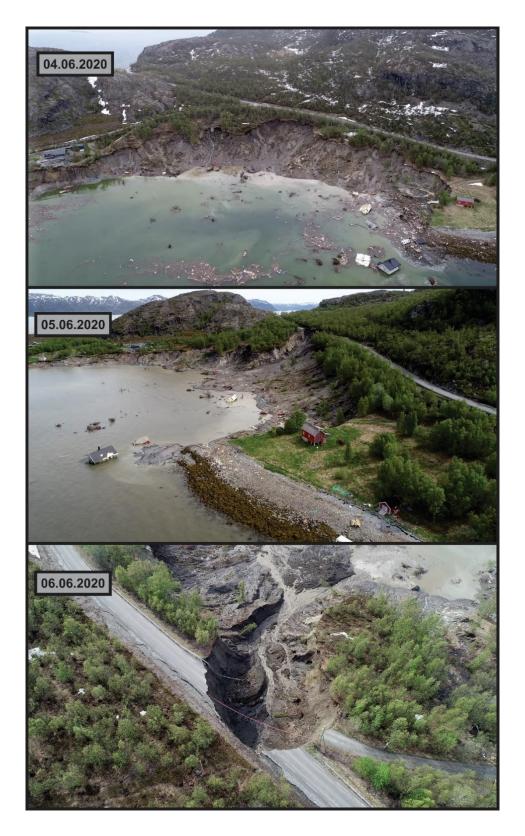
Figure 25: The development of the Kråknes landslide from the 4<sup>th</sup>-6<sup>th</sup> of June. As observed, the landslide removed parts of the main road on the 5<sup>th</sup> of June, and continued to develop backward until the 6<sup>th</sup> of June. (Photos: Anders Bjordal).

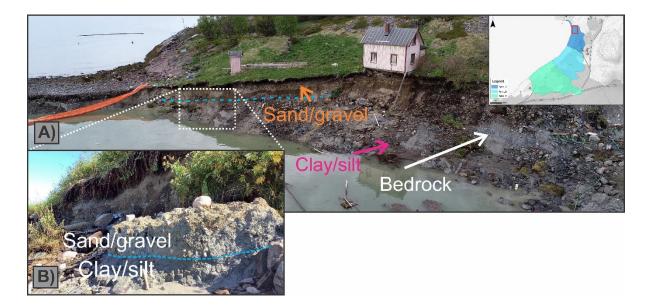
Figure 34: A) Photo taken in the NE direction. A layer of sand/gravel is observed above soft clay. Smaller areas of bedrock are exposed. B) Close-up photo of clay and sand/silt boundary (photos: Anders Bjordal, June 4th 2020).

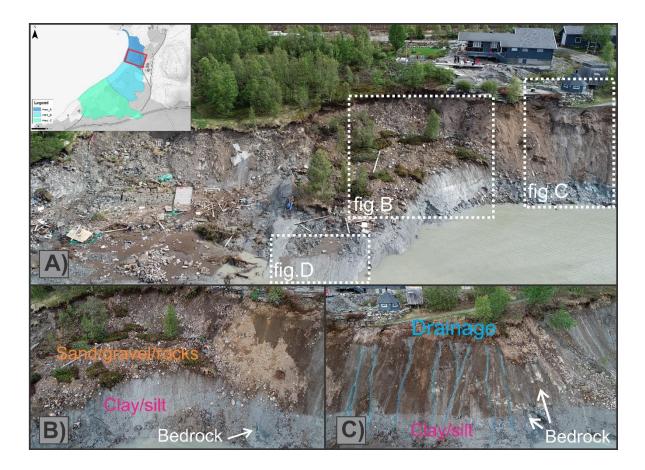
Figure 35: A) Drone photo of the scarp beneath Kråknesveien 416. Photo: Anders Bjordal. B) Thick landslide debris on top of clay/silt. Small patch of bedrock visible next to the water. Photo: Anders Bjordal. C) Visible signs of water drainage in the scarp. Water is interpreted to exit at the soil-bedrock interface. Bedrock is exposed in large parts of the scarp, with a thin veneer of clay/silt on top. Photo:Anders Bjordal.

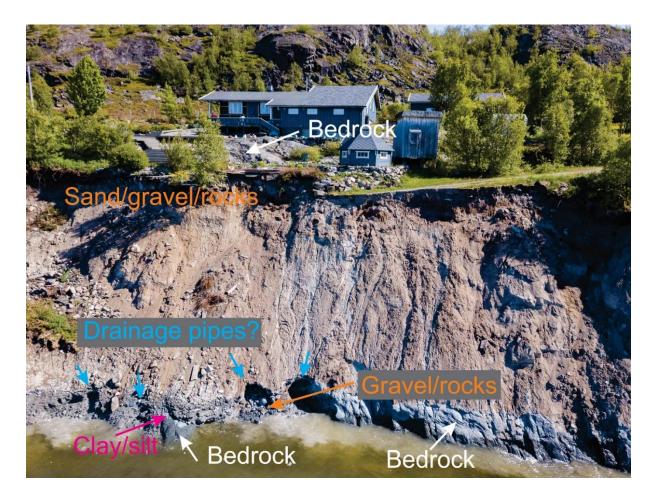
Figure 36: Photo of scarp three weeks after the landslide. Plumes of fine material indicate possible active drainage pipes, even two-three weeks. Photo: Raymond Eilertsen.

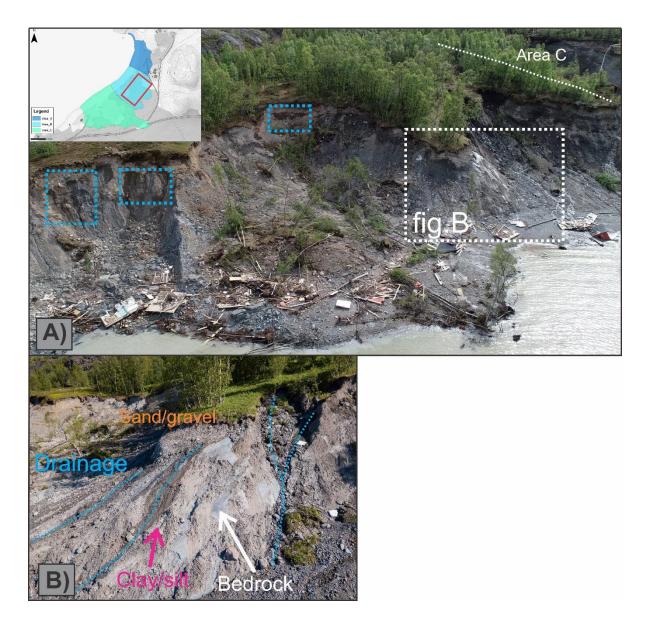
Figure 37: A) Drone photo of Area B. Blue squares indicate the location of lenses of coarser material. Photo: Anders Bjordal. B) Bedrock exposed under a thin layer of sand and gravel. Water can clearly be observed exiting at the boundary between bedrock and sediment. Photo: Raymond Eilertsen.

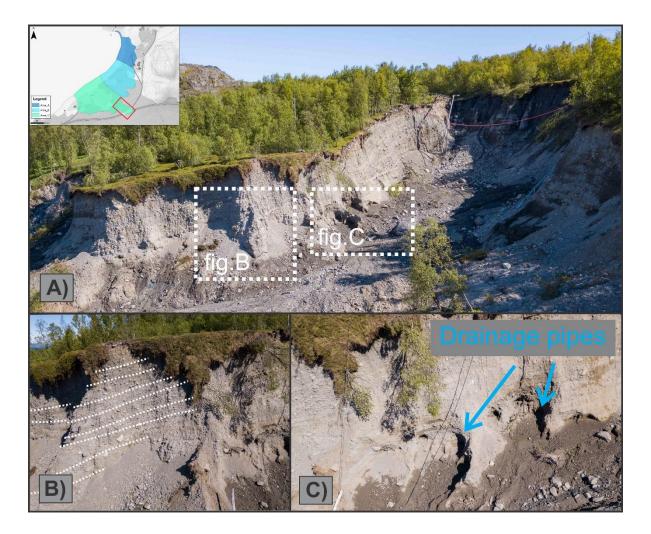
Figure 39: A) Photo displaying the scarp in area C. The scarp ranges from 10 to 15 meters in height, with unsorted sand and gravel being the dominating sediment. The location of figure B and C are illustrated with white boxes. B) Layers of unsorted sand and gravel dipping towards north. C) Drainage pipes exiting the lower end of the scarp, with darker colored sediments that are saturated with water.

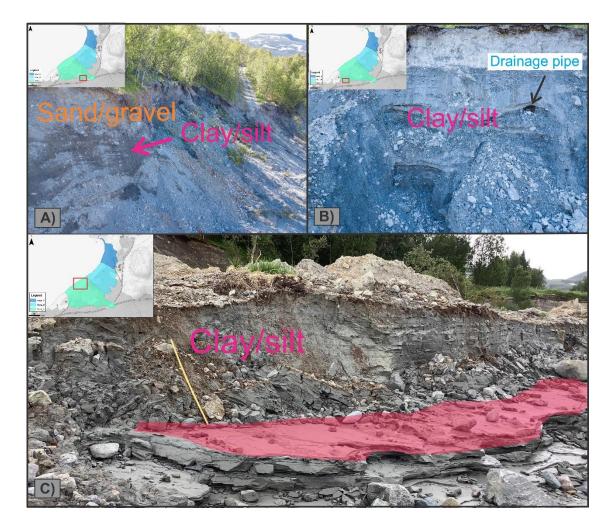
Figure 40: A) Scarp composed of unsorted gravel and sand, with a darker layer of silt and clay visible. The dark color indicates a higher moisture content compared to the surrounding sediment. (Photo: Raymond Eilertsen). B) Scarp composed of silt and clay, with remnants of a drainage pipe exposed. (Photo: Raymond Eilertsen). C) Outcrop of clay and debris which has been transported and deposited during the slope failure. The clay displays a layered stratigraphy with thinner layers of silt separating the clay. Smooth, low-friction surfaces appear where the overlying sediments have been removed, as illustrated by the red color.

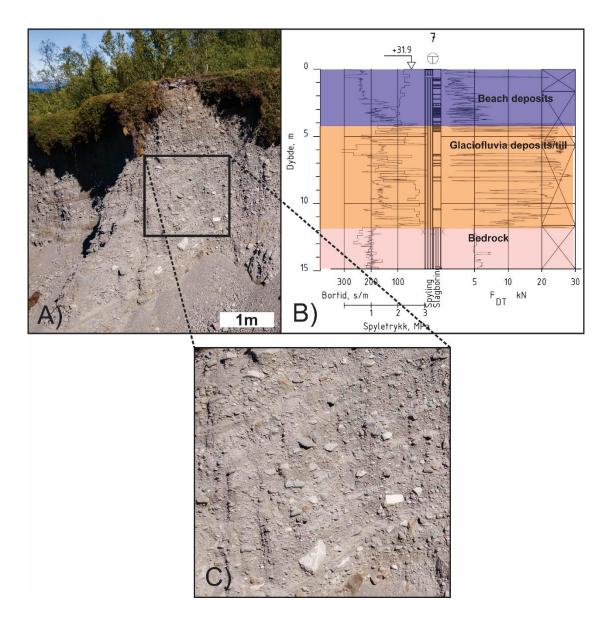
Figure 41: A) Photo of the layered unsorted gravel layer at the scarp. B) Interpreted total sounding data from the closest borehole (BP7). C) Close-up of the layered gravel. Clasts are observed to be subrounded to sub-angular, and show signs of imbrication.

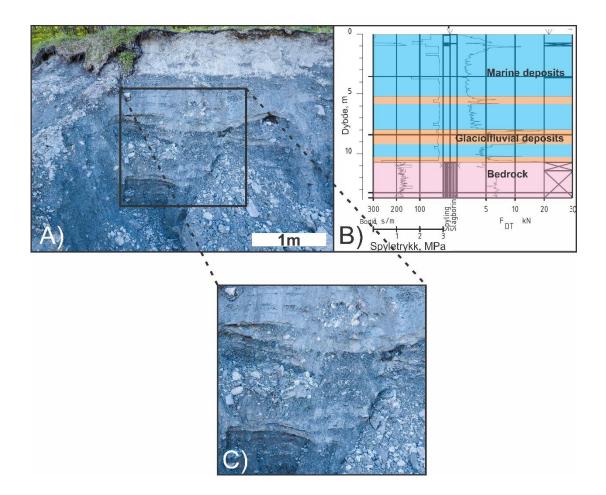
Figure 42: A) Photo of the clay/silt-layer interpreted to be a marine deposit. B) Interpreted total sounding data from the closest borehole (BP2). C) Close-up, showing the layered stratigraphy of clay and silt interrupted by coarser sediment.

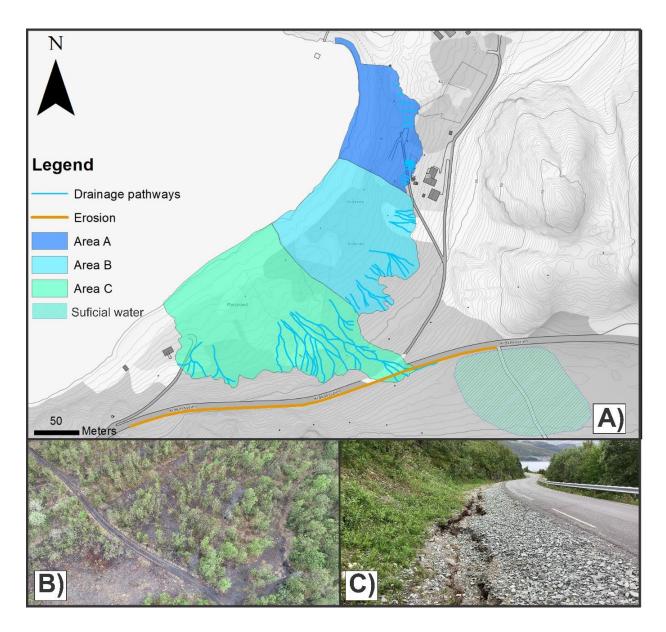
Figure 52: A) Mapped drainage pathways, surficial water and erosion at Kråknes, overlain a topographic map (Kartverket, 2020). B) Drone photo of surficial water. The ground in this area is completely saturated, with darker-colored areas being covered by water (Photo: Anders Bjordal, 05.06.2020). C) Visible signs of erosion of next to Kråknesveien. This photo is taken just below the area where the road collapsed.

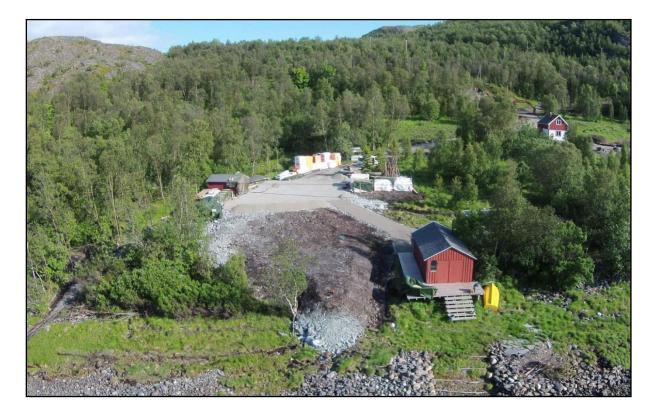
Figure 55: Photo of the groundwork associated with cabin building in 2015 (Photo: Vidar Heitmann).

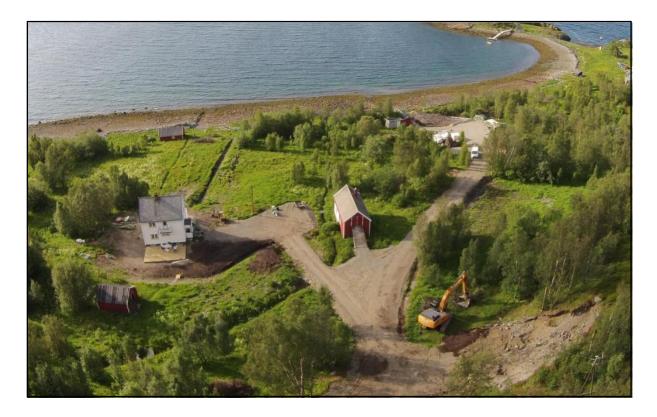
Figure 56: Bottom right corner shows where mass was removed. This mass was used for leveling the area east of the white house, and repairing the road. (Photo: Vidar Heitmann).

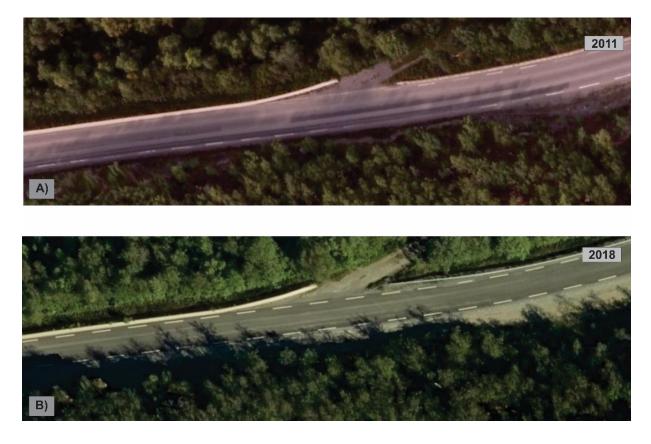
Figure 57: A) Aerial photo of Kråknesveien in 2011. B) Aerial photo of Kråknesveien in 2018, after the road was upgraded. (Source: Norgeibilder.no).
