Characteristics and failure mechanisms of the Sieidi unstable rock slope

Interpreting slope kinematics at Sieidi from slope morphology, structural analysis, thin sections and 2D InSAR

Master's thesis in Hard rock geology, GEO-3900, May 2024

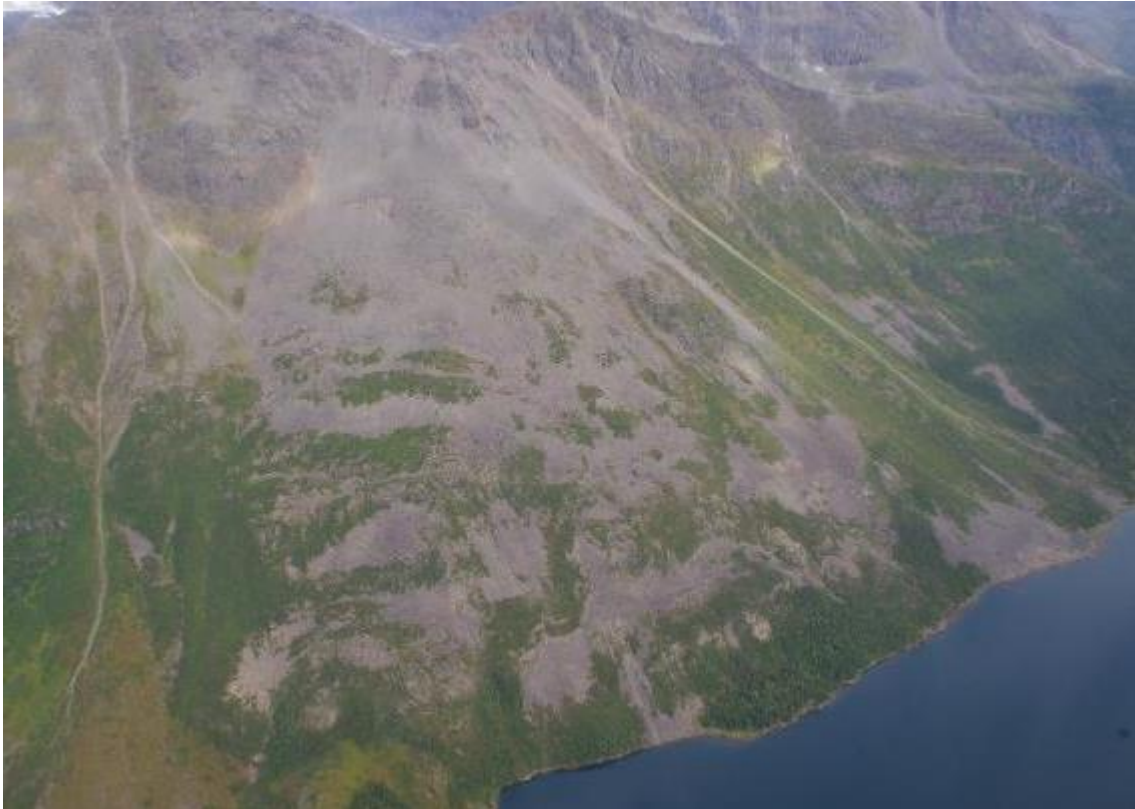
Figure 3 Sieidi URS (Photo taken by NGU 2019)

The URS is situated on the southeast-facing slope of a mountain called Sieidi (northern peak 1045 masl, southern peak 1060 masl), with the backscarp between them (Figure 2). The average slope angle is 33° and has a dip direction of around 135° (Figure 2). The slope is covered by rockfall/talus deposits and disintegrated rock. In certain places, displaced blocks can be seen, which are related to landslide processes and slope deformation at hand.

The slope is mainly covered by disintegrated rock, and in certain areas, dislocated blocks penetrate the boulder field and are visible as scarps or counterscarps. Talus and rockfall debris cover the slope between the bedrock and the disintegrated rock (Figure 3). Below the tree line, vegetation has grown in areas with low to no disturbance for plant growth (Figure 30). The back scarp is challenging to see in the field, firstly because it is not well developed, and a vast displaced block obscures the view, which makes it only observable from the top. Secondly, large boulders cover it, and sometimes snow/ice (Figure 28). Nonetheless, in studying the DEM, the back scarp is clearly visible, as shown in Figure 28. A clear indication of slope movement are the major scarps in the southern part of the URS striking in a NE-SW direction (Figure 29 & Figure 30). The rock mass shows a drop of up to 20m from the head of the scarp to the boulder field. The area around the major scarps is densely covered by vegetation, and the area in between is made up of mainly boulders (Figure 29). Around the scarps further upslope, the vegetation decreases as the altitude reaches the vegetation limit. More minor scarps can be observed in the toe area, which are covered with boulders and strike in an NNE-SSW direction (Figure 30). In the vicinity of these scarps, the vegetation is absent, too. Some morphological depressions below the vegetation limit are covered, whilst others are not. Furthermore, several debris flow tracks are observed at both lateral boundaries that follow natural drainage paths (Figure 31). These paths are easily recognisable on the DEM, even if tracing them in the field is difficult. In addition, within the URS, there is no evidence of debris flow tracks. All the field observations, together with the interpretation of the photographs taken and the orthophotos available on "norgebilder.no" with the study of the DEM, are summarised on the morphological map of the Seidi URS area in Figure 27.

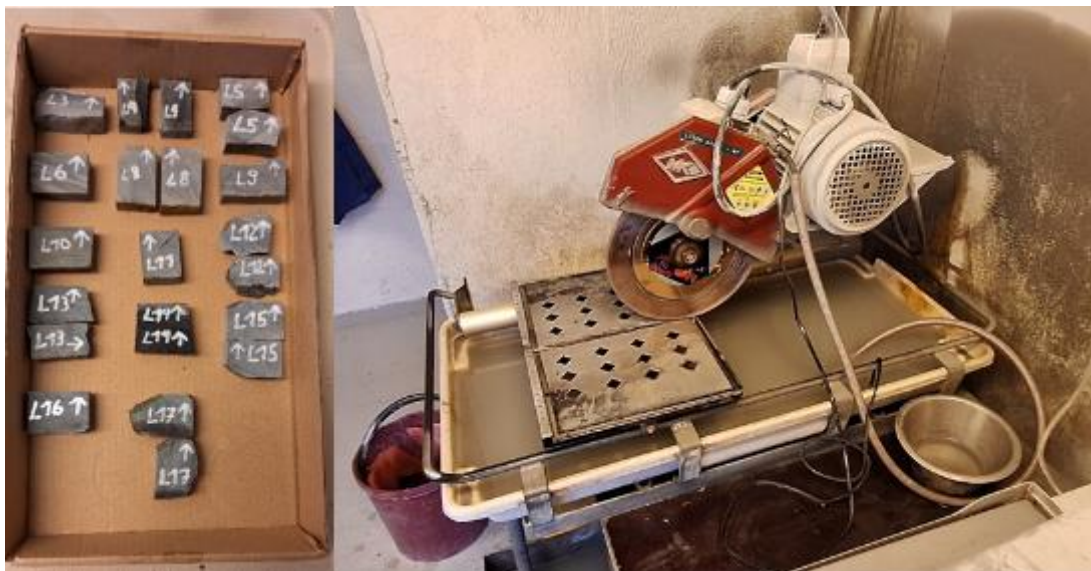
Figure 21 Sample blocks (left), Rock saw used (right)

The samples were cut into blocks of approximately 4 cm length, 2 cm width and 1 cm height, perpendicularly to the foliation, with a diamond-enforced rock saw (Figure 21). If the sample was big enough, two blocks were sawed out for the production of two thin sections; otherwise, two thin sections from the same block were ordered from the laboratory. The thin sections were polished to a thickness of 30 μm to then be analysed under a polarised microscope.

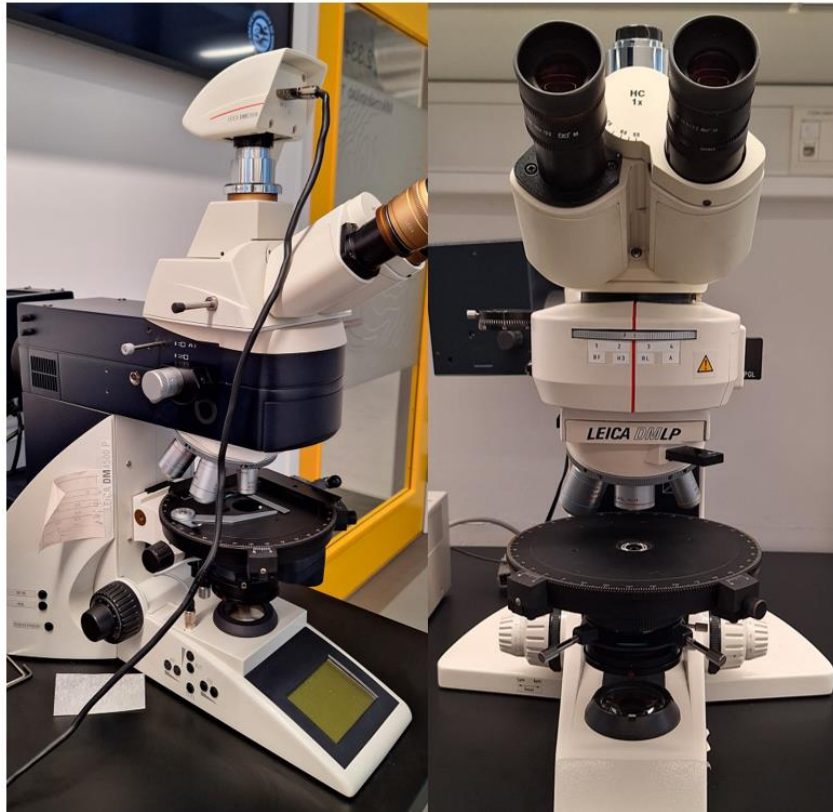
Figure 22 left Leica DM 4500 P microscope; right Leica DMLP microscope

In total, 25 thin sections were analysed by a Leica DMLP microscope (Figure 22), 21 originating from the stable part and 4 from within the URS. They were studied in terms of their mineralogy and microstructures both in plan polarised (PPL) and cross polarised (XPL) light. To capture the results as an image, a Leica DM 4500 P microscope was used, which was retrofitted with a scanning stage (Figure 22). The pictures were all taken in regard to the orientation in the field, i.e. the part facing the sky is at the top of the image. The findings are used to qualitatively interpret the rock strength and mechanisms of failure at a microscale.

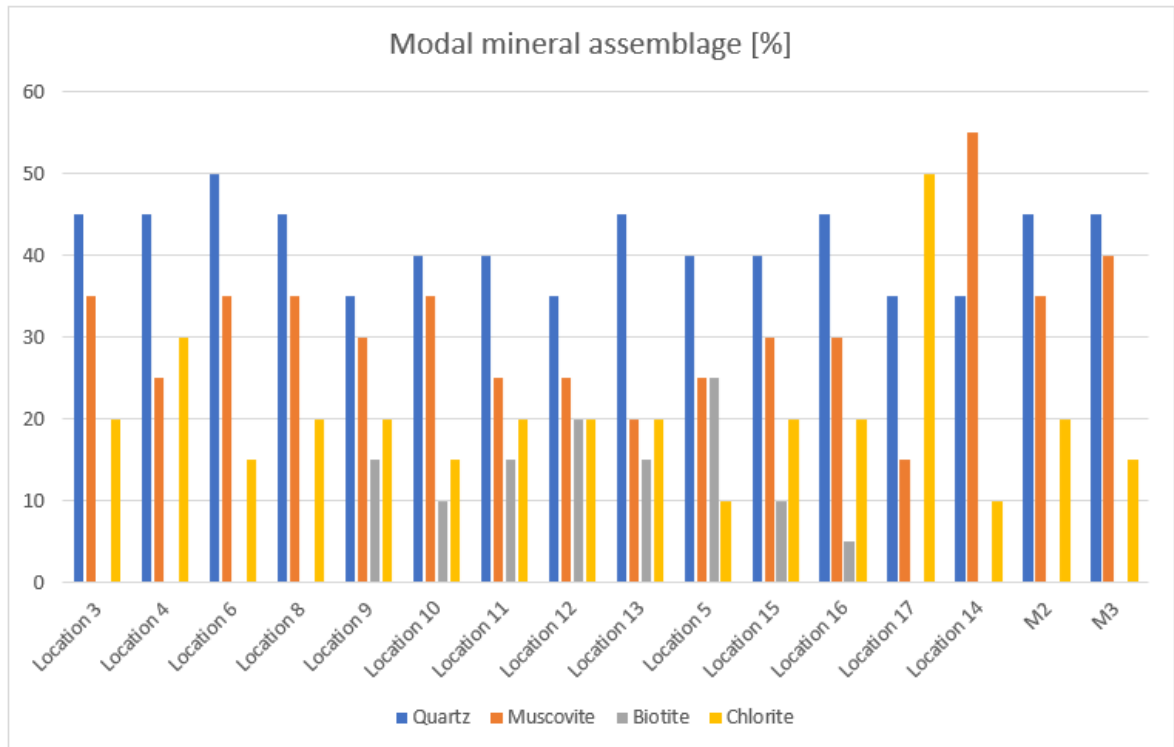
Figure 25 Mineral assemblage observed in each sample; the samples are listed according to the altitude recorded with location 5 representing the highest location and 1 & 14 the lowest.

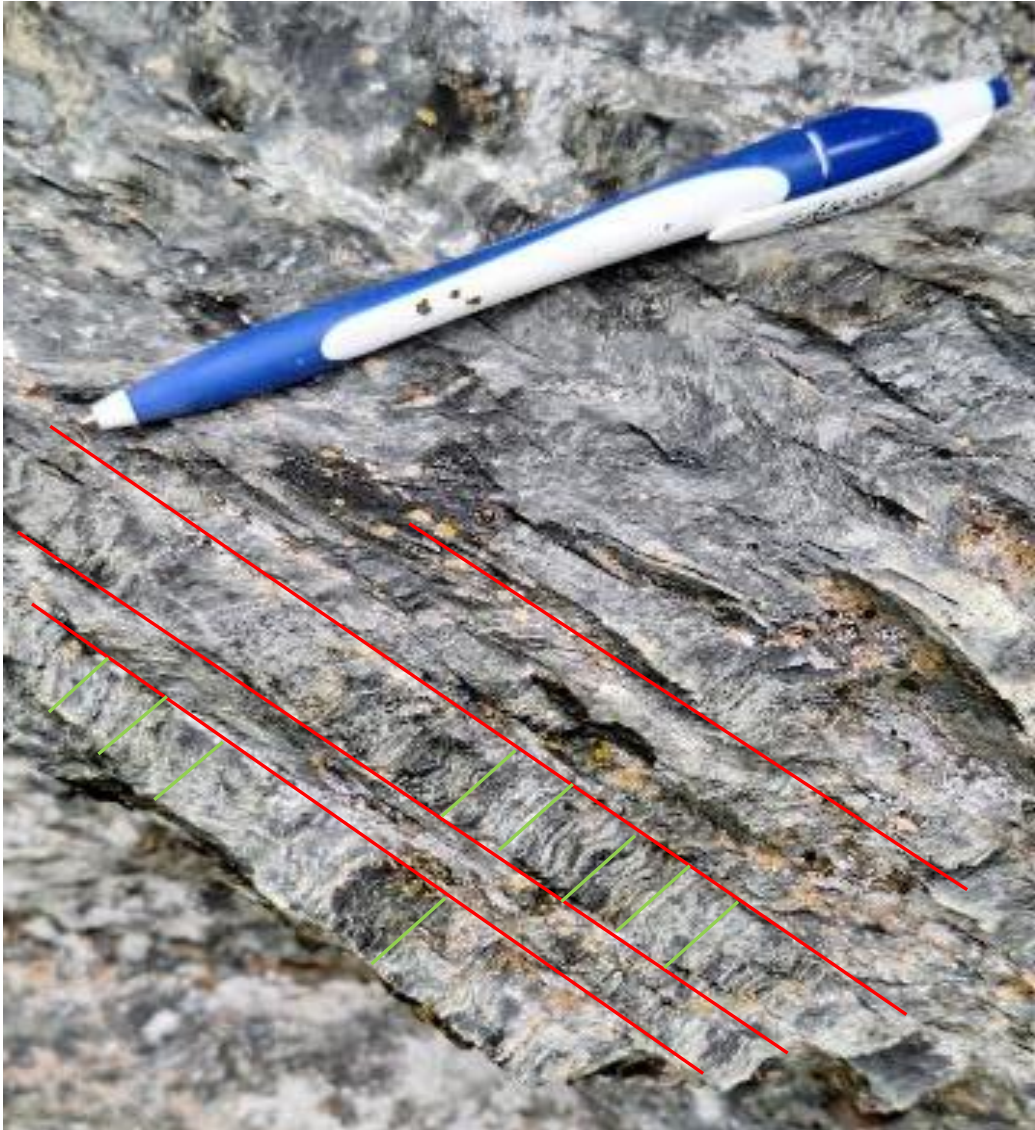
Figure 26 Two generations of schistosity S1 (green) and S2 (red)

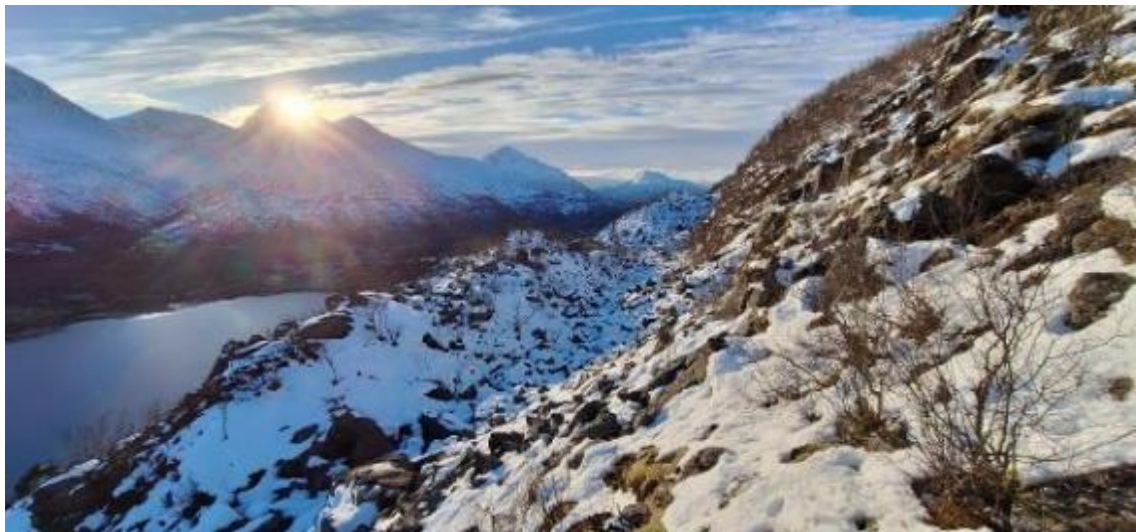
Figure 29 Big scarp and counterscarp

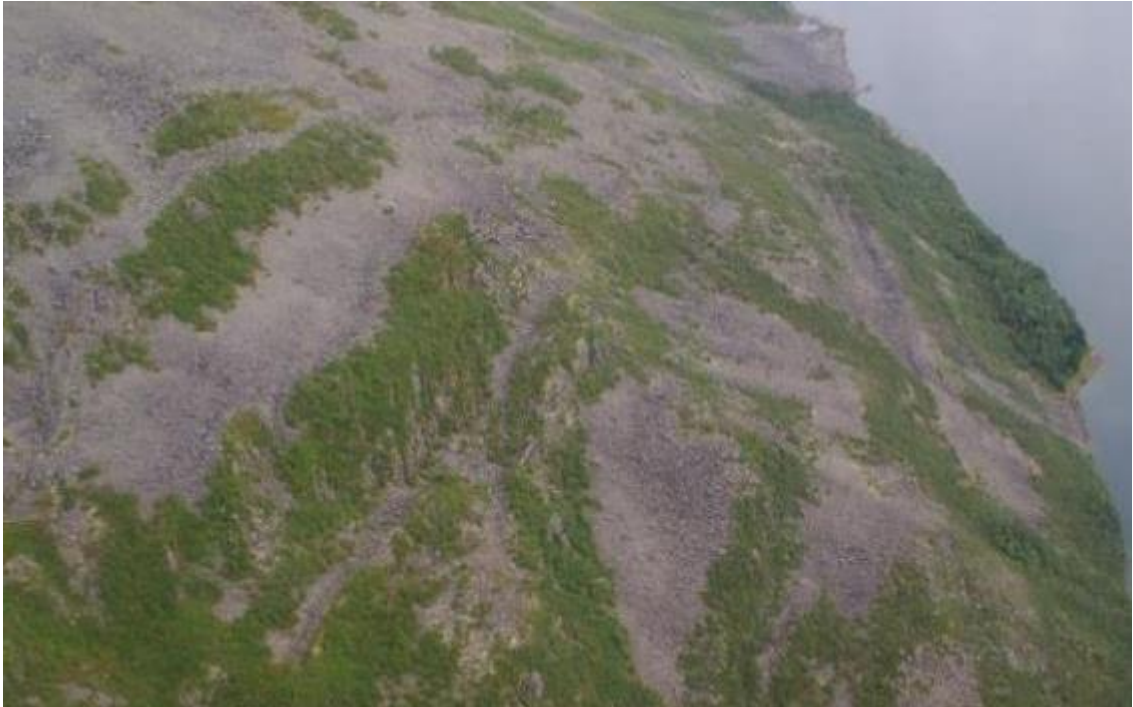
Figure 30 In the front left corner: big scarp and counterscarp; in the back right corner: small scarps covered by boulders (Photo taken by NGU 2019)

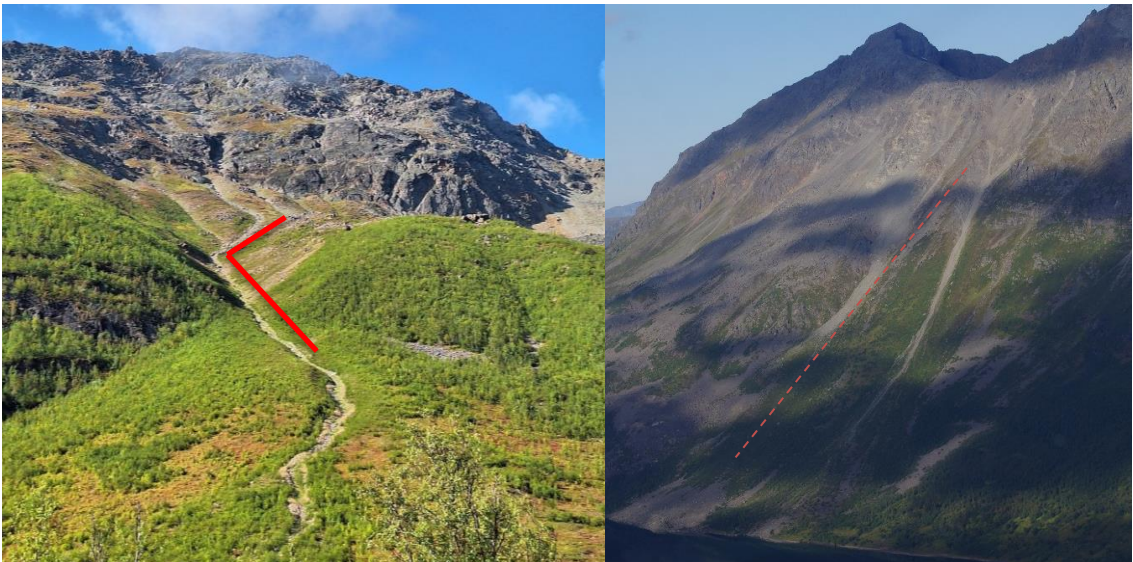
Figure 31 Southern (left) & northern (right) lateral boundary (red; inferred limit: dotted line) with debris flow tracks (Photo to the left taken by NGU 2019)

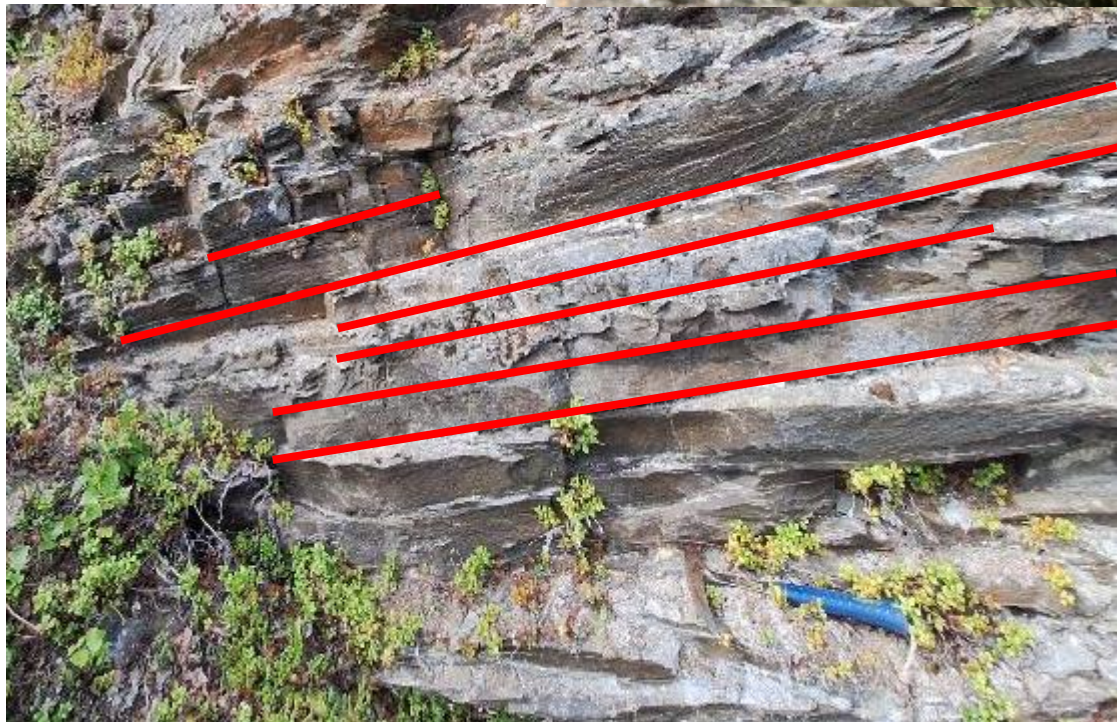
Figure 33 Foliation set projection; Foliation expressed in the field (picture top right taken by NGU 14/08/23)

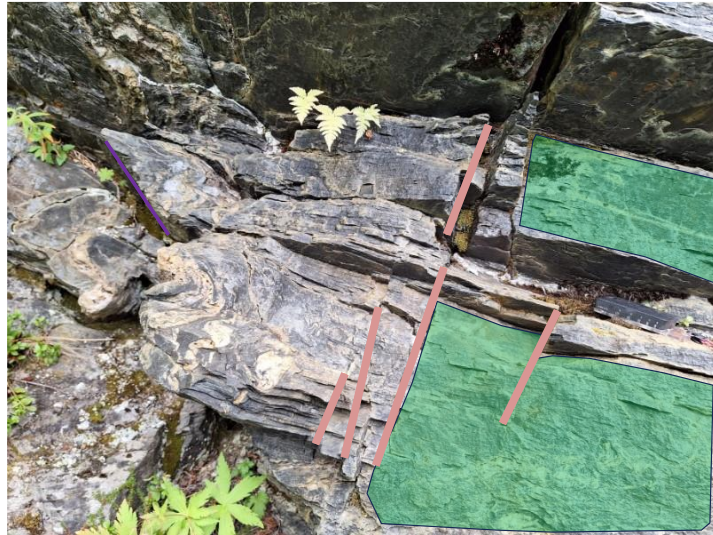
Figure 35 Joint set 1 (orange) & 2 (green) at location 7

At Seidi, three joint sets are observed (Figure 34). Joint set 1 (orange) dips at 80° to the west (103°). The other two sets are considered to be conjugate. Joint set 2 (green) dips NNE (335°) at 89° , whereas joint set 3 (purple) strikes 87° to the SE (228°). These conjugate joint sets are best observed at locations 10-16 (Figure 36, Figure 37, Figure 38), excluding location 14. The joint set 1 is easily recognisable at the locations (Figure 20) 1, 3, 5, 7 (Figure 35), 11, 12 and 14-17 (Figure 38). With regard to the dip direction, sets 1 and 2 are oblique to the foliation compared to joint set 3, which is roughly parallel. Since all the fracture planes dip very steeply, the joint sets comprise areas on opposite sides of the stereonet. Some examples of how the joint sets are represented in the field are shown in Figure 35 to Figure 38.

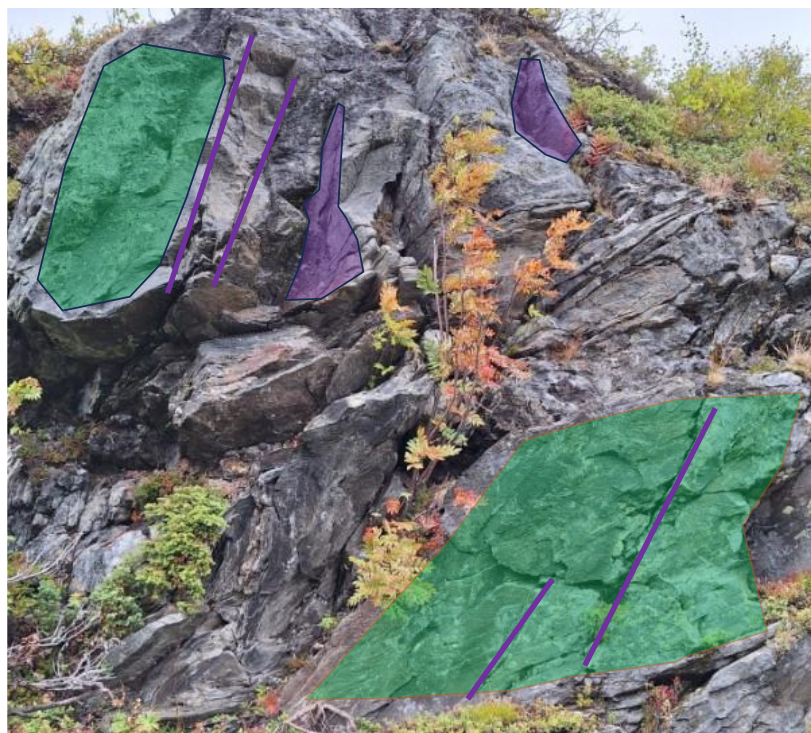
Figure 36 Joint set 2 (green) & 3 (purple) at location 10

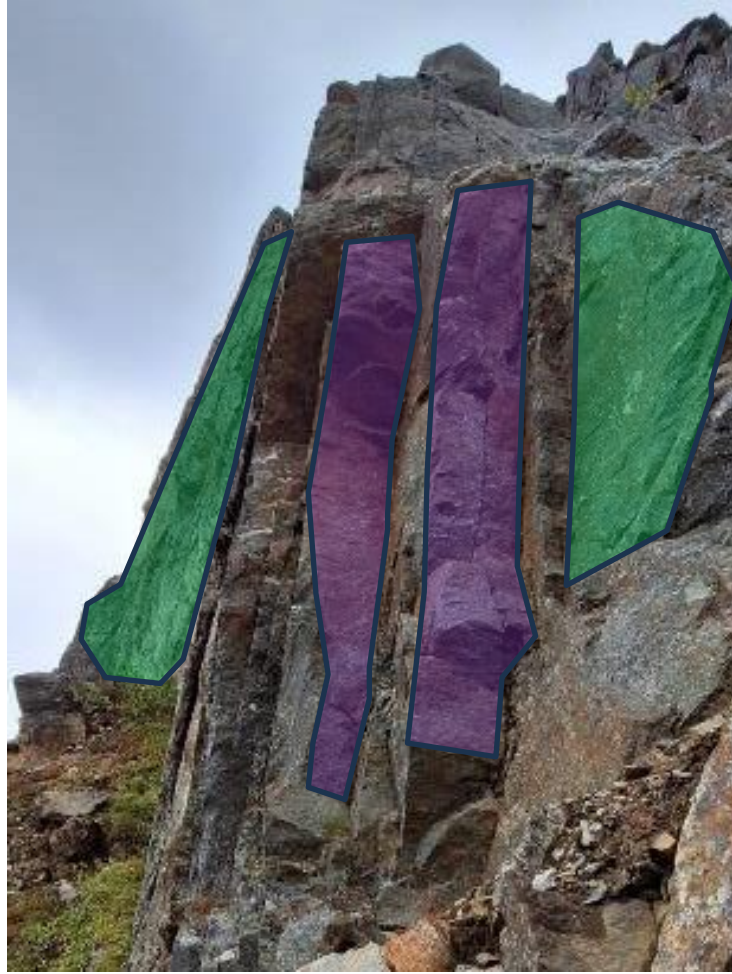
Figure 37 Joint set 2 (green) & 3 (purple) at location 13

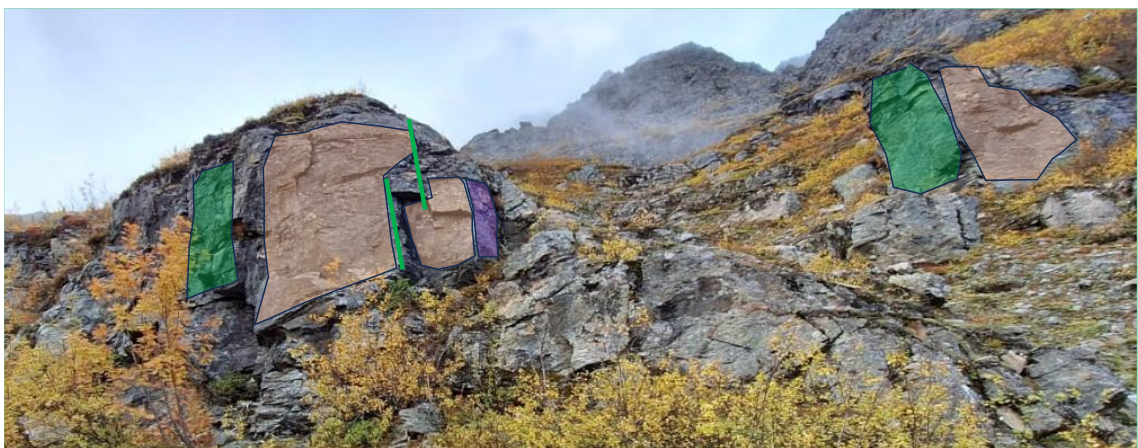
Figure 38 Joint set 1 (orange), 2 (green) & 3 (purple) at location 16

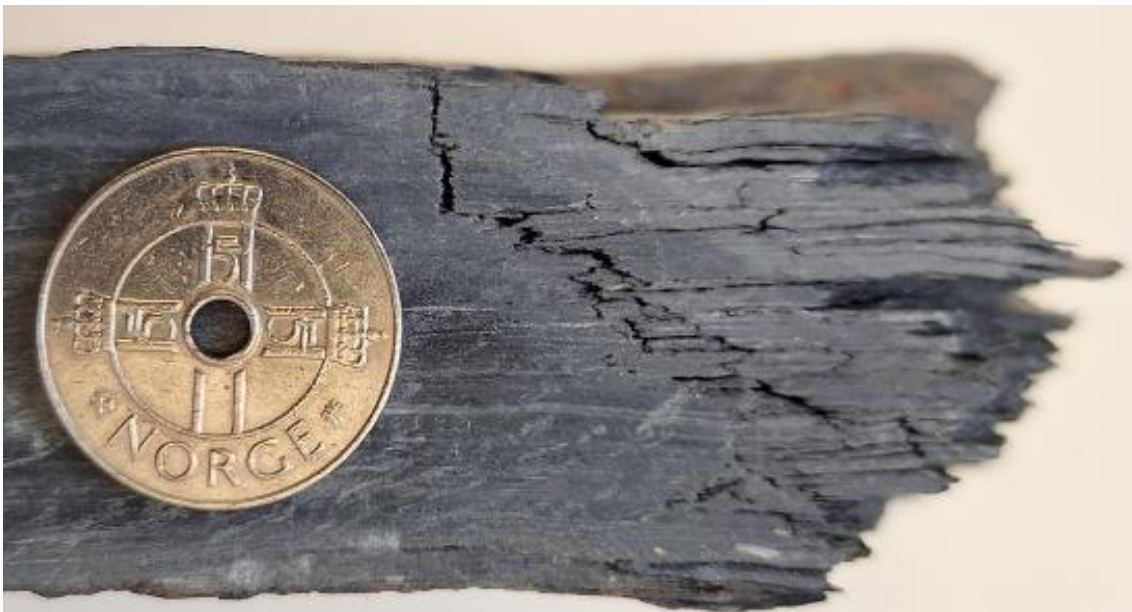
Figure 44 Stepped fracture in a phyllite.

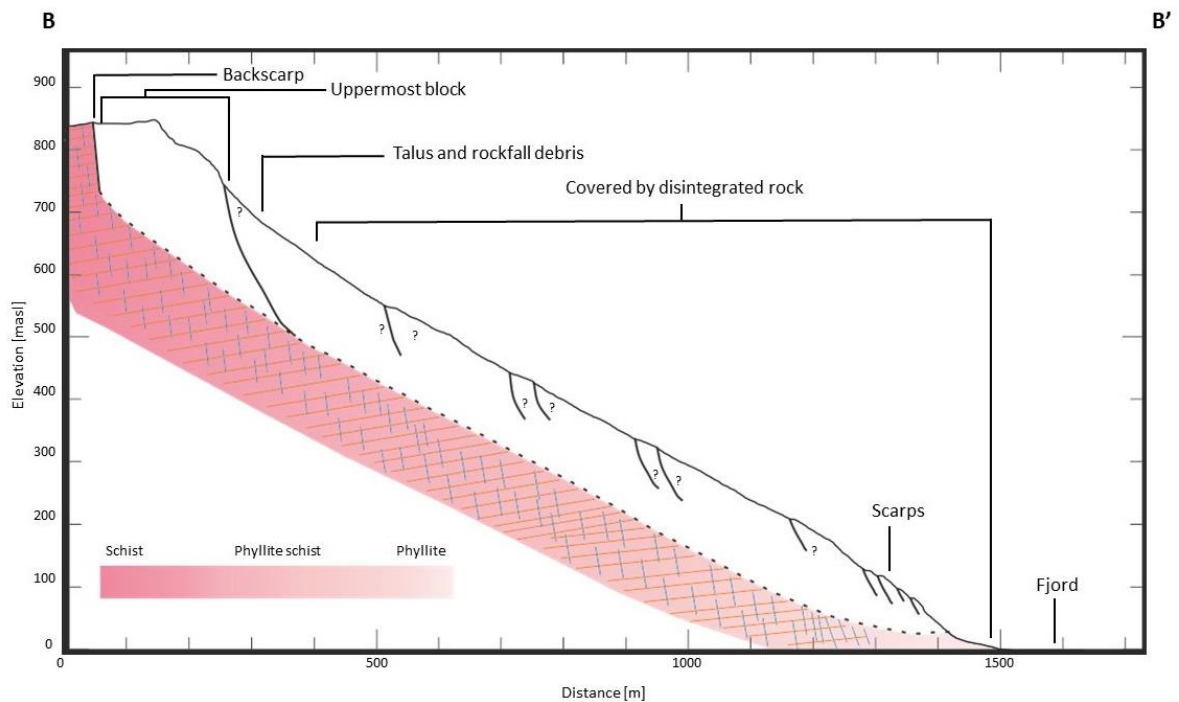
Figure 52 Geological interpretation along cross-section B-B', The elements that are interpolated are marked with a question mark as their presence cannot be confirmed as a cover of disintegrated rock might obstruct them. The foliation is drawn in orange, and the joints are blue in the cross-sections. The other structures are drawn in black and represent the interpreted morphological elements present. The dotted line represents the interpreted rupture surface and is not observable in the field. Drawn with CorelDRAW

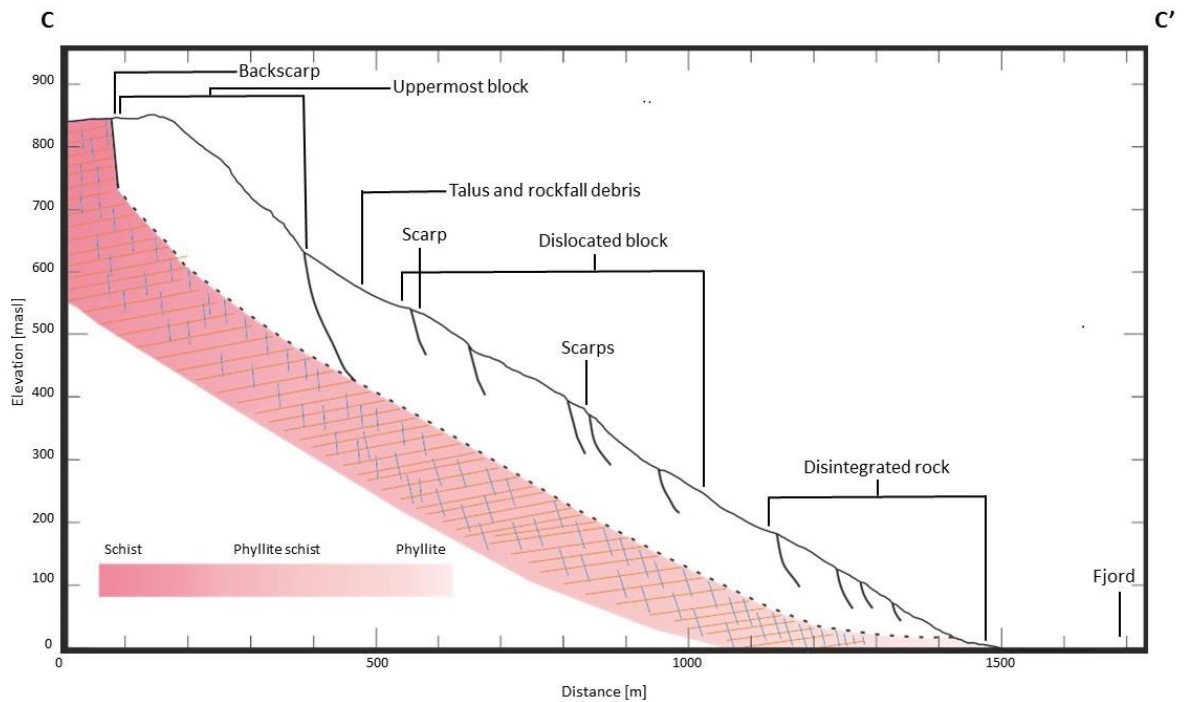
Figure 53 Geological interpretation along cross-section C-C', foliation is drawn in orange, and the joints are blue in the cross-sections. The other structures are drawn in black and represent the interpreted morphological elements present. The dotted line represents the interpreted rupture surface and is not observable in the field. Drawn with CoreDRAW

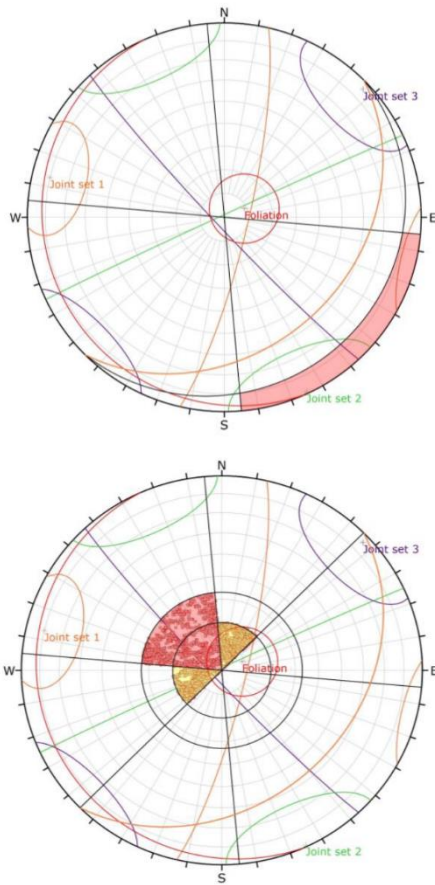
Kinematic Analysis		Flexural Toppling		
Slope Dip	33			
Slope Dip Direction	135			
Friction Angle	20°			
Lateral Limits	40°			
		Critical	Total	%
Flexural Toppling (All)		24	405	5.93%
Flexural Toppling (Set 13: Joint set 1)		6	65	9.23%
Flexural Toppling (Set 14: Joint set 2)		17	86	19.77%
