Full-scale tests of deicing with seawater

Ane Sæterdal^{*}, Per-Arne Sundsbø

Dept. of Building, Energy and Material Technology, The Arctic University of Norway, UiT, Campus Narvik, Lodve Langesgate 2, Narvik 8514, Norway

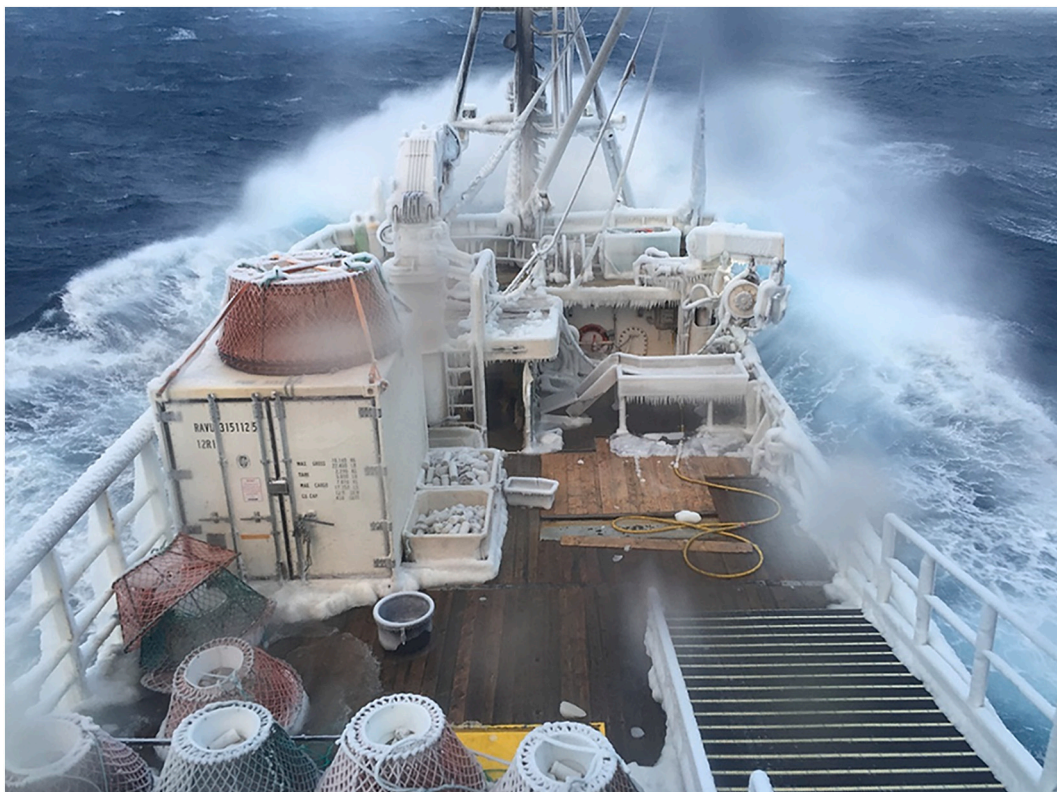
Fig. 1. Anti-icing measure on the M/S Northeastern traveling in sea-spray icing conditions (Birkeland, 2023).

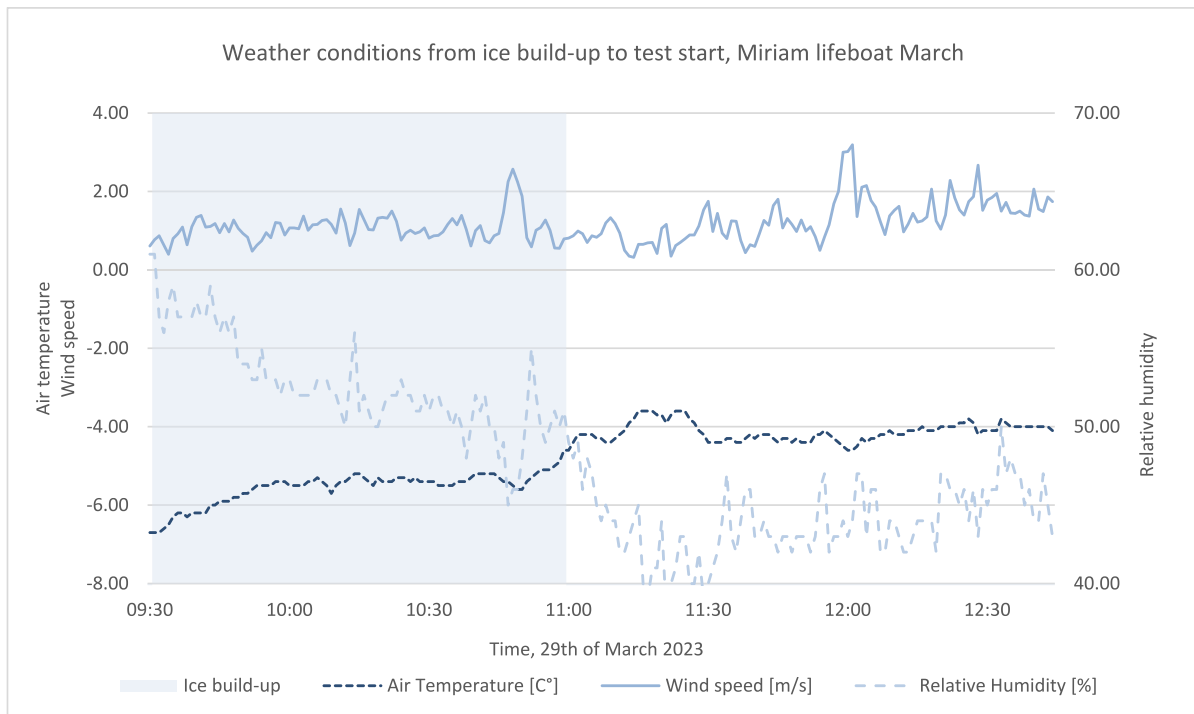
Fig. 3. Weather conditions from ice build-up to test start, Miriam lifeboat March, data from Gill weather station mounted on the vessel.

Similarly, on the 29th of March the air temperature, wind speed and relative humidity were logged with 1-min intervals, see [Fig. 3](#). The data was gathered by the Gill weather station mounted on the lifeboat, see

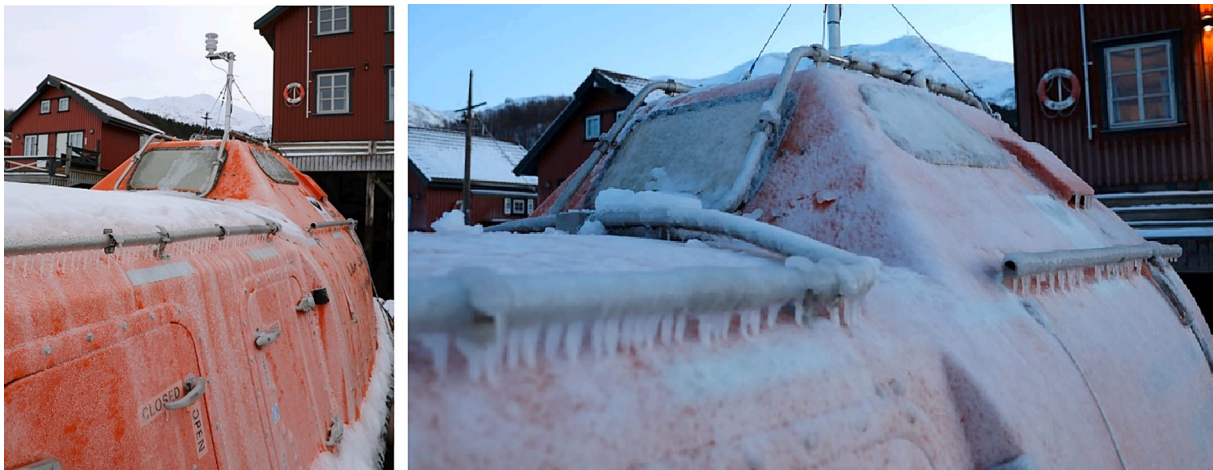
Fig. 8. Ice layer on the Miriam lifeboat prior to tests, March (left) and January (right).

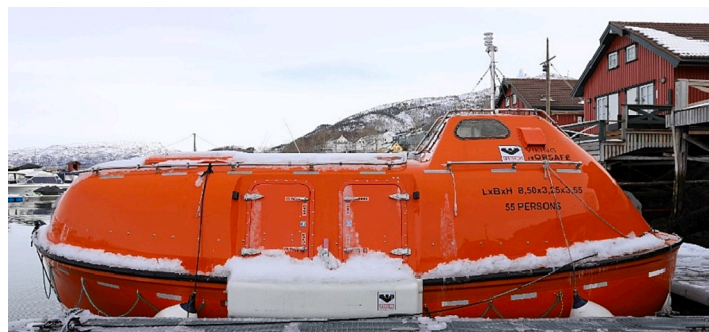
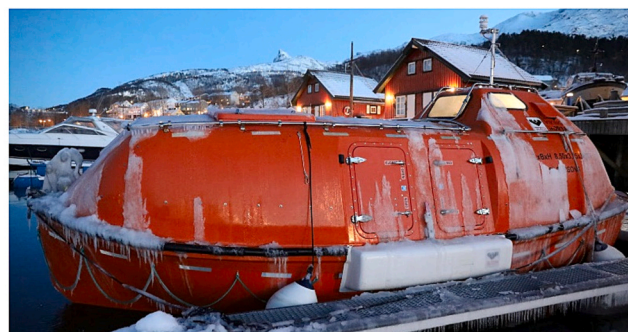
Fig. 10. Portside after the deicing procedure in March (left) and January (right).

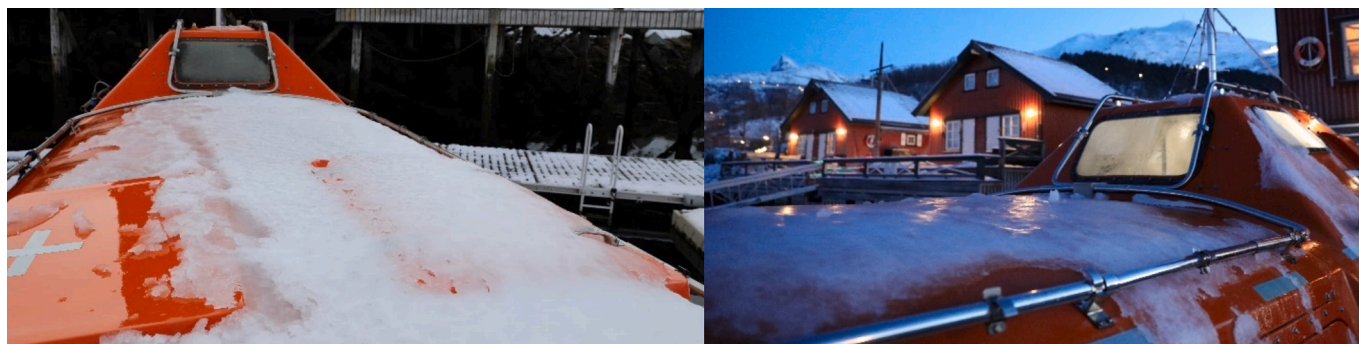
Fig. 12. Ice on the roof after deicing test Miriam lifeboat, March (left) and January (right).

On the roof, the surface is horizontal with minimum help of gravity for water distribution and ice removal. In addition, the ice thickness was greater on the roof compared to the sides of the vessel for both tests. Consequently, the sprinkler water distribution system was not sufficient to fully remove the ice. In January, with an average initial ice thickness of 17 mm on the port side of the roof, the remaining ice layer was reduced in thickness, and locally deiced areas occurred, see Fig. 12. The

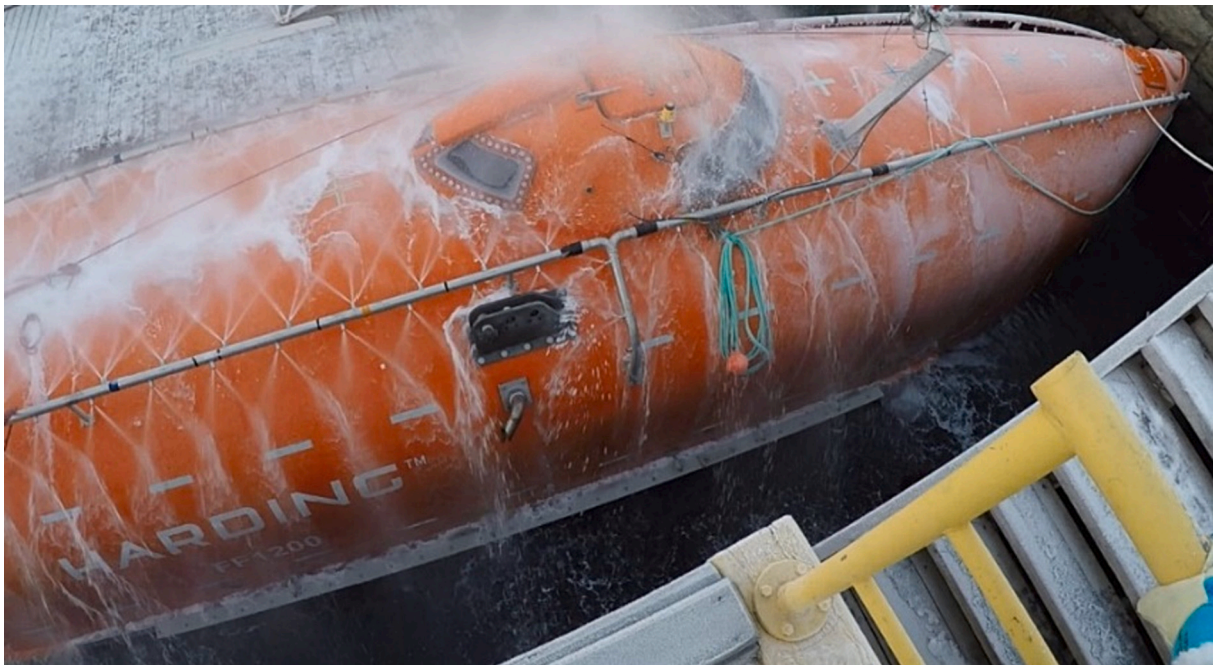
Fig. 15. Deicing of the Palfinger FF1200 lifeboat (Sundsbø and Jacobsen, 2018).

The nozzle design is an important element of the seawater distribution system. A fully operational system is essential for vessel safety. The two tested lifeboats have different solutions for the nozzle design, as can be seen in Figs. 19 and 20. On the Miriam lifeboat holes in the distribution pipeline allow water to exit, and a metal sheet deflects and spreads the water on the vessel's surface. The angle of this shield greatly affected the water distribution, and the flexible sheet was easy to distort reducing its performance. During the icing phase, the metal sheet largely protected the pipeline from clogging. During the experiments on the Miriam lifeboat the seawater was applied manually, and the result could have been less favorable with ice created from sea-spray due mainly to the lateral wind forces. The FF1200 Lifeboat had an ice layer created by sea-spray during operational conditions, and some of the extruded nozzles clogged as a layer of ice encapsulated the nozzles. Once the nozzles thawed the water was finely distributed, as can be seen in Fig. 15.

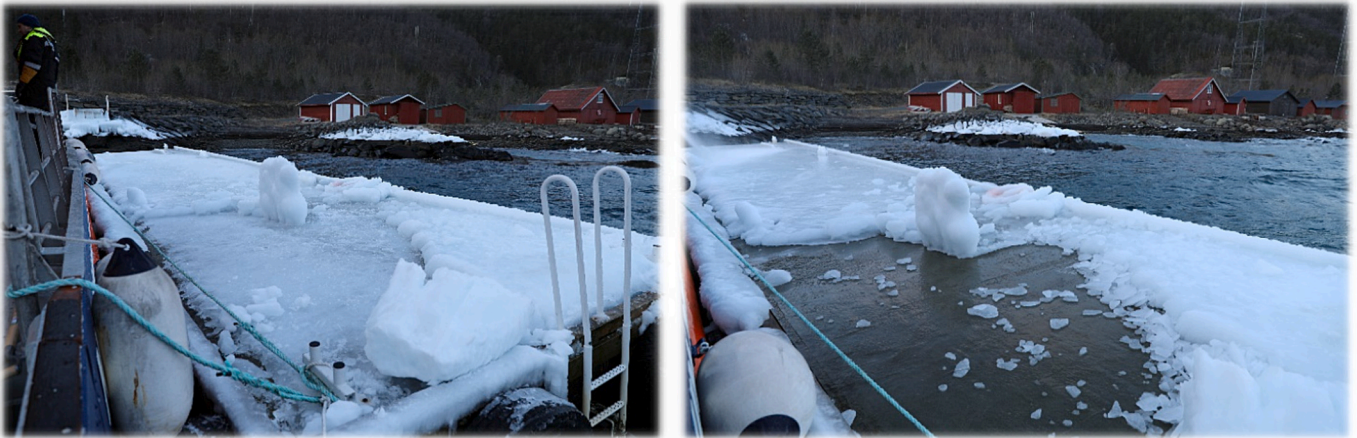
Fig. 17. The pictures show the dock at arrival and close to the end of the experiment.

The main efforts for deicing were concentrated at the Southwest half of the dock, with the aim of reducing the ice load on this side to stabilize the structure. The seawater was sprayed at a slow pace across the 20-m-long edge, back and forth. About halfway through the procedure, the deicing effort was directed towards the part of the dock where the effect was most visible. Fig. 17 shows the dock before and after the

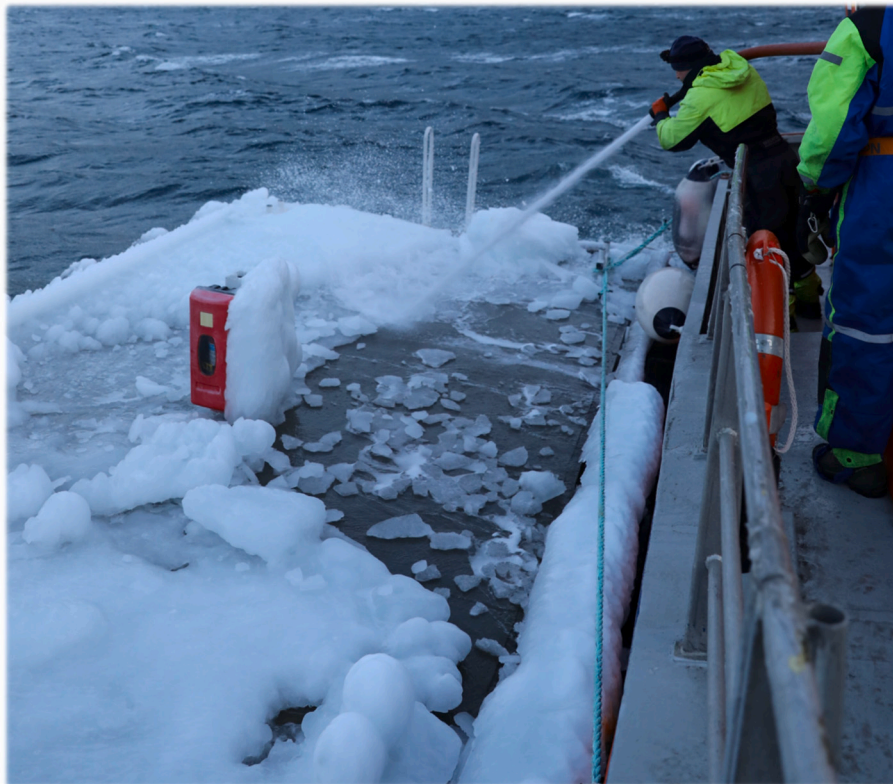
Fig. 18. Ice break-up when removing ice with a fire hose at full capacity.

experiment. Ice was removed due to the thermal capacity of the water but also broken apart by the impact of the concentrated jet from the fire hose. When aimed at the separation line between the substrate and ice edge, the water jet effectively broke apart pieces of ice, see Fig. 18. For approximately 8 min the spray was focused on the eventually deiced area, and the first 2 min had reduced engine power. The deiced area measured approximately 11 m², resulting in an ice removal rate of roughly 4130 kg/h, given an assumed ice density of 0.91 Mg/m³ (Timco

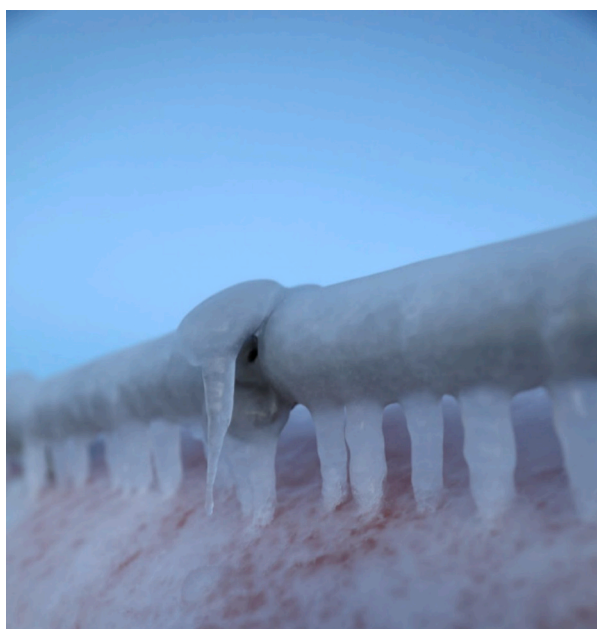
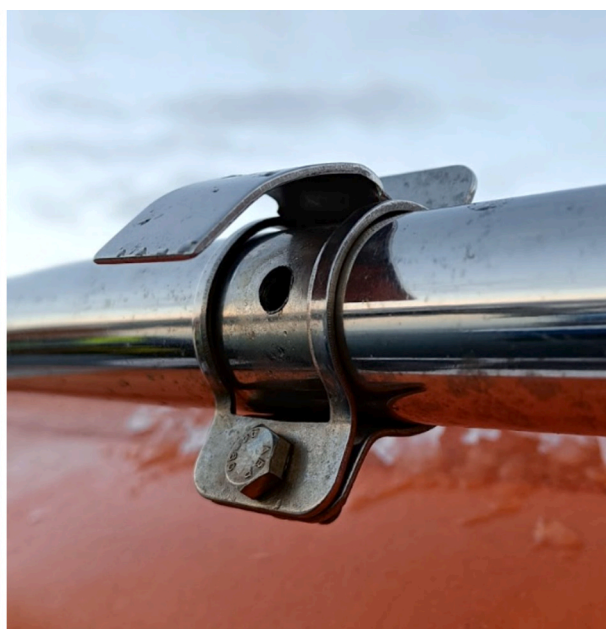
Fig. 19. Sprinkler nozzles before and after deicing the Miriam lifeboat.

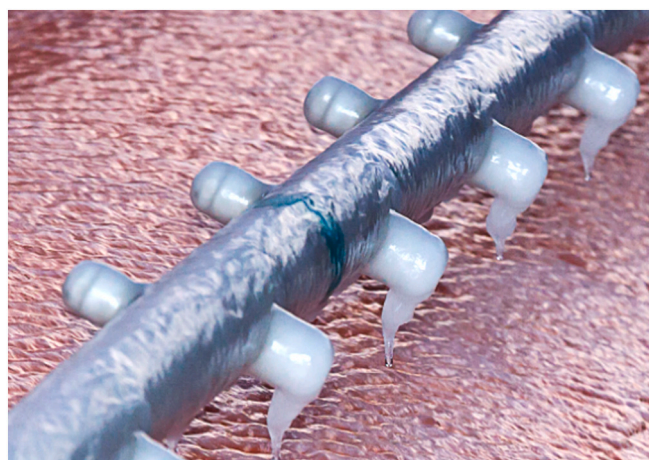
Fig. 20. The Palfinger FF1200 lifeboat sprinkler nozzles before deicing (Sundsbø and Jacobsen, 2018).

Metoccean conditions during the sea-spray icing test were measured by two Aanderaa weather stations, see Table 3, one on the lifeboat and the second on the support vessel. In addition, a rider buoy was launched to measure wave height. The conditions during ice build-up in the Ofotfjord were an average air temperature of -9.2 °C, mean wind speed of 9.7 m/s, seawater temperature of 4.0 °C, and 1.3 to 1.5 m wave heights. The metoccean conditions correspond to fast icing, between 10 and 30 mm/h, according to the guidelines (ISO 19906, 2019). In the sea-spray icing test ice was accumulated on the lifeboat within the period of 1.5 h. Flushing and consequently ice removal was observed in certain areas when using provocative maneuvers to increase the frequency of sea-spray. Fig. 13 illustrates the initial ice layer distribution on the vessel before deicing, and Fig. 20 shows a close-up of the ice and sprinkler system.
