Structural geometry and controlling factors for a rock slope failure area at HOMPEN/VÁRÁŠ, Signaldalen, Troms, North Norway

Maria Hannus

May, 2012

FACULTY OF SCIENCE AND TECHNOLOGY  
Department of Geology

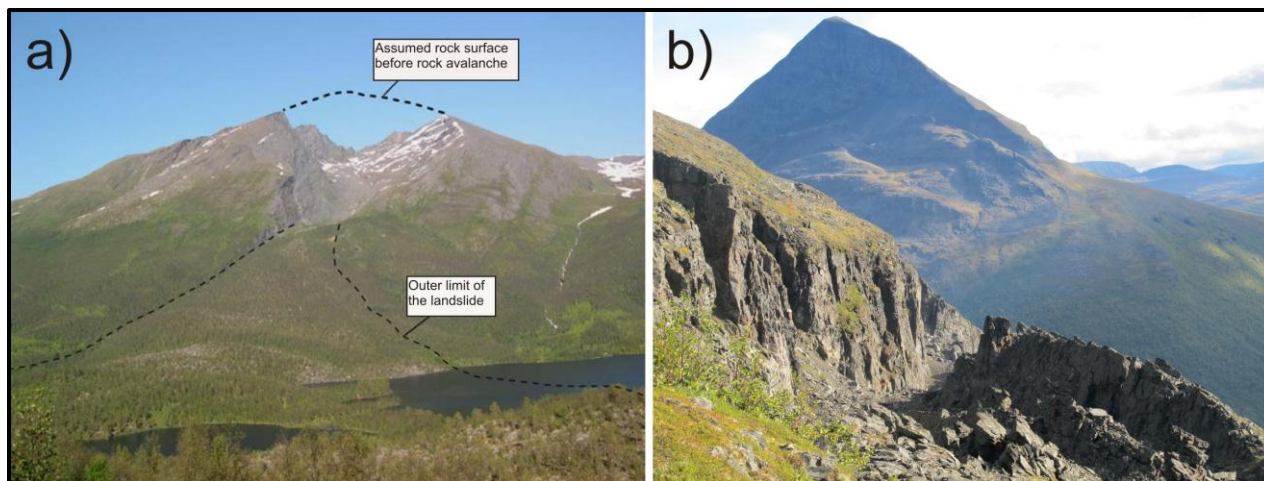
**Figure 1.2:** Examples of big RSF in Troms. (a) Huge triangular cleft in the mountain Hølen, Balsfjord , collapse of 100mill.m<sup>3</sup> (Modified from Blikra et al., 2006a). (b) View of the collapsed northern scarp of the peak Paras (500 million m<sup>3</sup> ) in Signaldalen. View is through the graben at Hompen looking south.

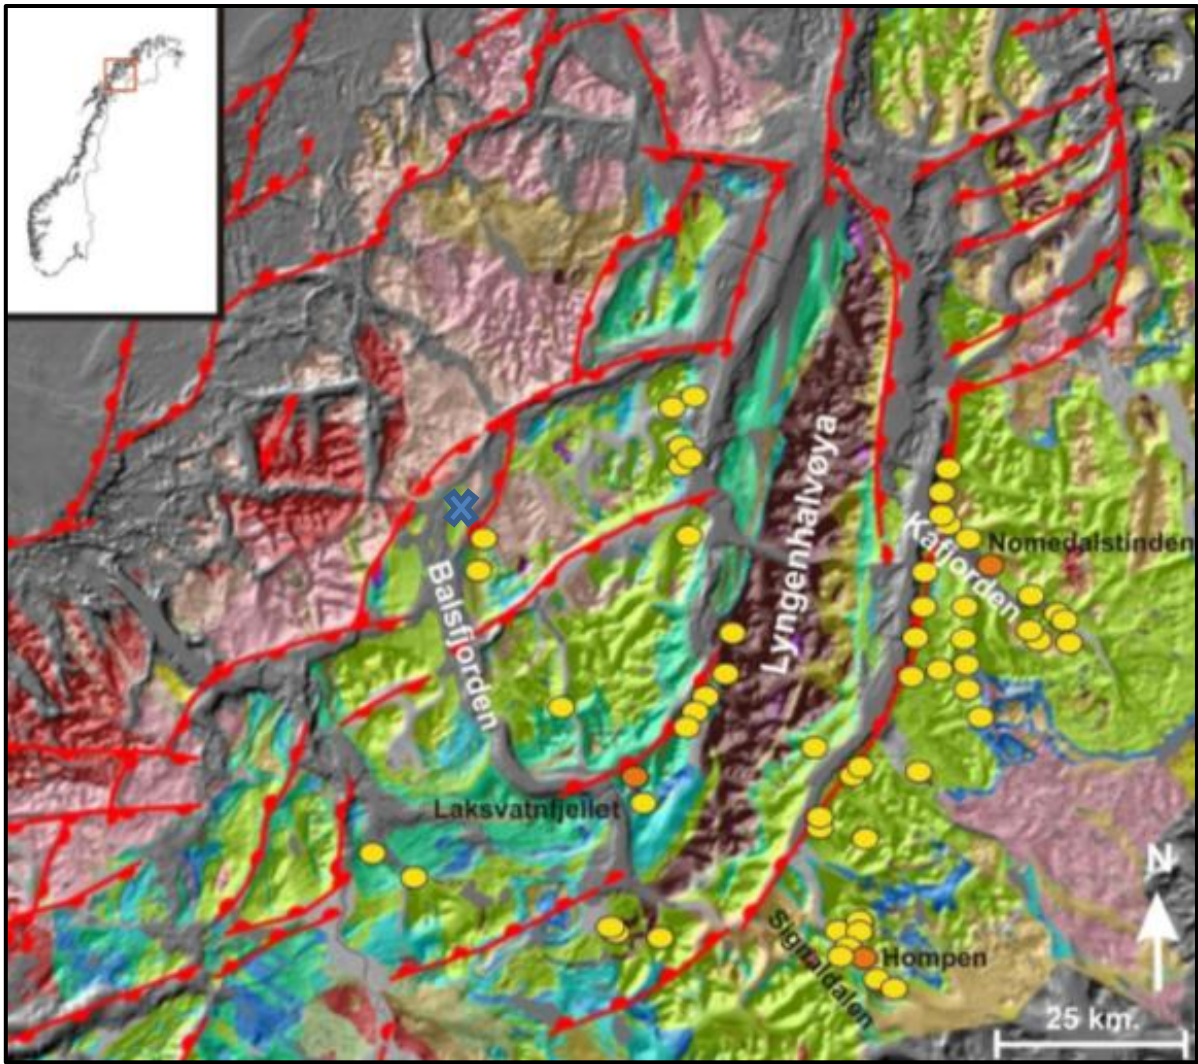
Figure 1.4: Regional DEM image and lineament map showing the studied RSF areas (Laksvatnfjellet, Nomedalstinden and Hompen) in addition to several other RSF's mapped by NGU (labeled by yellow dots). Tromsø is marked with X on the lineament map (Modified from Hansen et al., 2011).

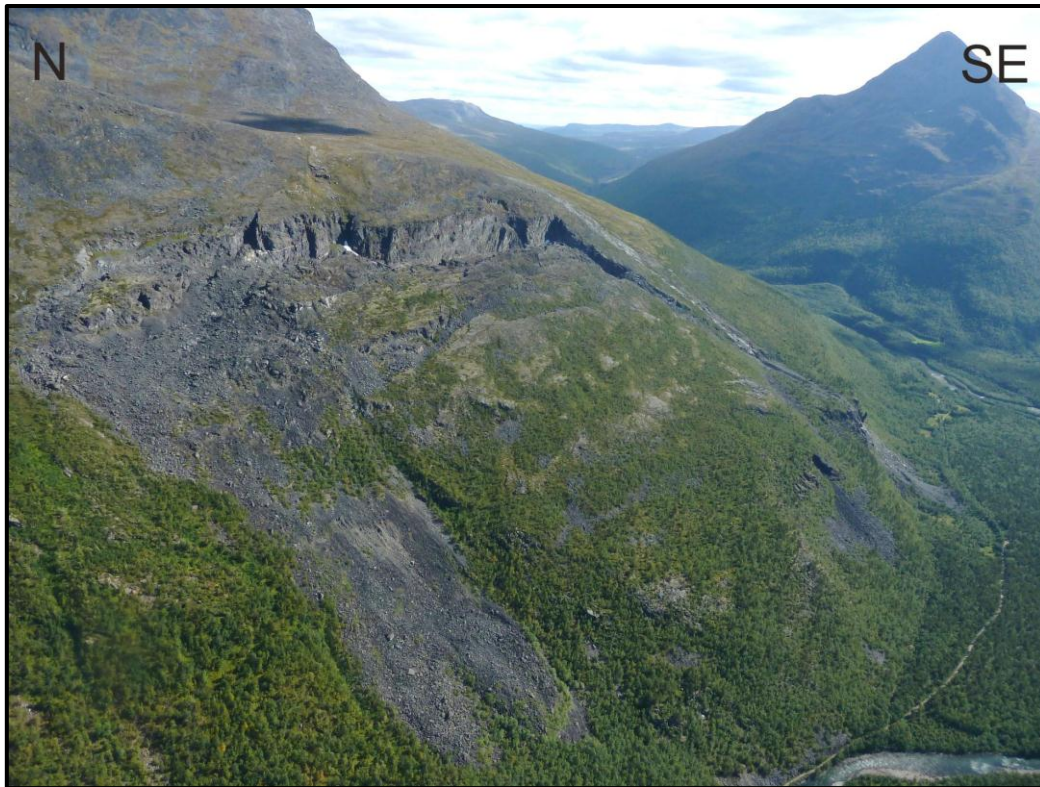
**Figure 1.6:** Photo showing the SW facing slope of the the RSF at Hompen/Varas. The clear back scarp striking NW-SE and the southern scarp striking SW-NE (photo by Bunkholt 2011).

The study area is situated on a steep southwest-facing mountain side, just above the Signaldalen river. The unstable mountain slope starts on an elevation of c. 200 m a.s.l. (Fig. 1.6). The lower part of the hillside typically consists of talus, which has been vegetated by bushy birch wood, and the lower slope has angles up to  $45^\circ$ . The whole mountainside has an average dip angle of about  $35^\circ$ , up to the back scarp which marks the upper termination of the RSF and being located at c. 550 m a.s.l. The back scarp is an un-traversable vertical wall c. 100 meters high (Fig. 1.6). From the back scarp up to the shoulder, the dip angle is around  $30^\circ$ . The landscape on the top shows a plateau-like morphology. The total RSF area is between c. 0.63-1.5 km<sup>2</sup> (Fig. 1.6).

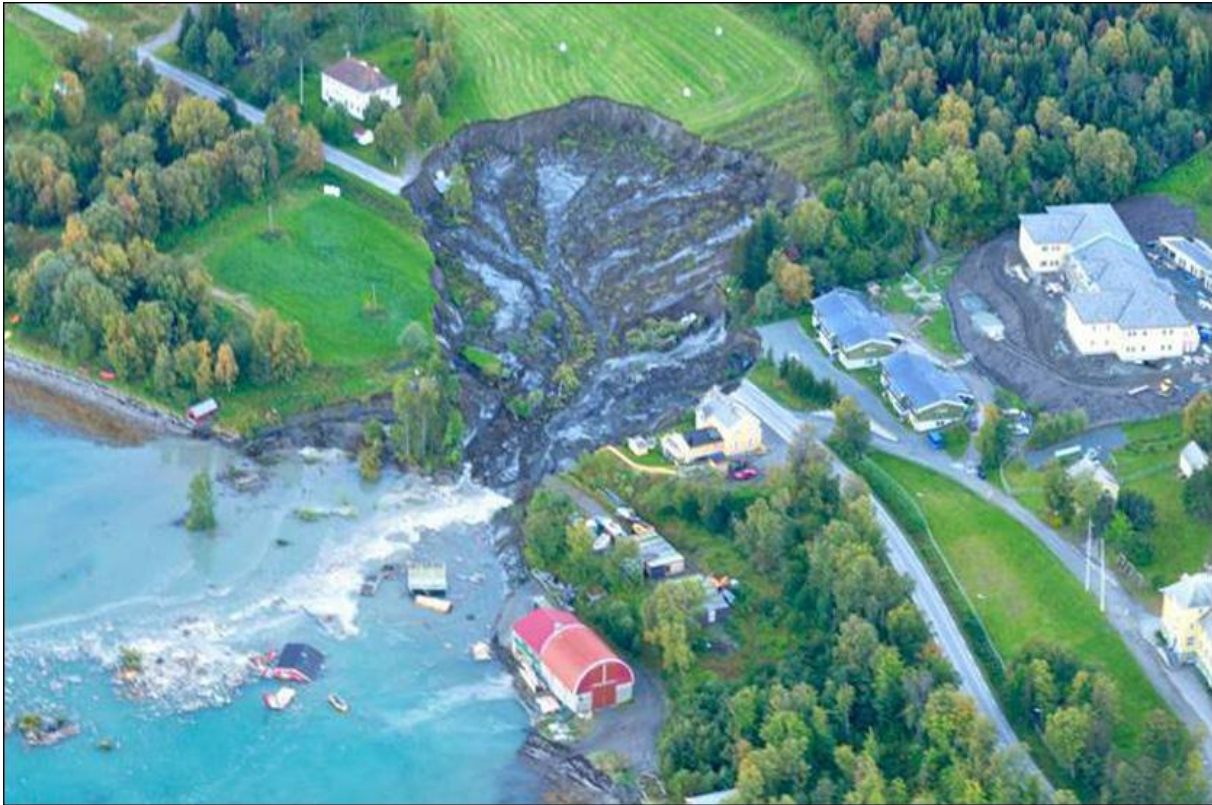
**Figure 1.11:** Photograph showing the outline of a mudslide in marine clay deposits near Lyngseidet. This slide occurred in September 2010 (photo by Andrea Taurisano/NVE).

In Troms there have been several glacial and interglacial periods. The area is still strongly affected by these processes, in the mountains we have daily weathering processes and in the low land we can see catastrophic effect of the marine sediments as huge mudflows (Fig. 1.11).

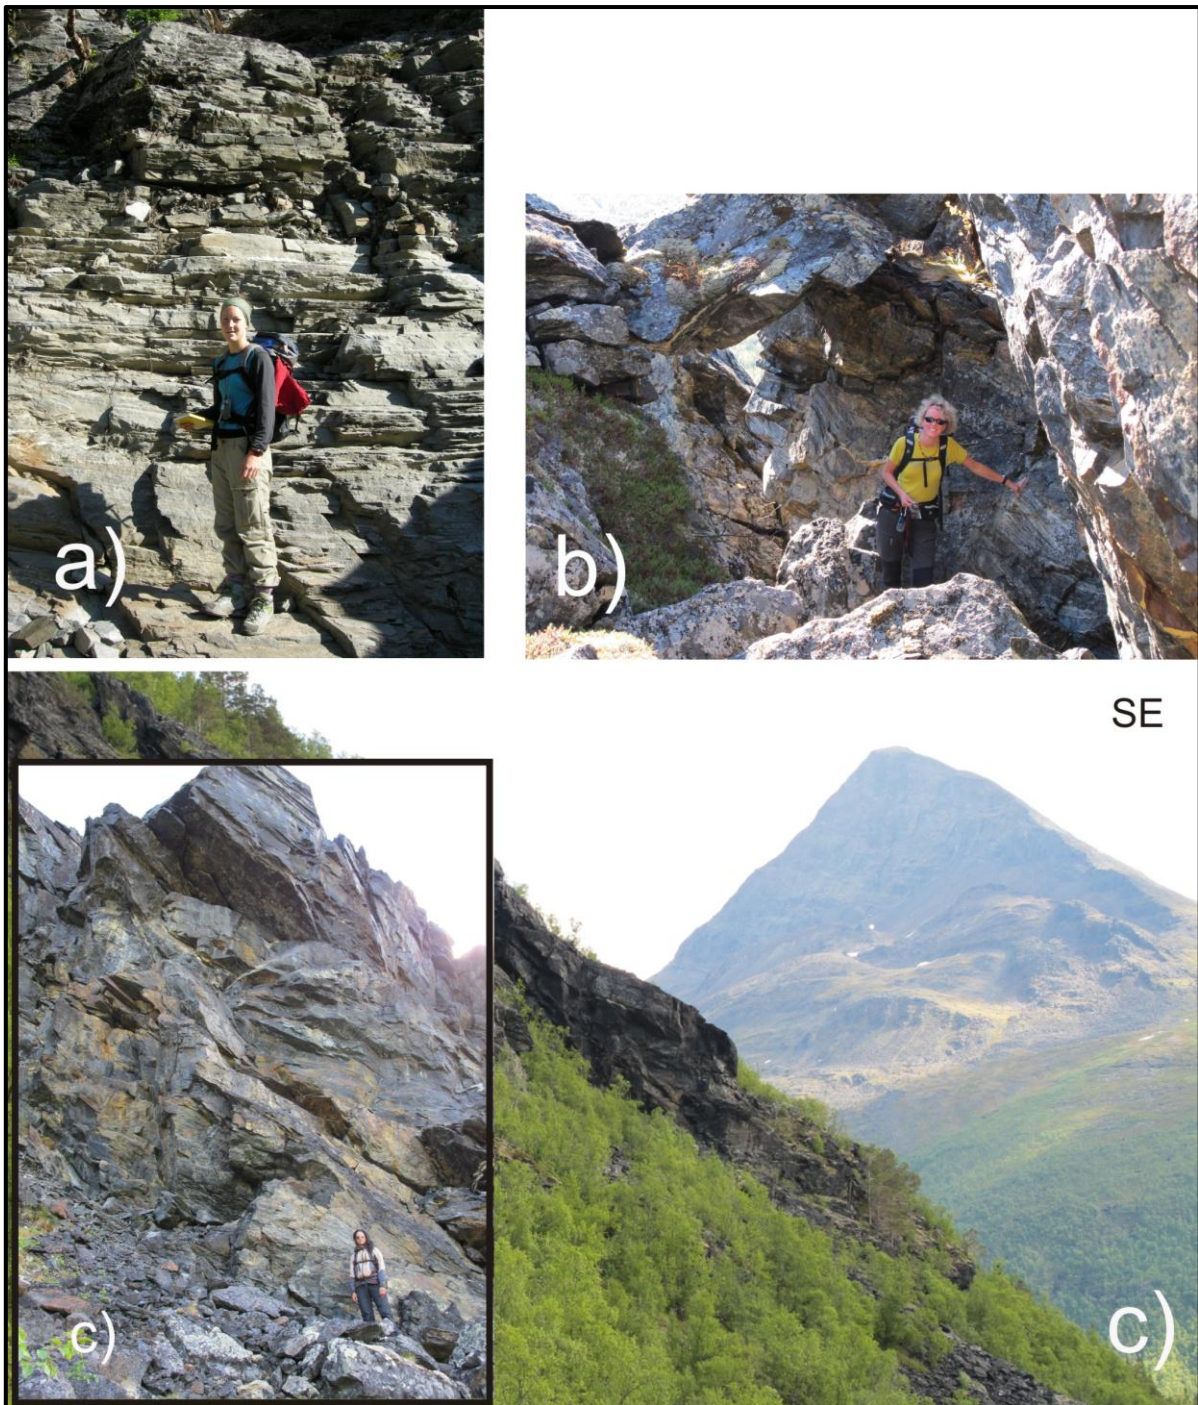
**Figure 3.4:** Illustration showing a) sub horizontal layers of mica schist's in the lowest part of the RSF area; b) the granite rock in the crevasse area above the toe zone scarps; c) the toe zone scarp consists of hornblende which is located on top of mica schist's.

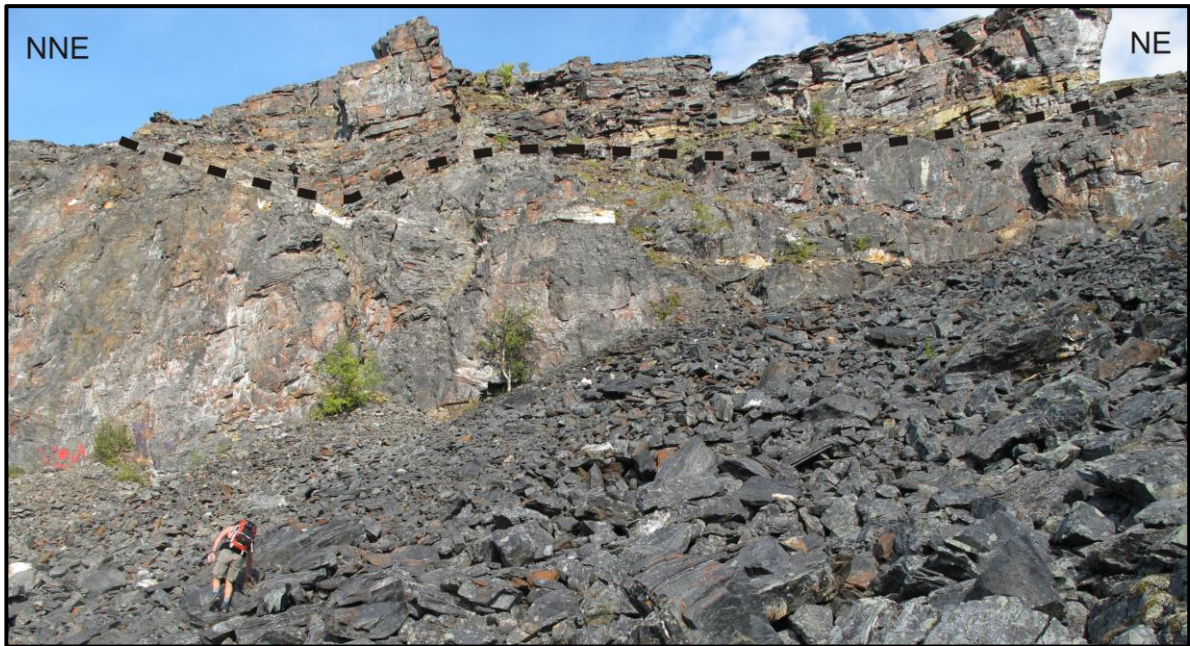
**Figure 3.5:** The photo shows a lithological contact between the more competent amphibolite and the fractured hornblende schist. Notice that the bedrock in the upper part of the scarp displays a more fractured appearance than the lower amphibolites. Photo is taken looking up from the talus area in the north of the RSF area.

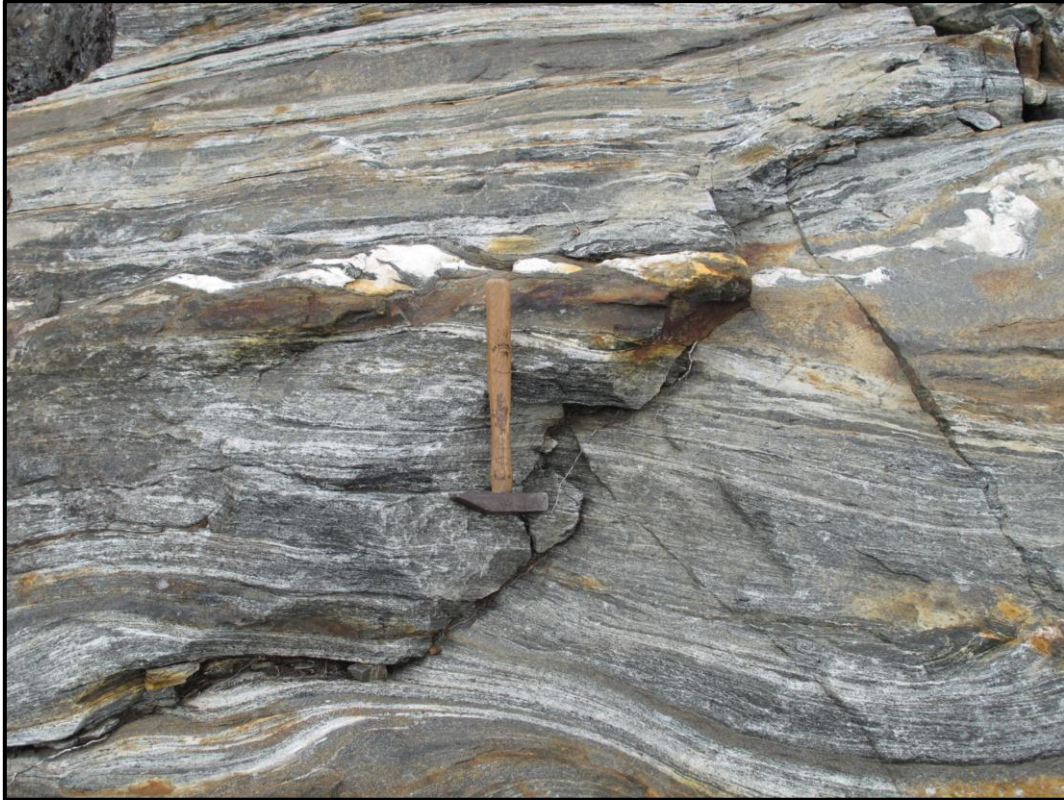
**Figure 3.8:** The photo illustrates a typical gneiss texture, with mylonitic and migmatic texture from the Hompen area.

Other gneisses show migmatite foliation which is highly irregular and undulating, a mixed rock (Fig. 3.8), migmatites are formed due to partial melting the new material crystallize to a leucosome and another part of the old material a mesosome which may have resisted the melting. These together form the new fabric, which gives a foliation to the rock. It is often seen that the new material is folded; local partial melting is one of the characteristics (Blatt et al., 2006).

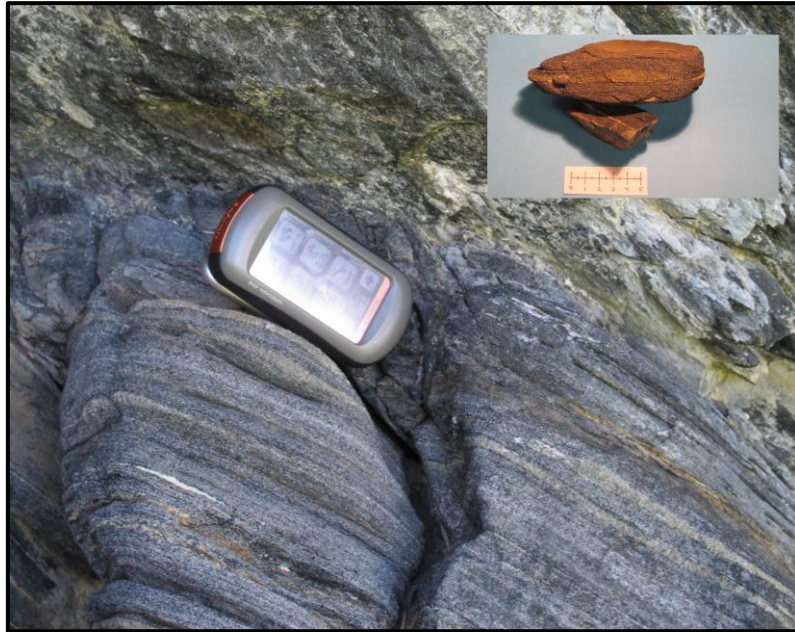
**Figure 3.10:** Amphibolite showing a high schistose foliation a flaky texture, the host rock has preserved older small lenses of an unspecified lithology this location is labeled (Fig. 3.3).

Mica schist's can be displayed in an infinite of variations, schist means split and gives the character for the rock. Schist's are formed by both high temperature and high pressure. The mica grains are aligned as well as hornblende and other flat or elongated minerals; this is what makes up the foliation. The percentage of aligned minerals decides if it will be called a schist or gneiss. If the texture has a very large amount of micaceous minerals, the rock will get a flaky texturing with easy cleavable layers the rock will be presented as having a schistose foliation (Fig. 3.10) (Fossen, 2010).

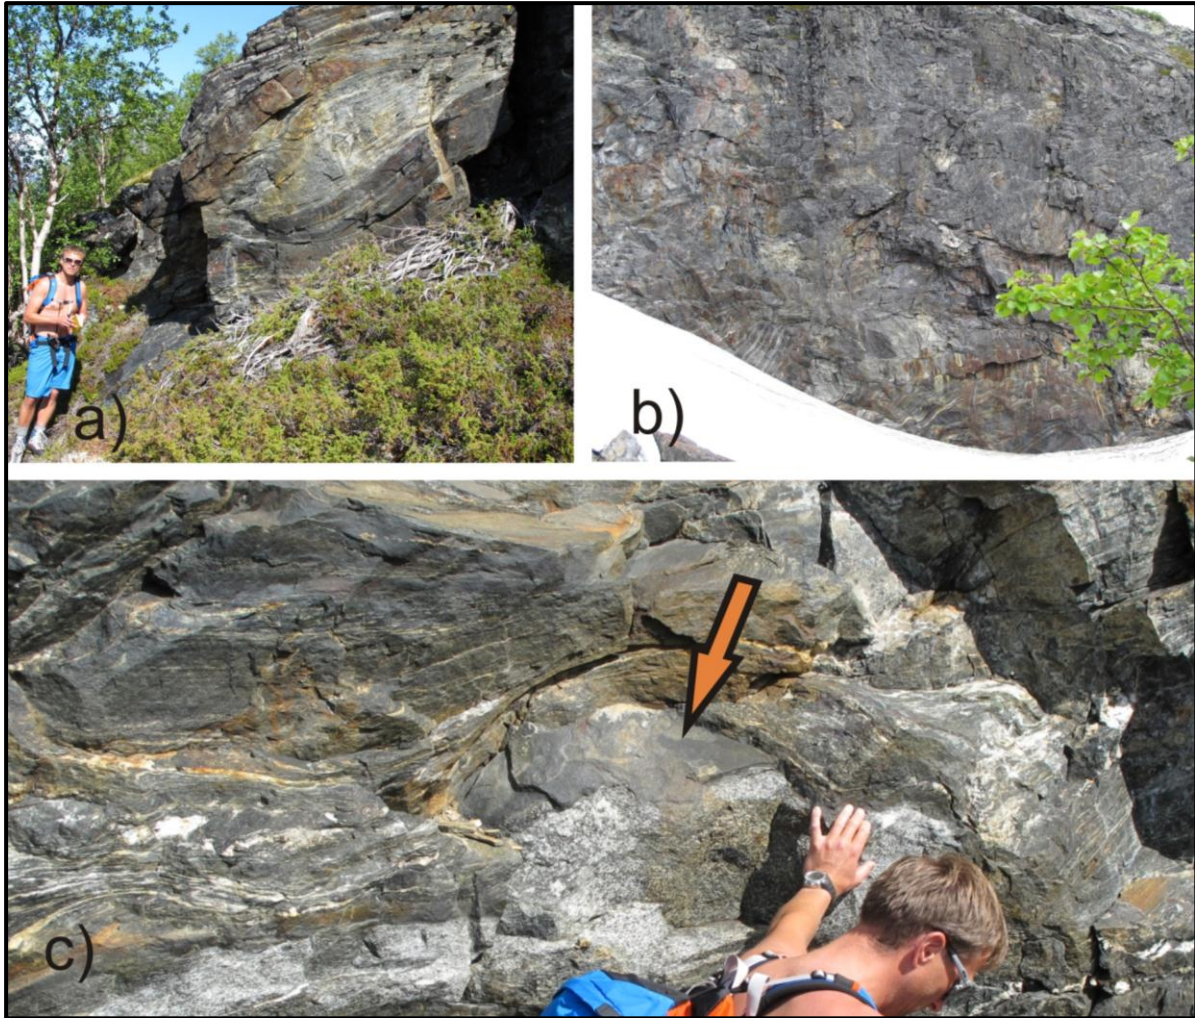
**Figure 3.12:** a,b) Lensoide structures in the bedrock, b) lenses of different lithology the surrounding rock can work as a sliding surface, as seen here.

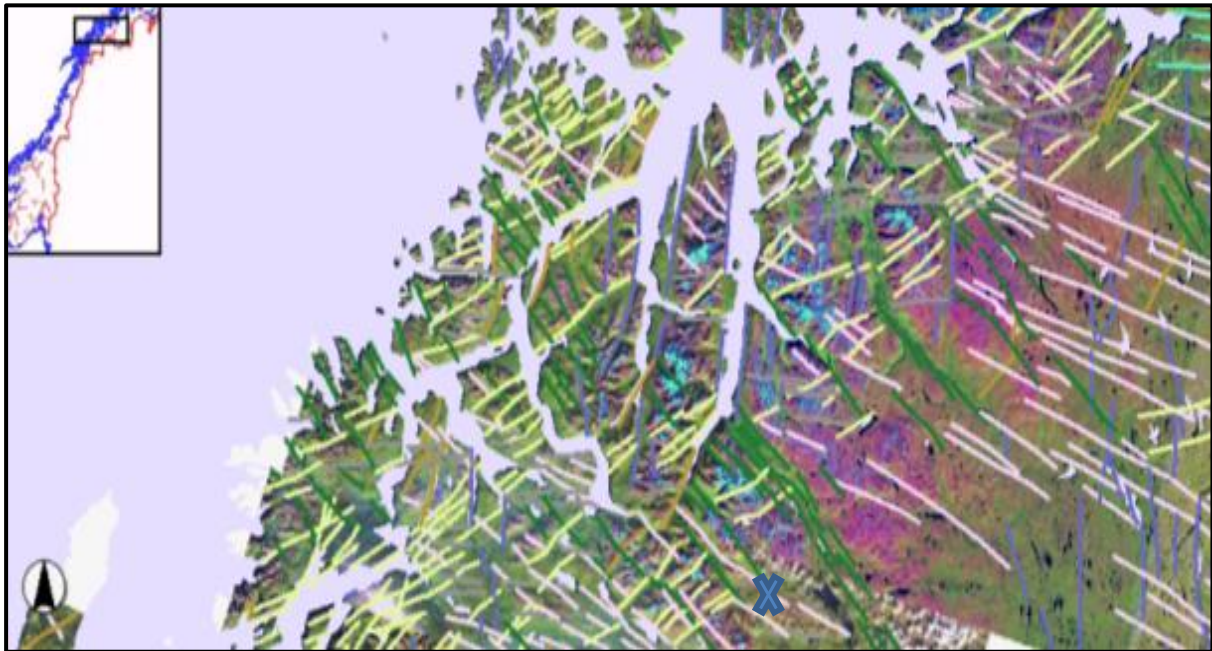
**Figure 4.2:** Lineament map that illustrates the dominant trends in western and central Troms, a dominant WNW-ESE and subordinate NW-SE and NE-SW trends. Note also a NNE-SSW trend parallel to the Lyngen peninsula in central part of the map. The RSF area is marked on the map with a X. (Modified from: Gabrielsen et al., 2002; Hansen et al., 2010; ngu.no 2011).

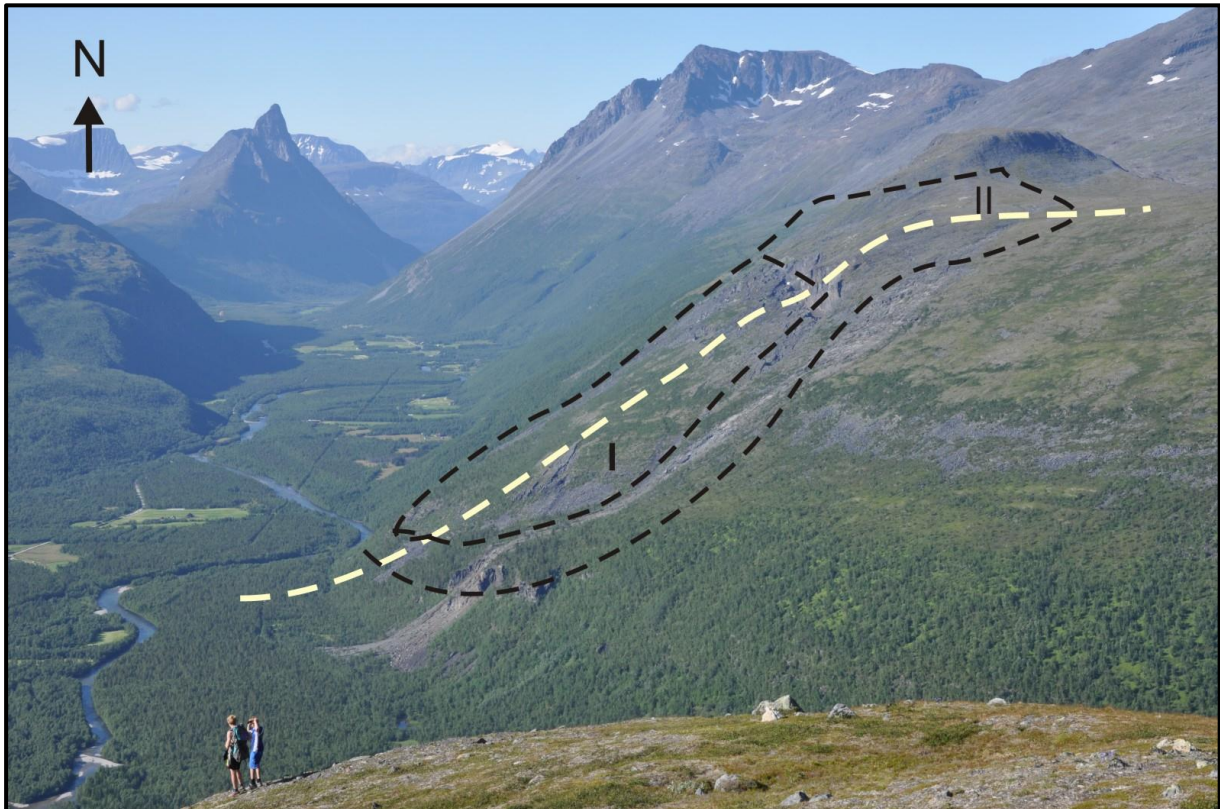
**Figure 4.3:** Overview photo of the RSF area showing the typical glacial U-shaped valley topography (Signalaldalen valley) and the steep slope of the east side of the valley, where the studied area is located. The Domain I and II are labeled. The photo is modified from Blikra (2011), and the view is toward north.

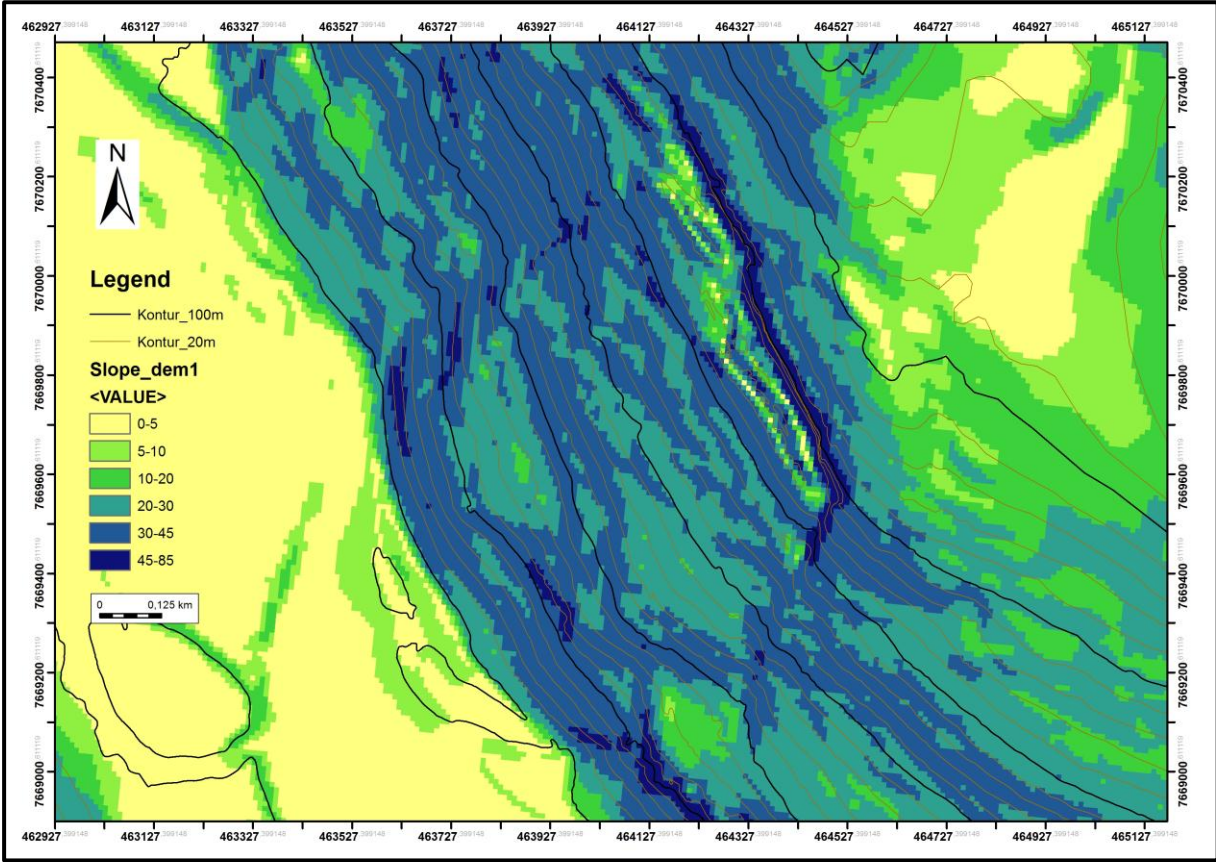
**Figure 4.5:** Slope map of the RSF area at Hompen. The mean inclination is around 35°. The Back scarp is displayed with the dark purple color, in the middle of the map striking NW-SE. Map is made in Arc GIS.

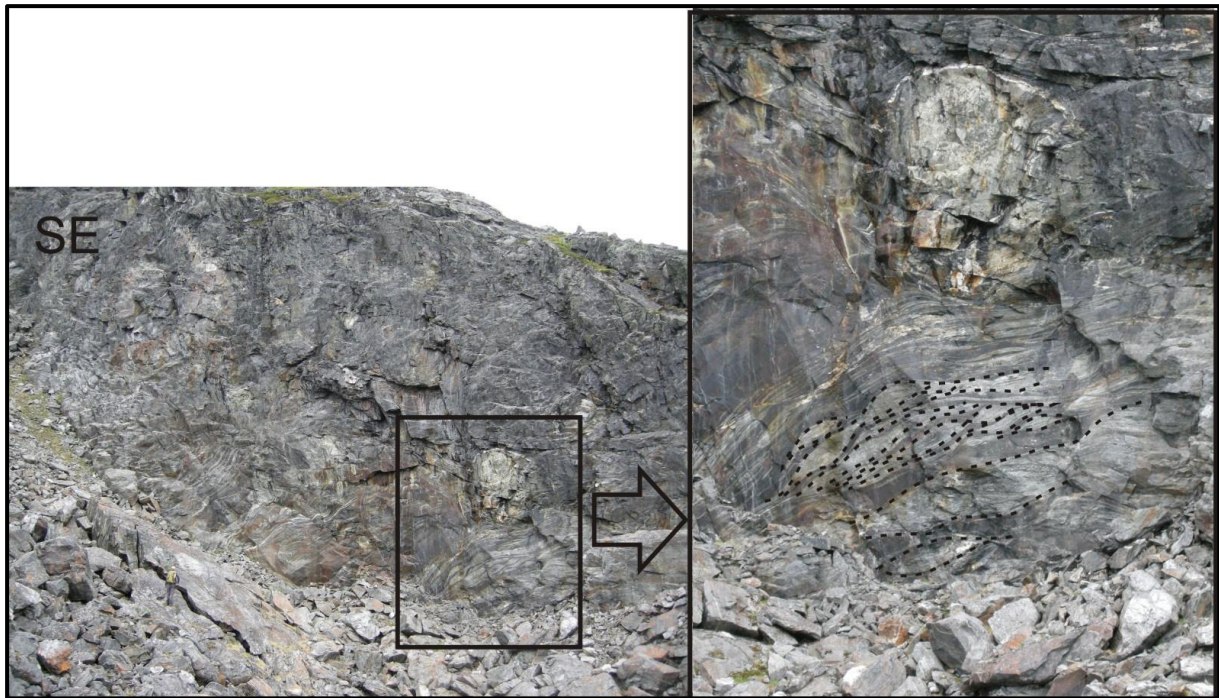
[Figure 4.8:](#) The southern scarp shows an undulating foliation, due to boudinage structures. For scale view the man on the left photo, left corner.

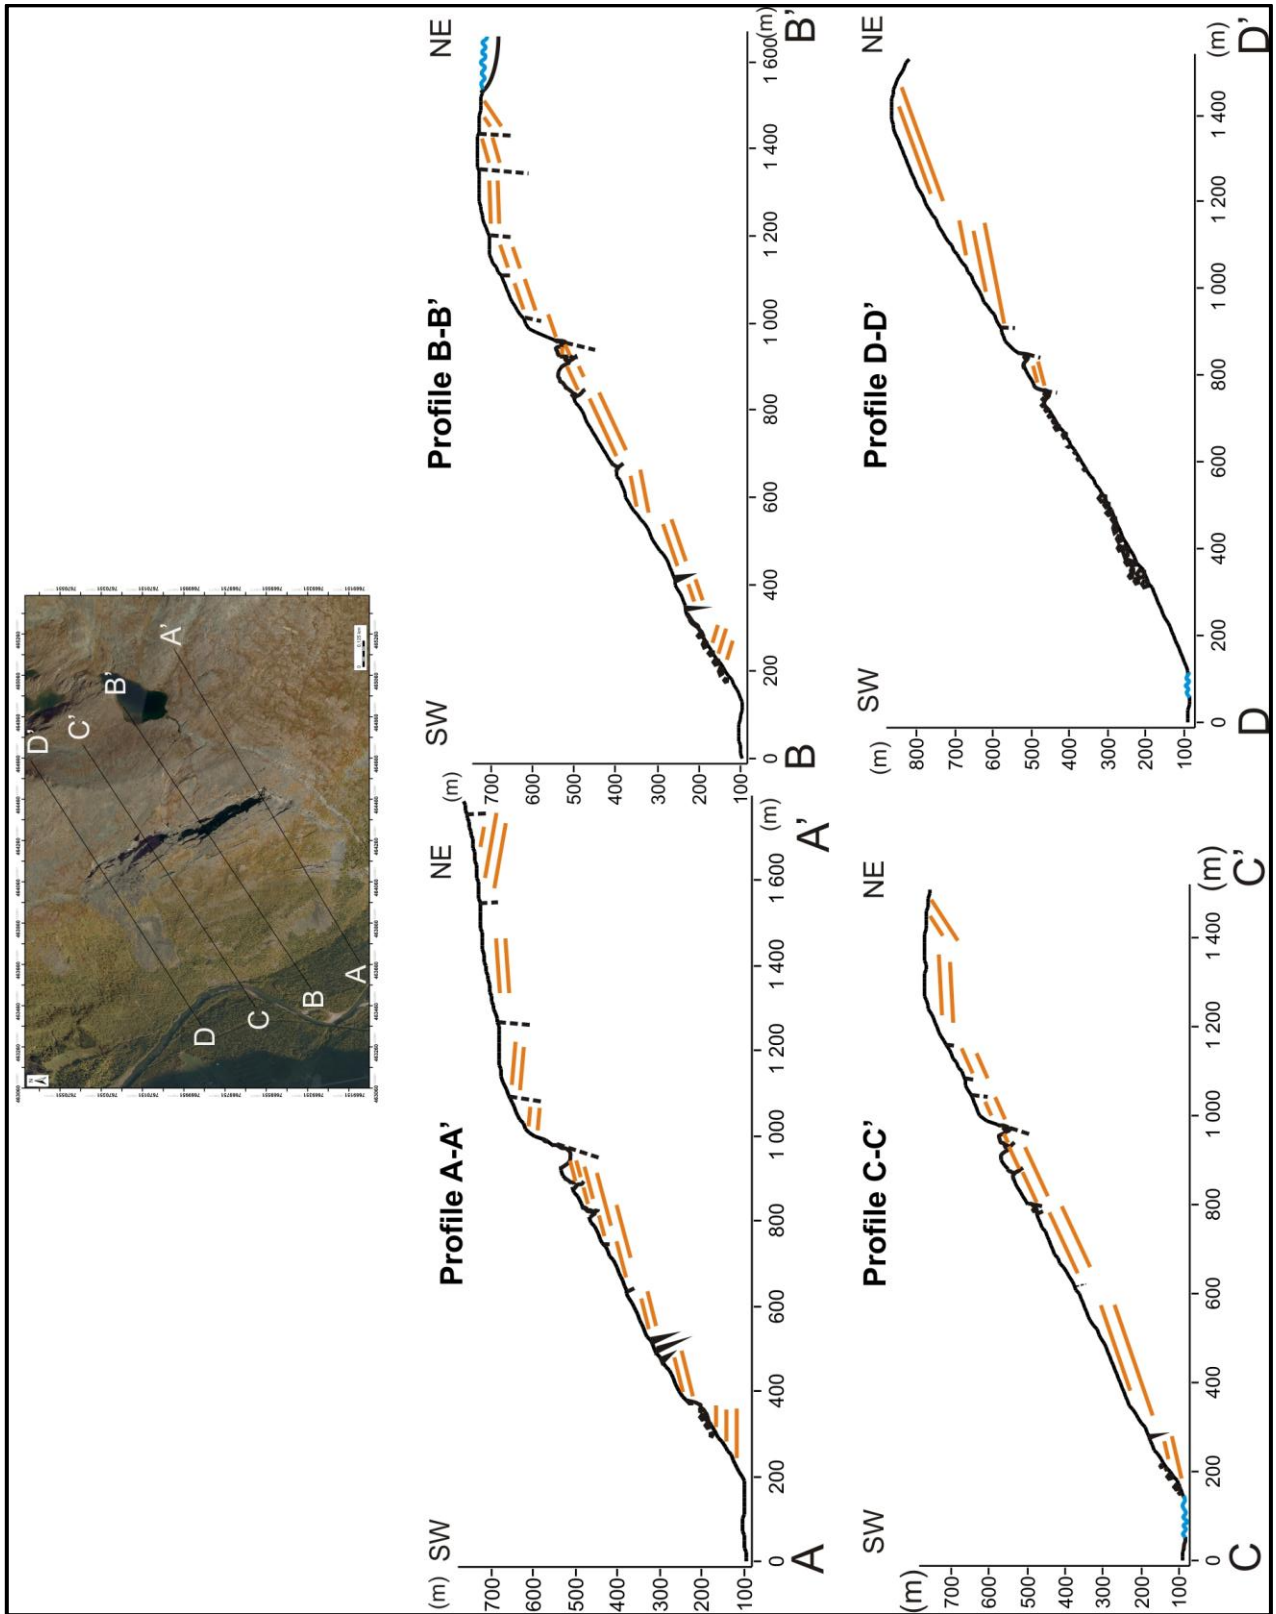
**Figure 4.11:** Profiles A-D, showing the small variation in foliation in the rock slope failure area. The measured foliation is here visualized as apparent dip in respect of the profiles direction.

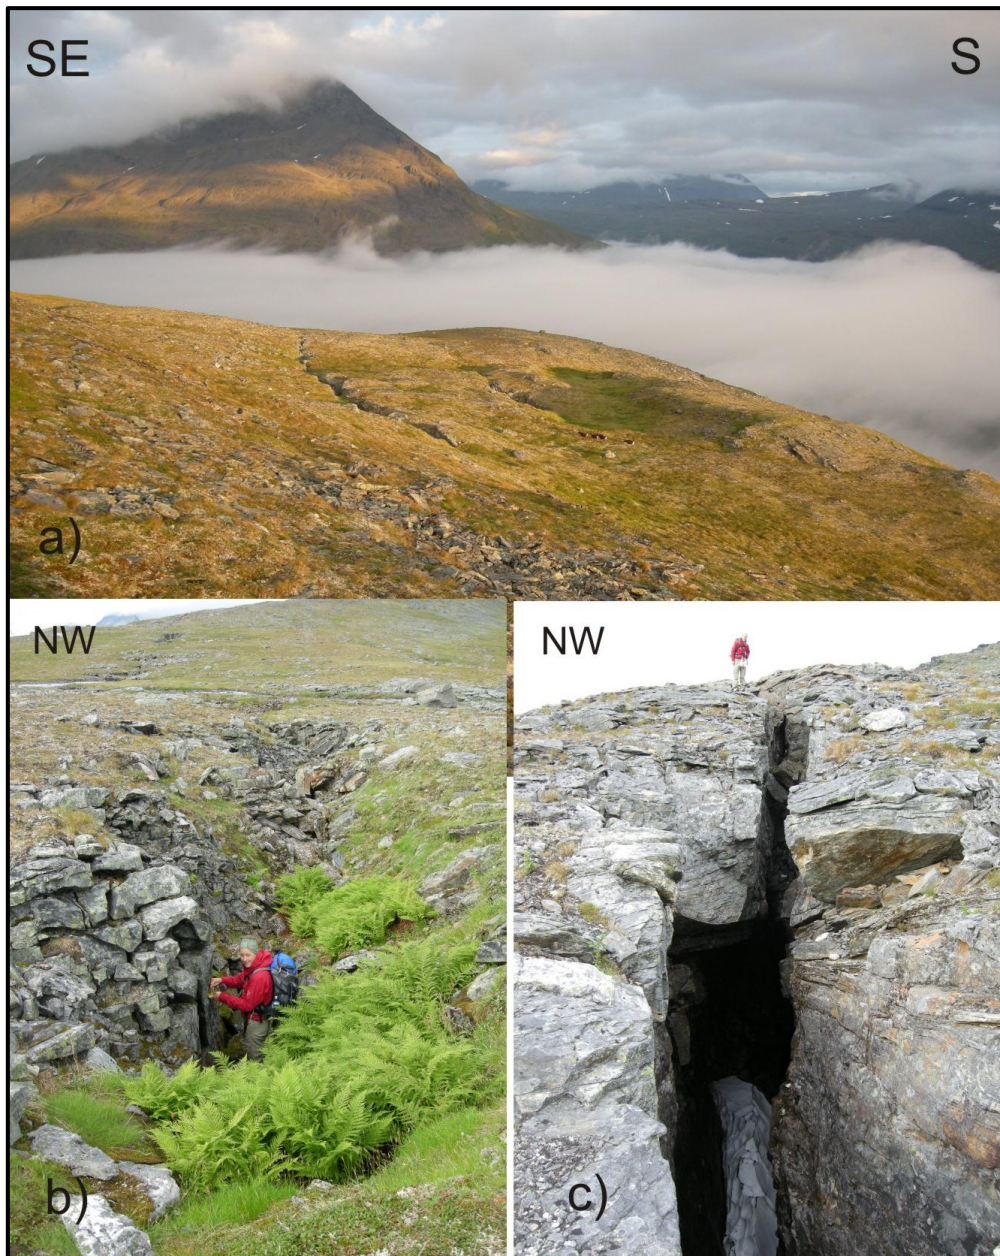
**Figure 4.13:** Photos showing various fractures in the studied RSF area: (a) Extensional fractures showing a slight bending geometry towards NW (b) Some are vegetated with ferns (c) Open fractures in Domain II, above the main rock slope failure area. The deepest ones have almost an “A” shape, narrow on top and widening deeper; they are so deep and cold that the snow does not melt in them 20 meters down.

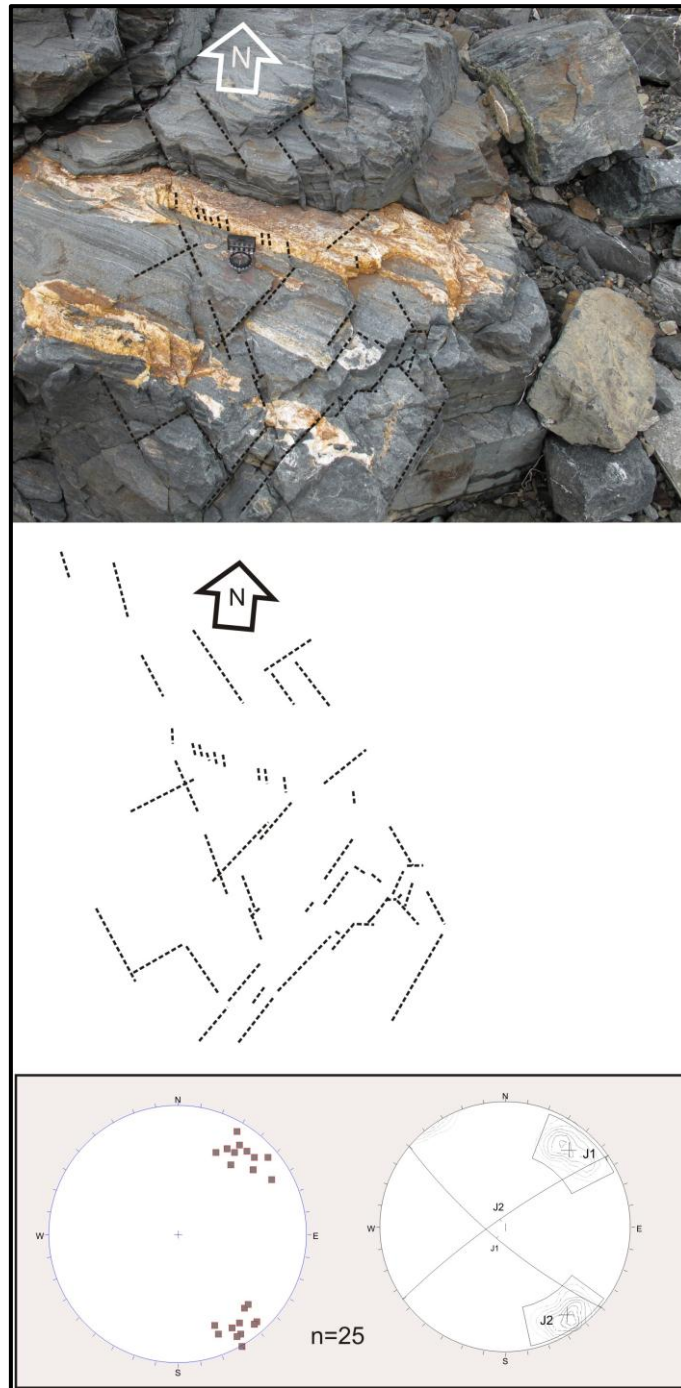
**Figure 4.14:** A Small scale; fracture analyses in Domain II (34W 464183/7669042), showing the two trends NW-SE and NE-SW.

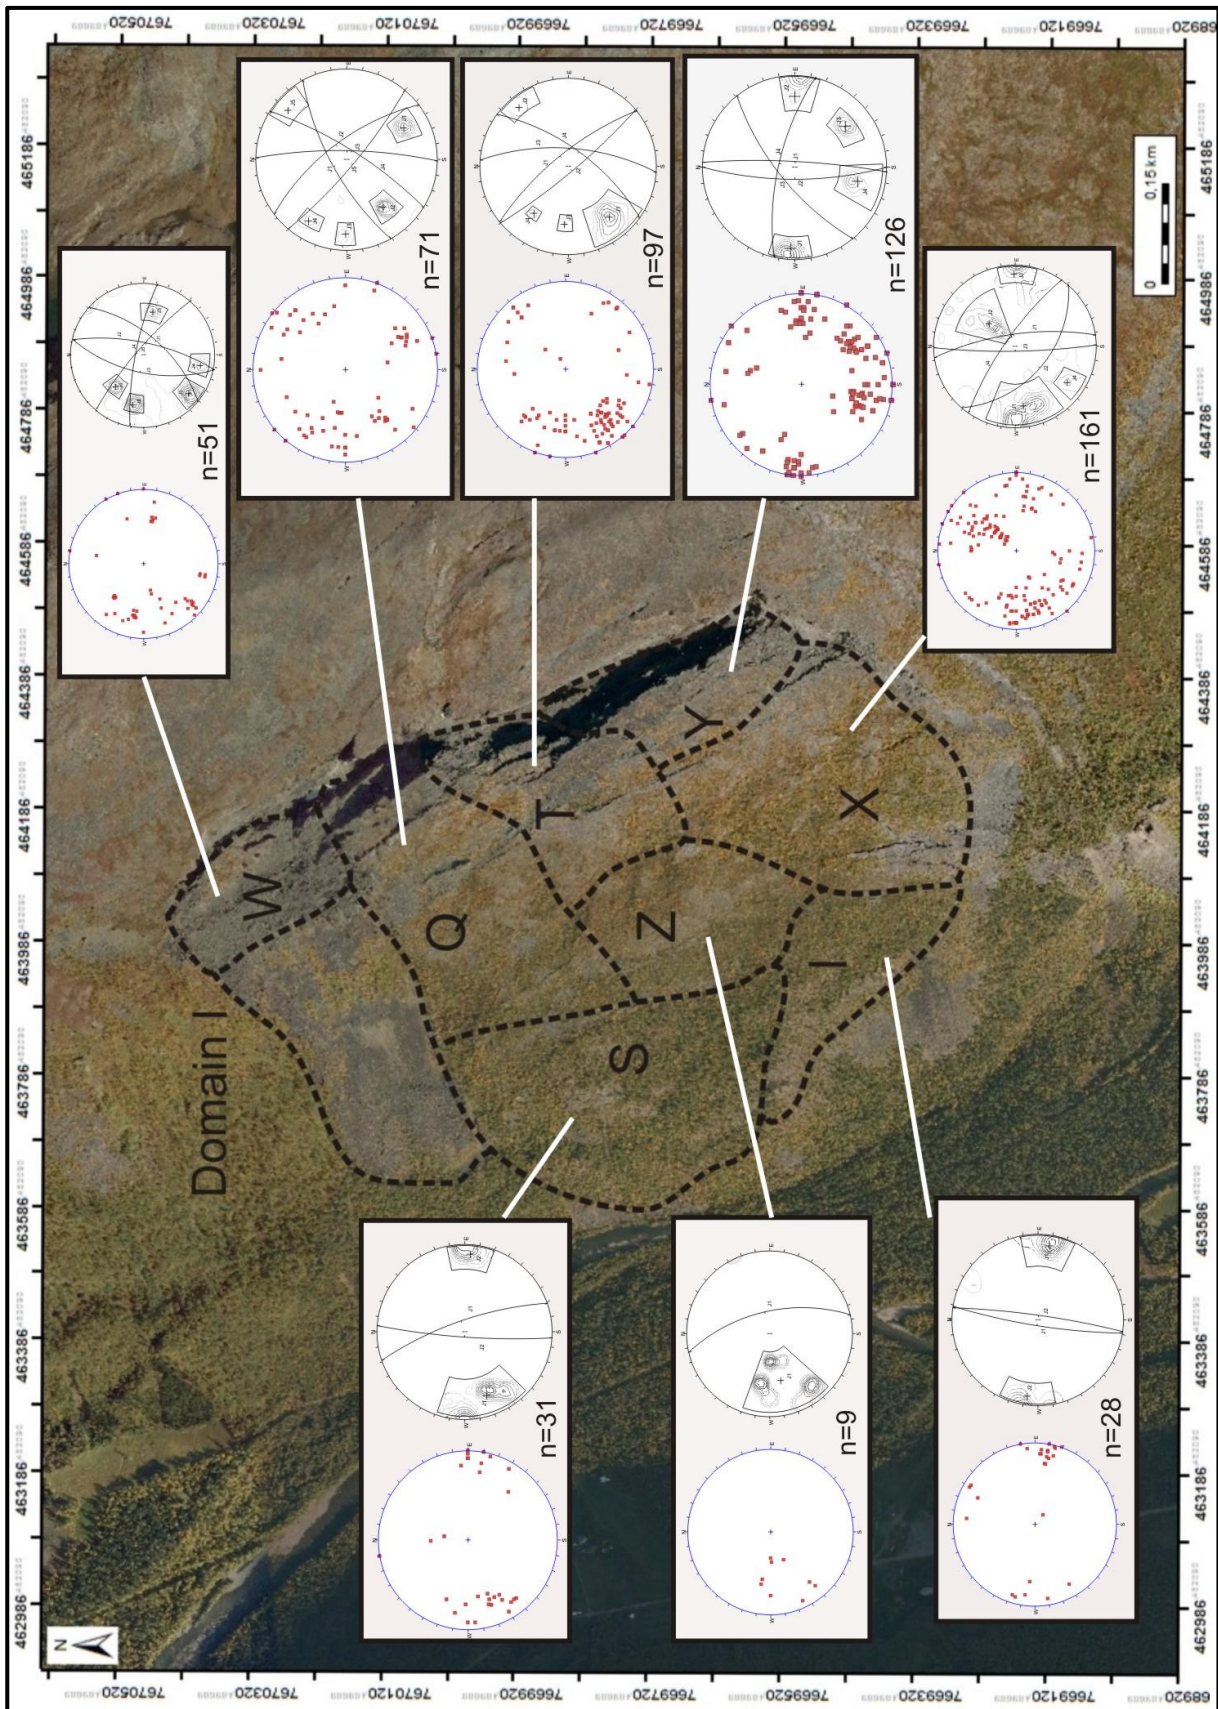
**Figure 4.16:** Orthophoto with the subdivision of (Domain I) the RSF area into smaller sub areas, and which allow fracture orientations to be evaluated in a spatial outline. Fractures are plotted in stereo diagrams as poles and analyses are made as contour plot in Dips (Rockscience, 2011).

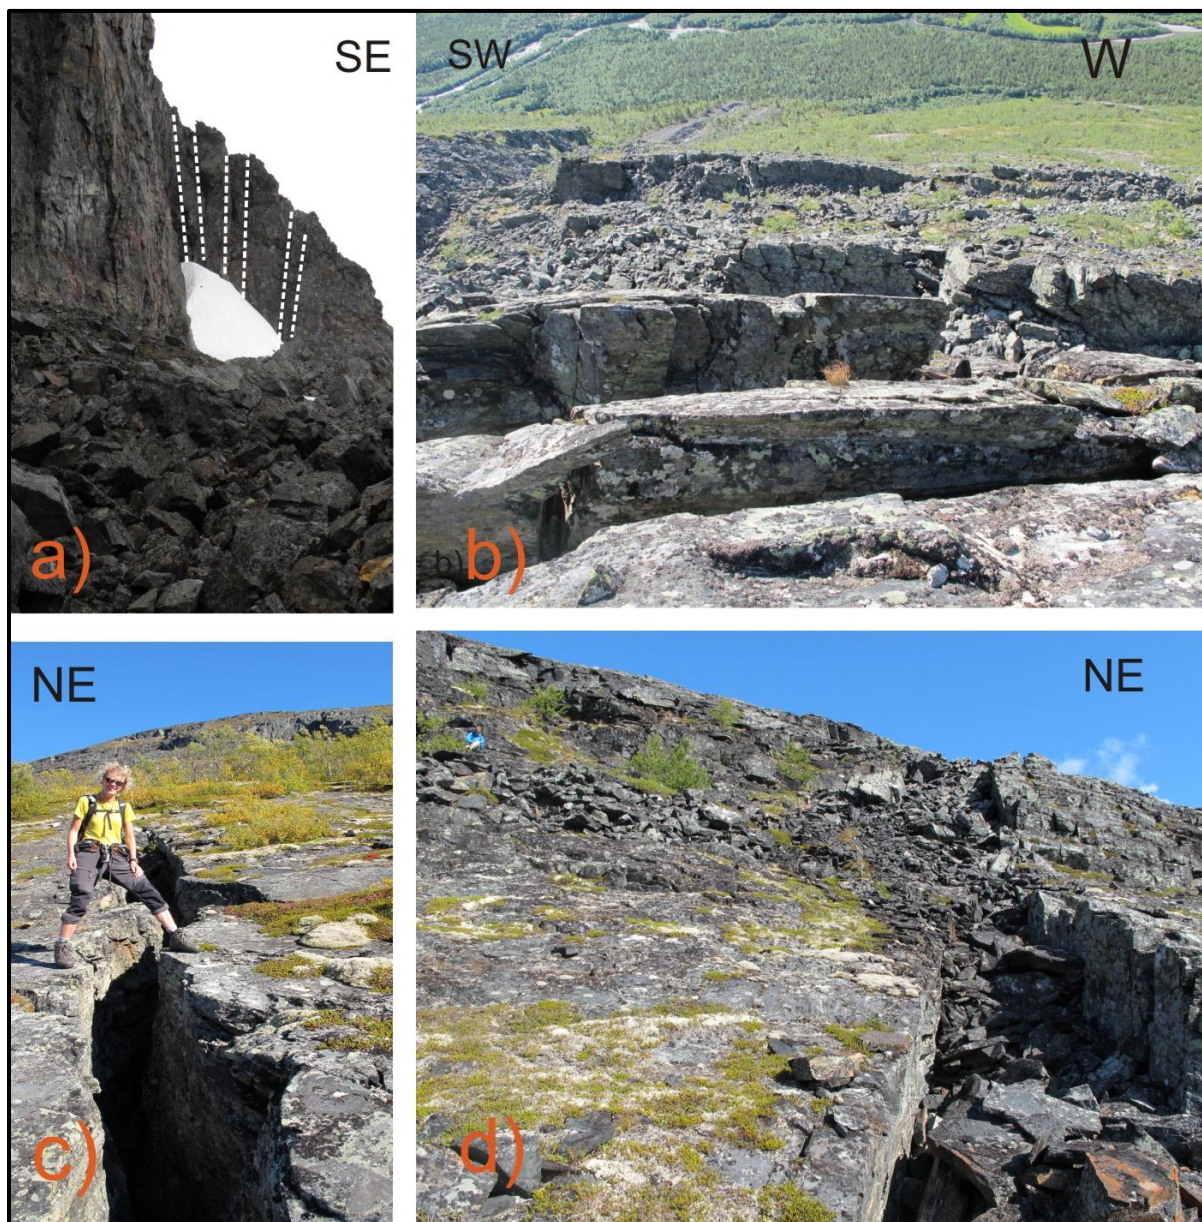
**Figure 4.17:** a) The upper part of the southern scarp has several joints striking SE-NW, parallel to the back scarp. b) Counter scarps in area Y show orientation NW-SE (Fig.4.13 and Fig. 4.19). c) Tensile fractures in Y, striking NE-SE perpendicular to the back scarp going downslope into area X; both show clear displacement and the fractures are up to 15 meters deep. d) Perpendicular fracture to the back scarp striking NE-SW filled with talus material.

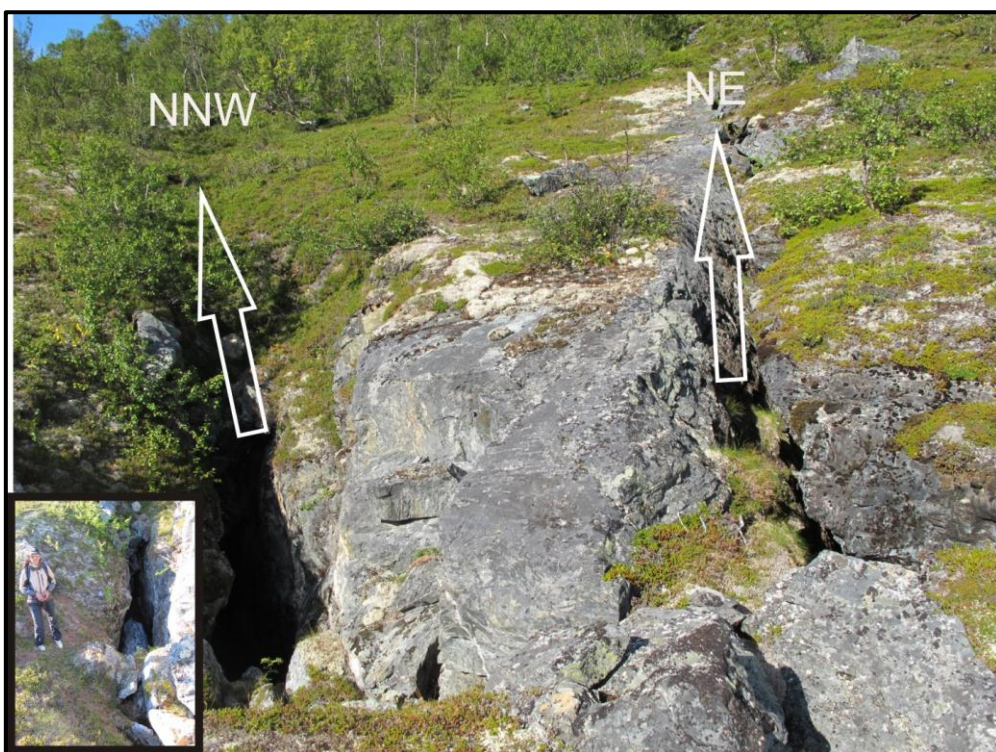
**Figure 4.18:** Perpendicular and oblique fractures in relation to the back scarp in upper x-area, striking NE-SW and NNW-SSE. Note the inserted picture fore scale and to visualize that there is snow in the fractures in late summer.
