Structural geometry and controlling factors for a rock slope failure area at HOMPEN/VÁRÁŠ, Signaldalen, Troms, North Norway

Maria Hannus

May, 2012

FACULTY OF SCIENCE AND TECHNOLOGY  
Department of Geology

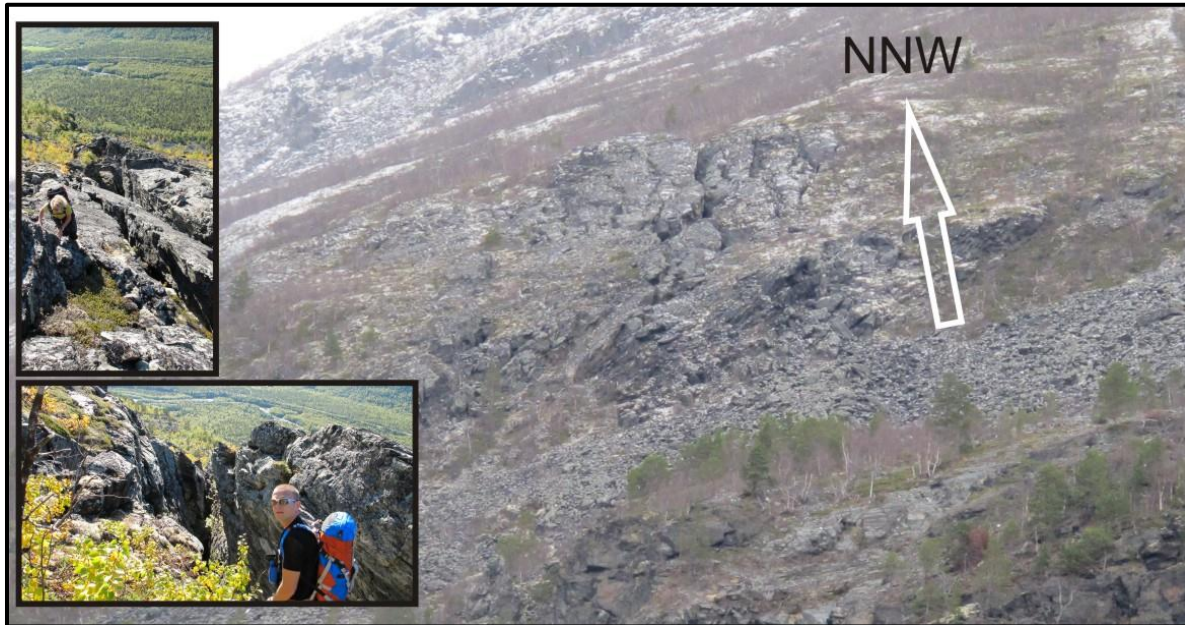
**Figure 4.19:** Crevasse system with orientation NNW-SSE. The small inserted pictures show the steep and exposed topography in the area.

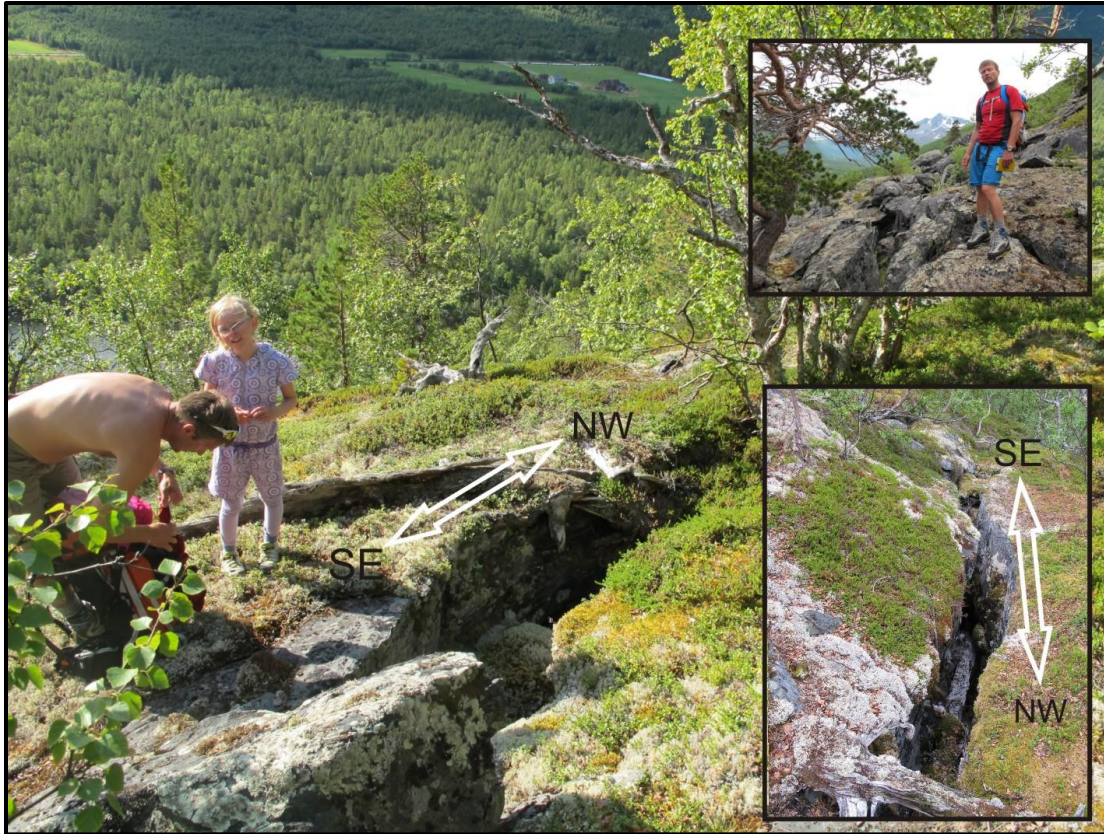
**Figure 4.20:** Fracture seen in the upper part of S-area just above the steep lower part of the RSF. The fractures strike NW-SE with a steep dip NE. Several of the fractures have snow even in late summer, where the elevation is 200 m.a.s.l. The fracture enters in a chaotic cliff area in the NW, the upper inserted photo.

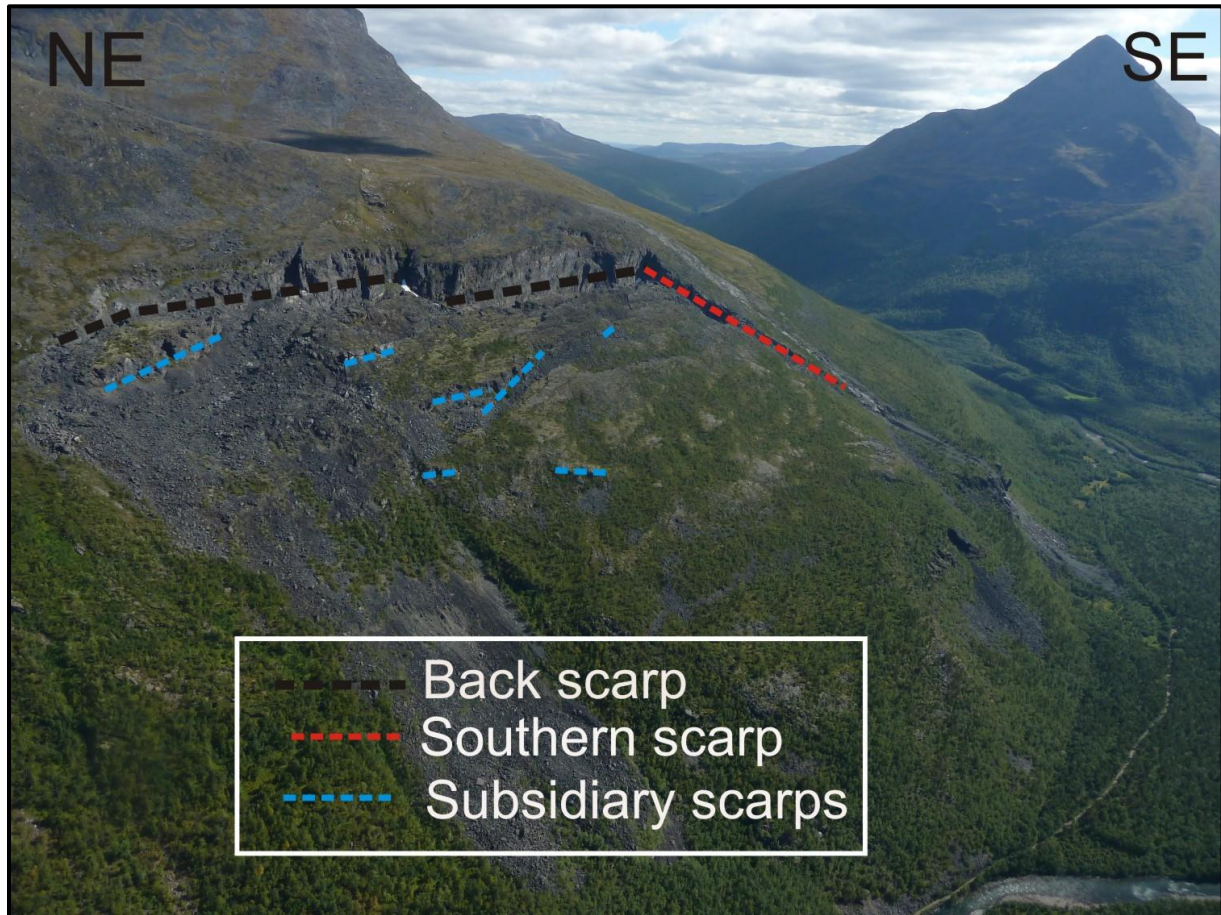
**Figure 4.21:** The photo illustrates the domain I, of the rock slope failure. The back scarp strikes NW-SE and the southern scarp strikes NE-SW. Subsidiary scarps are marked with blue lines (Modified photo Bunkholt, 2011)

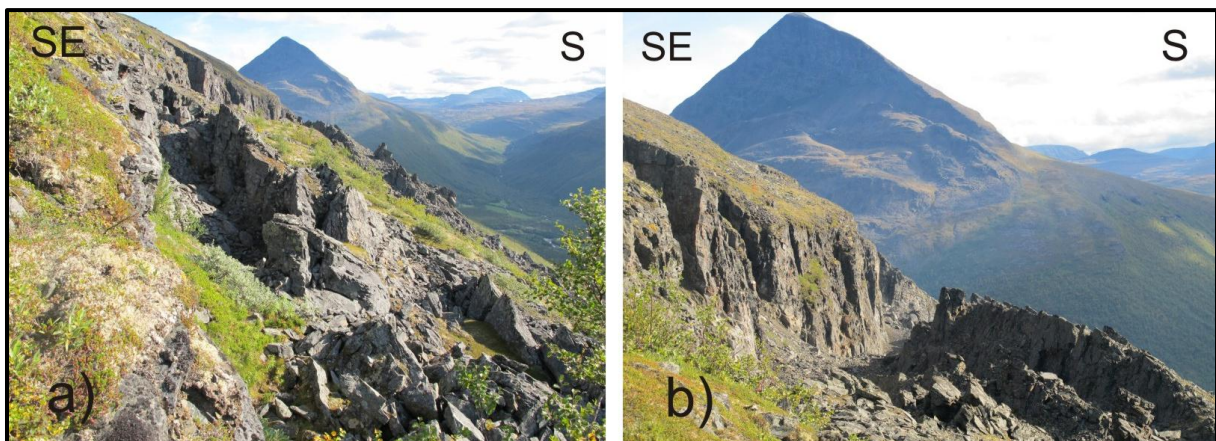
**Figure 4.22:** The back scarp a) looking from the far north, here the back scarp is less pronounced and the cleft in front is not that wide. b) An overview of the more southern part of the back scarp, there the wall gets higher and the cleft in front gets wider.

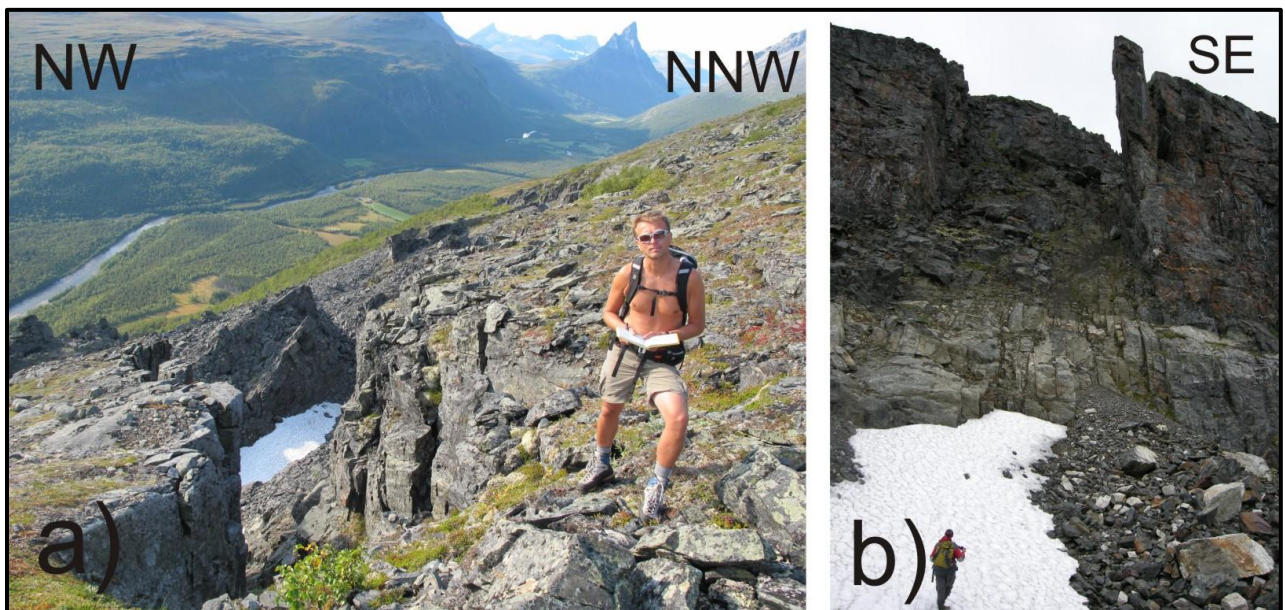
**Figure 4.24.** The scars in the back scarp; a) this deep cut in the back scarp are linked to a talus trench in SE direction, view description for trenches for further information. b) A scar looking from the back scarp side, this scar might be linked to a subsidiary scarp striking parallel above the back scarp, view (Fig. 4.19) map in Domain II.

The back-scarp cuts with a high angle, the sub-horizontal or gently SW-dipping foliation of the bed rock in Domain II above (Fig. 4.9), and is itself cut by major fractures/scarps striking NE-SW with dip ( $>60^\circ$ ) to the SE (Fig. 4.22b, Fig. 4.24). The surface/wall of the back-scarp has some major steep scarps with strike W-E; these are located in the northern part (Fig.

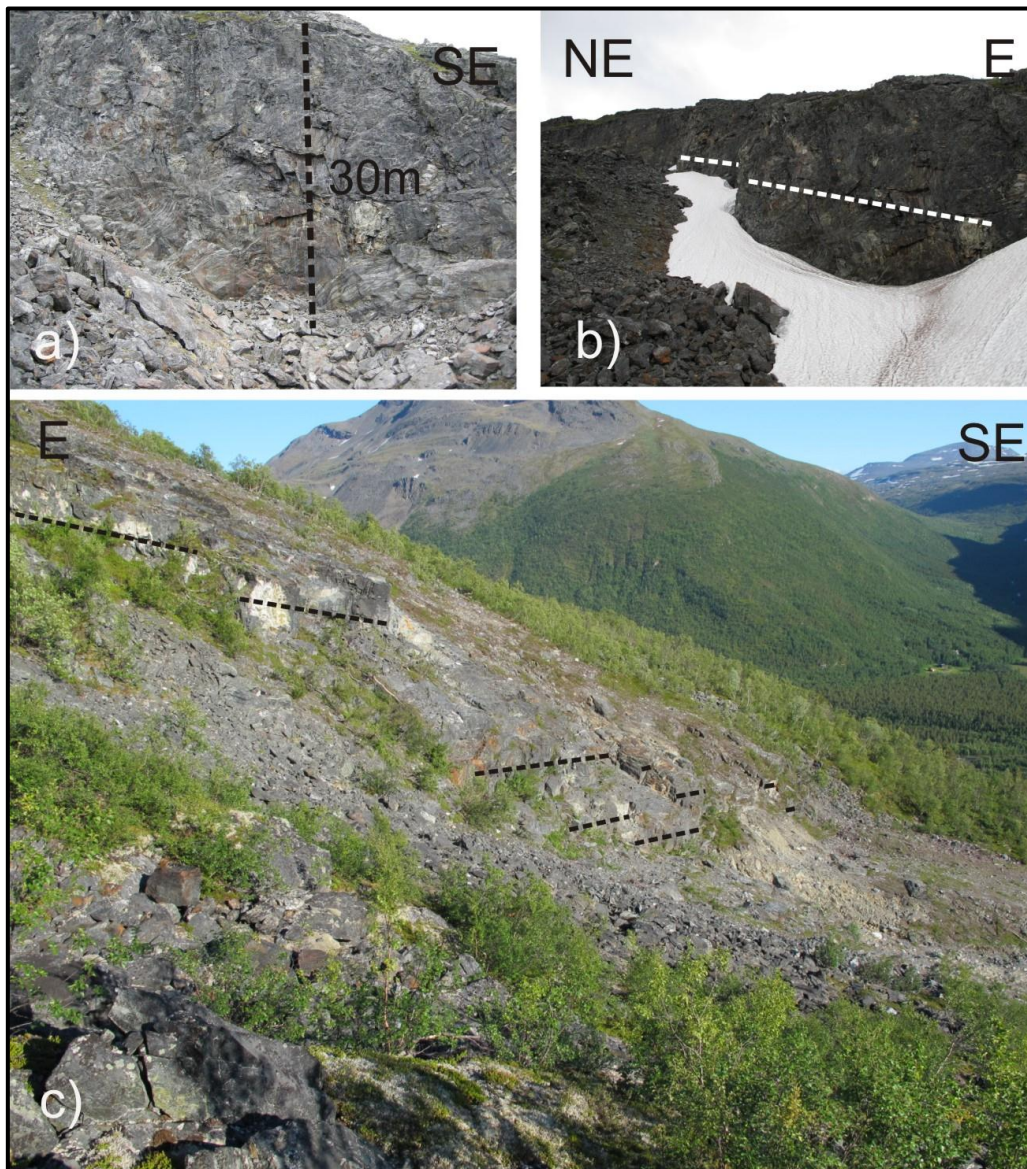
**Figure 4.25:** Southern scarp; a) A vertical 30 m high wall, follow downhill SW b) taking some echelon steps, the height of the scarp is lowering. C) In the middle of the slope, the scarps are vanishing out to the south east.

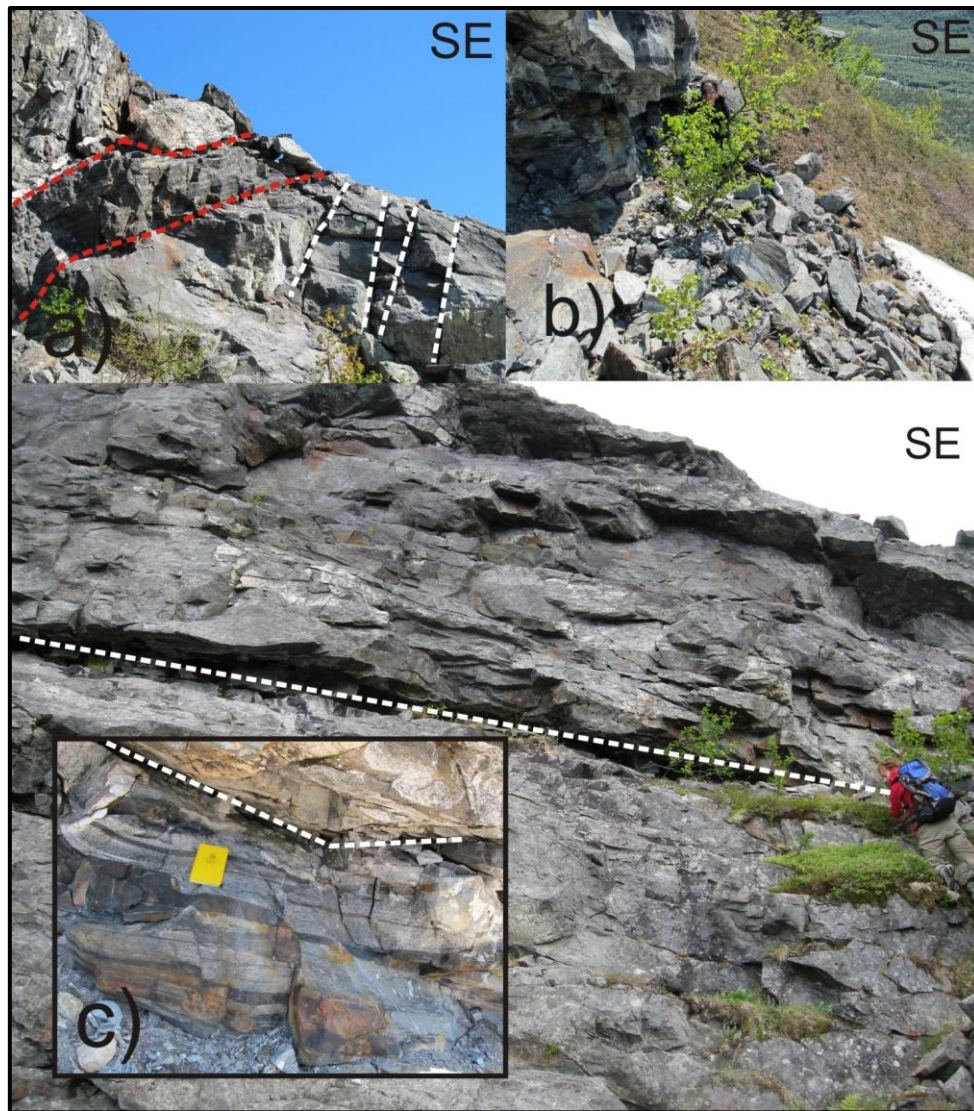
**Figure 4.26:** a) The southern scarp showing the irregularities with mafic lenses (stippled red) in the bedrock, and fractures striking SE, parallel to the back scarp. b,c) The sub horizontal fracture plane in Mylonitic rock following the same orientation as foliation strike NW-SE dip to SW. c) A close up of what might be a local detachment, Mylonitic rock might here work as the weak zone.

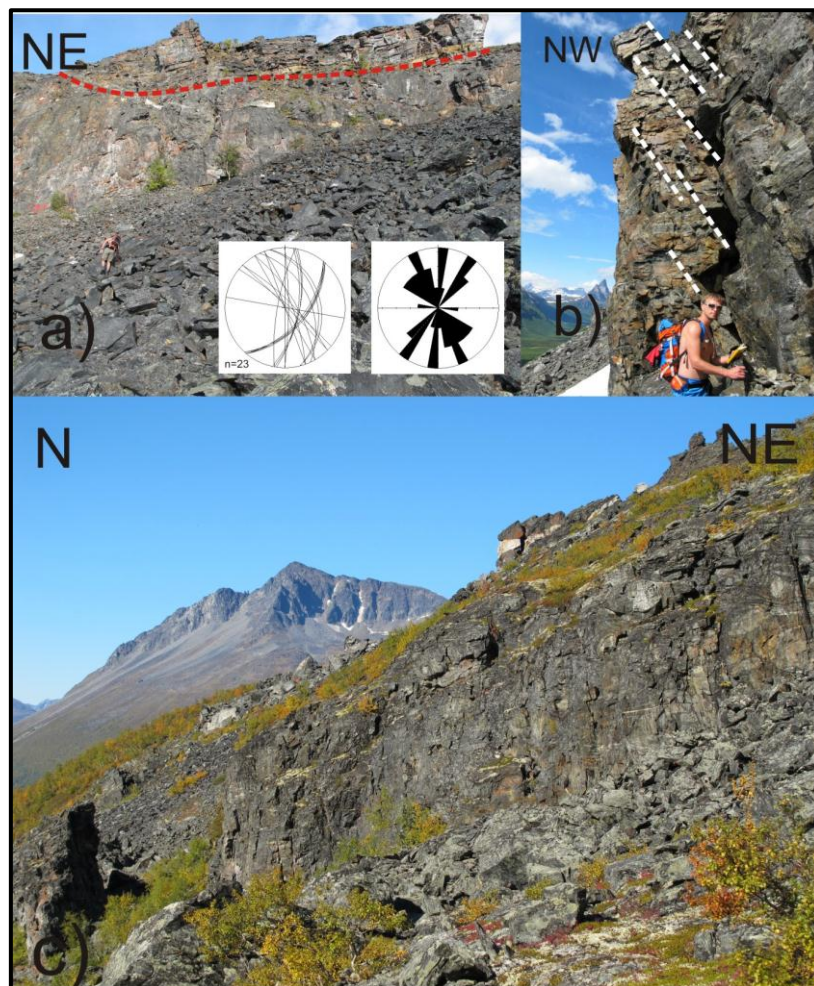
**Figure 4.27:** a) Subsidiary scarp in W-area; note a lithological difference in the bedrock, marked with red. b) Oblique fractures towards a scarp, can induce rock failure as toppling (see Ch. 5). c) Subsidiary scarp in Q-area, this scarp has a counter scarp connected to it (also view Fig. 4.28Bc).

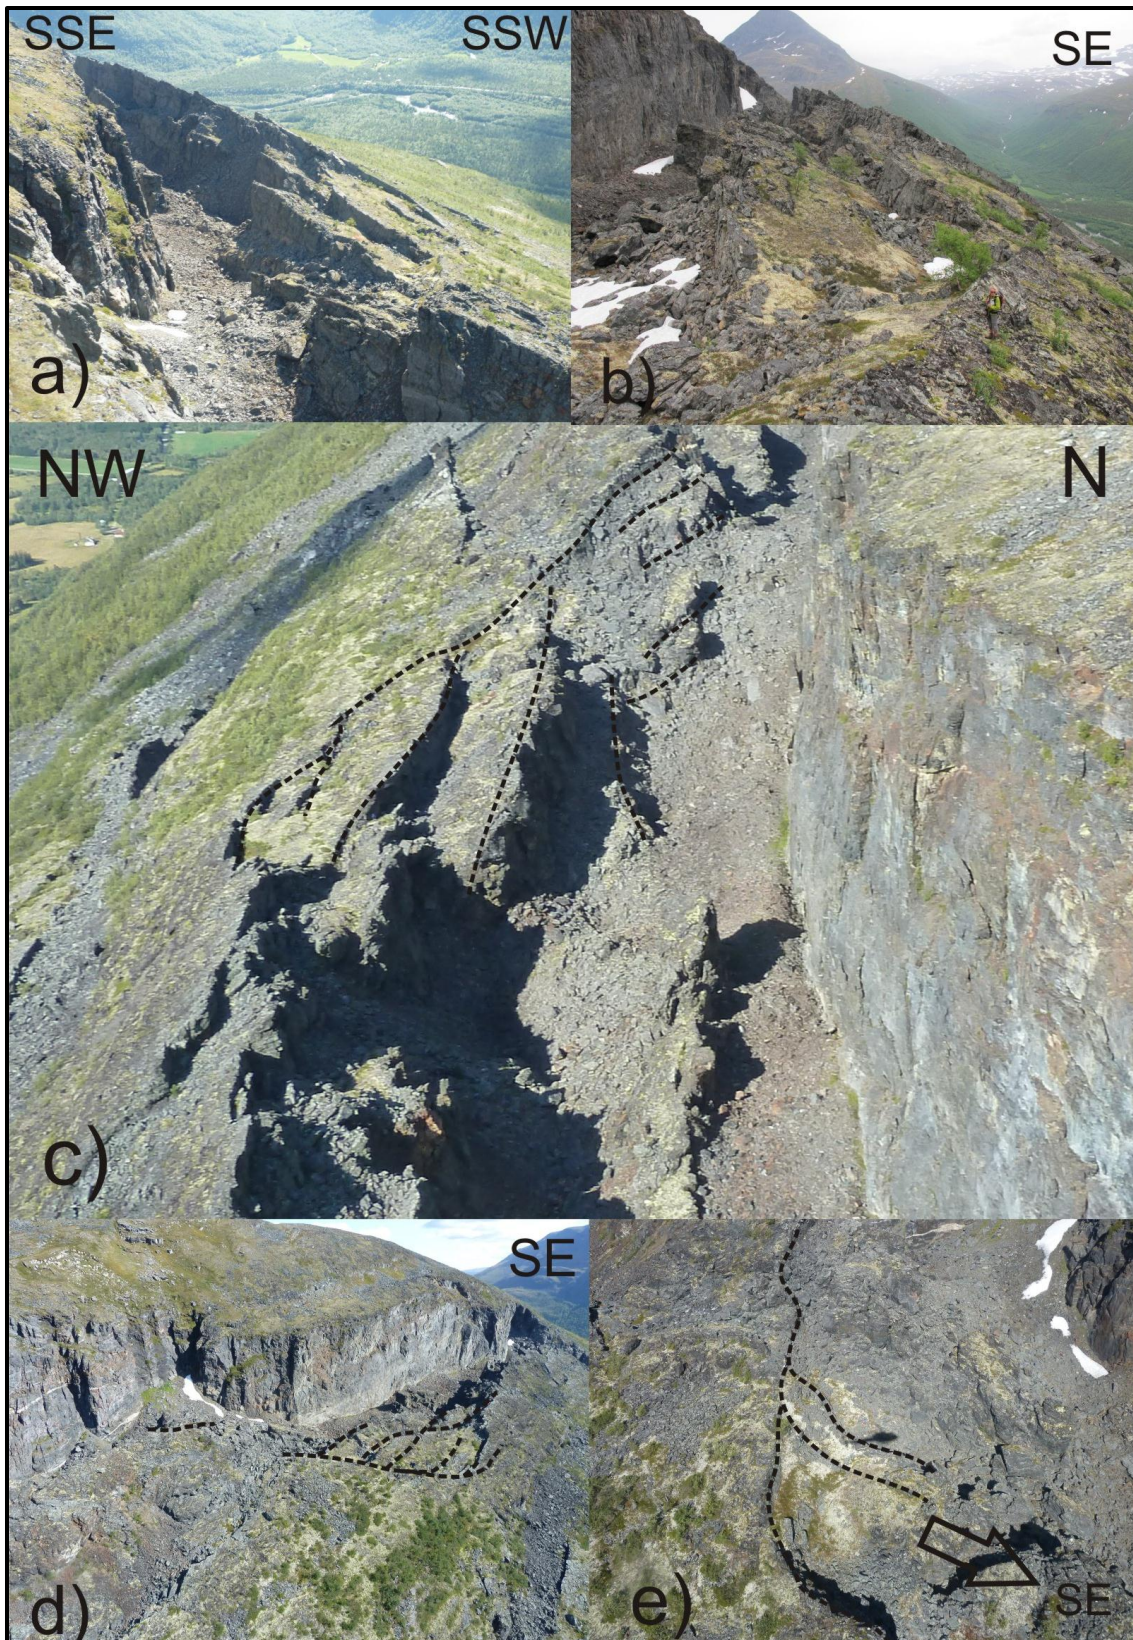
**Figure 4.31:** This illustrates an accommodation structure; a transfer scarp oblique to the back scarp. The transfer scarp has strike SSW-NNE dip to SE, bending into several anti- scarps with strike parallel to the back scarp NW-SE. a-b) photos show the bending fracture plane into the counter scarp system view person for scale in b. c-d) Coming up from the central graben into a collapsed relay ramp, entering the bending fracture plan striking NNE-SSW and bends into the counter scarp system striking NW-SE. e) From a birds view the bending structure are very clear; for scale see shadow of helicopter and persons standing in the northern-most junction. (Modified aerial photos Bunkholt, 2011)

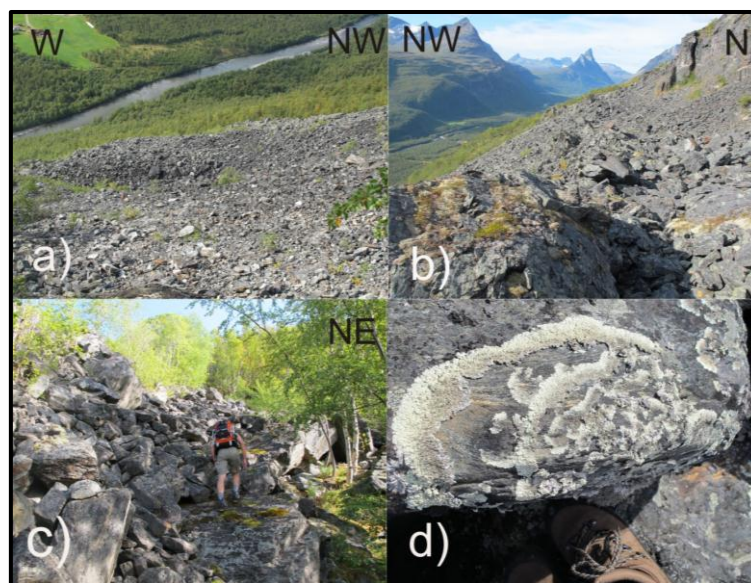
**Figure 4.32:** The photo series are showing the talus field in the northern part of the rock slope failure area. a) The lower part of the field displaying a lobe character. b) The upper part is ending in a ridge shape covered by boulders, interpreted as a counterscarp to the scarp seen in the photo. c) On the way up in the talus field the material is sorted the way that the biggest material is on the sides. d) Radial growth of lichen can help to give a relative age to the talus field.

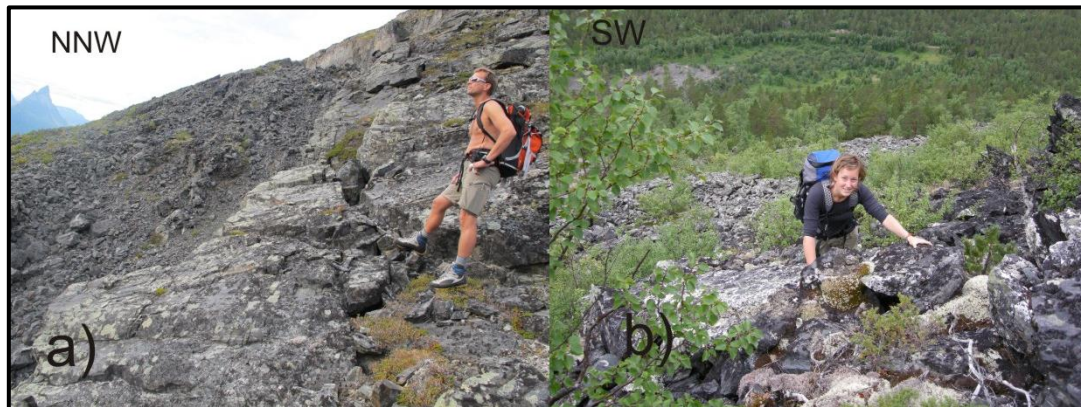
**Figure 4.33:** a) Talus slope in connection to the southern scarp, the rock is unstable. b) Smaller areas with talus scree in the lower part of the rock slope failure area and beneath it looking down into the valley.

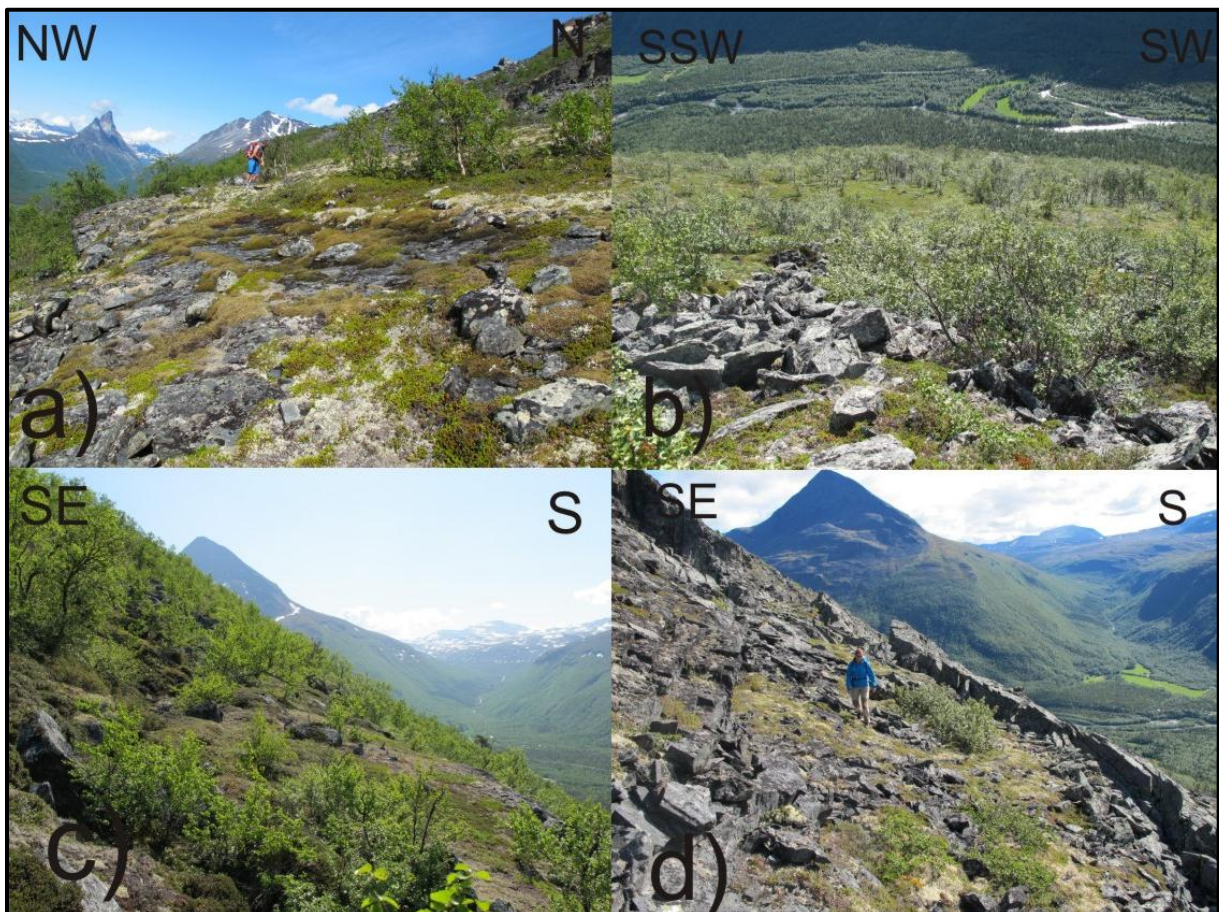
**Figure 4.34:** a) Looking north there are several gently down valley dipping terraces, formed in the polished bedrock. b) Terraces are easiest seen when looking down into the valley as here. c) Same as in a, but here the terrace are more vegetated. d) In the higher part of the rock slope failure there are smaller terraces partly filled with rock or vegetated as on this photo, these are located between counter scarps.

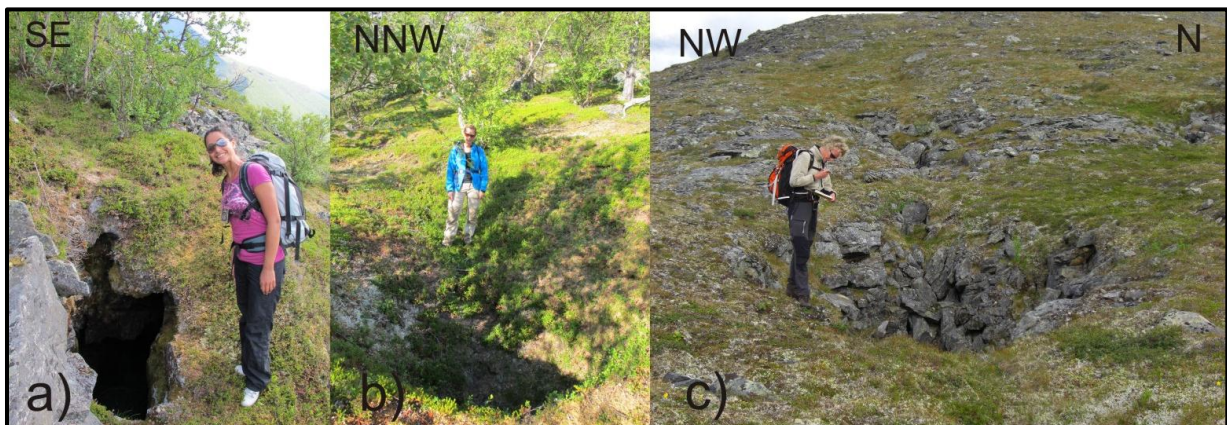
**Figure 4.35:** a) Sinkholes SW of the main rock slope failure area. b) Active sinkhole when the vegetation have been disturbed and ruptured the hole went several meters down and is interpreted as a fracture. This is located in the lower part of domain I. c) Aligned sinkholes at the plateau in Domain II.

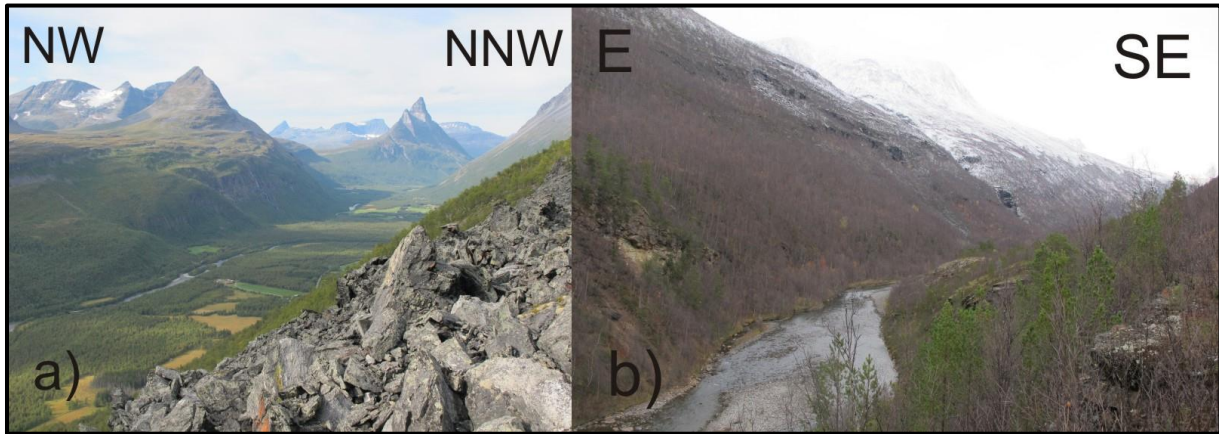
**Figure 4.36:** a) U-valley-Signalaldalen; Signalaldalen river is meandering its way towards the sea in North West. b) V-Valley of Stordalen, the river is eroding its way deeper into the bedrock.

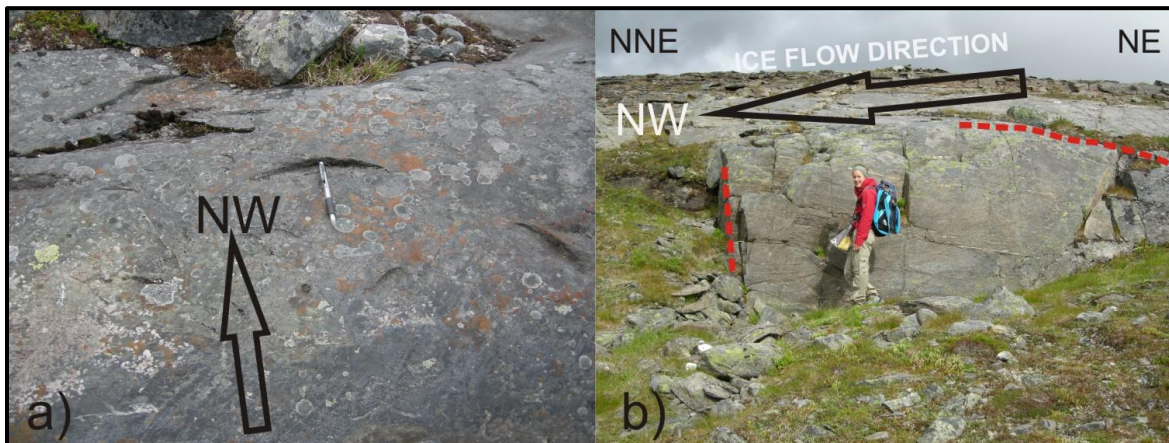
**Figure 4.37:** a) Chatter marks as crescentic scars showing on an ice movement in direction towards NW. b) The illustration show a roche's moutonnees, Ice flow from right to left. Note the lee face which has been quarried out and the abraded stoss side.

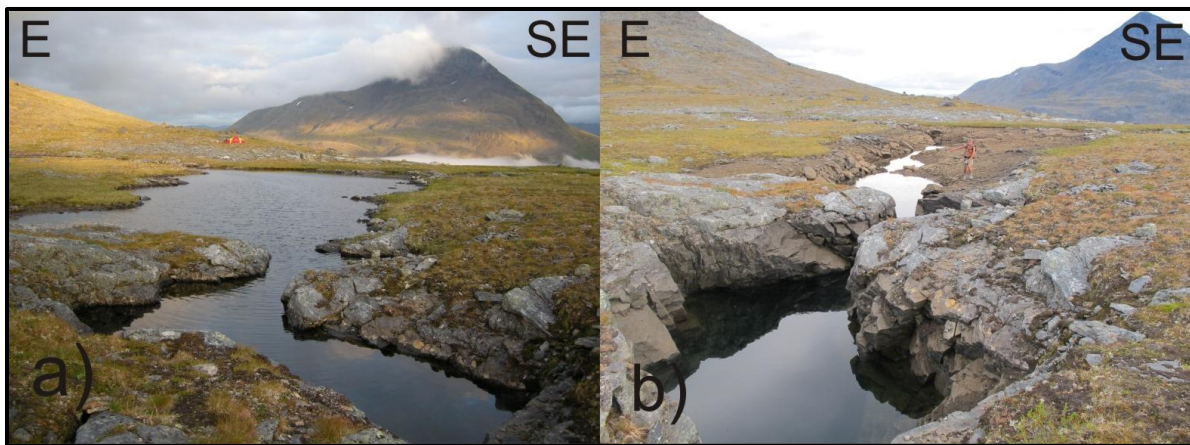
**Figure 4.40:** a) The small pond just before the emptying event in 2010. b) The drainage of the small pond in Domain II, has happened in 2011. The drainage is a rapid (one day) yearly drainage event, happening in late summer.

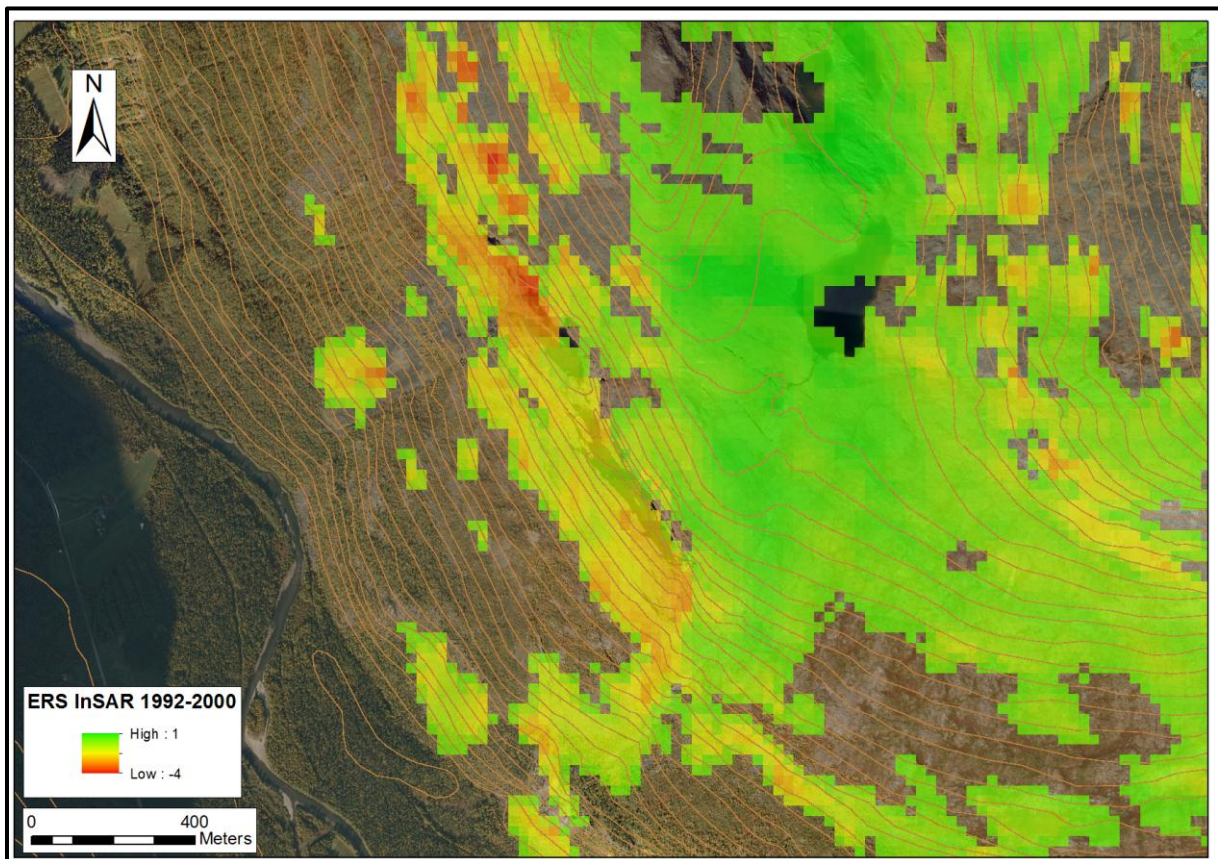
**Figure 4.42:** InSAR photo of the RSF area showing that the mountain slope underlain by the RSF area moved up to 10mm/year downwards in the time period 1992-2000. The InSAR documented subsidence is likely controlled by morpho-structures of the RSF area. (Photo is from Henderson et al., (2009), modified by Bunholt, 2012).

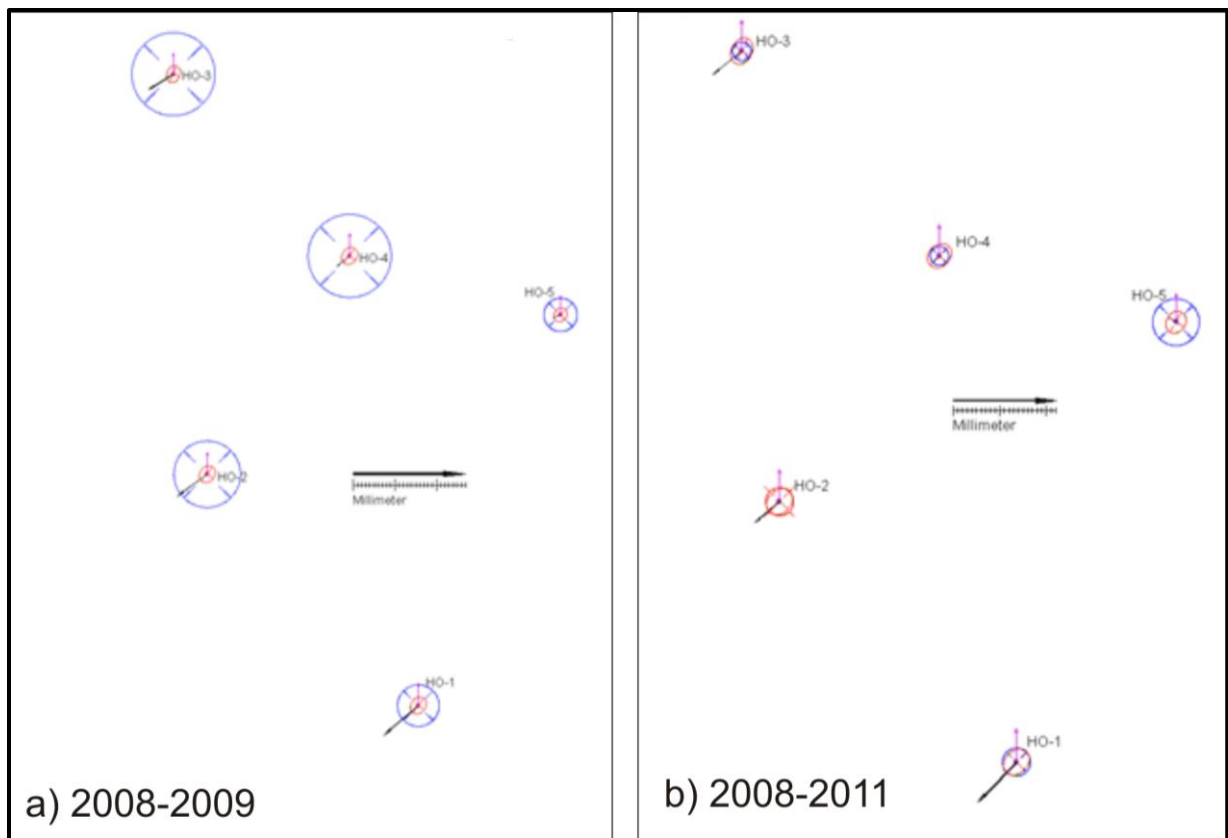
**Figure 4.45:** Illustration of confidence Figures over the change of the GPS points. For interval a) 2008-2009, the measurements show significant subsidence on all the points and horizontal movement with significance in HO-1. b) 2008-2011. Show that there is a horizontal movement to the south, with a clear significance of point HO-1, HO-2 and HO-3 and an almost significant subsidence at HO-5. Modified Eiken (2012).

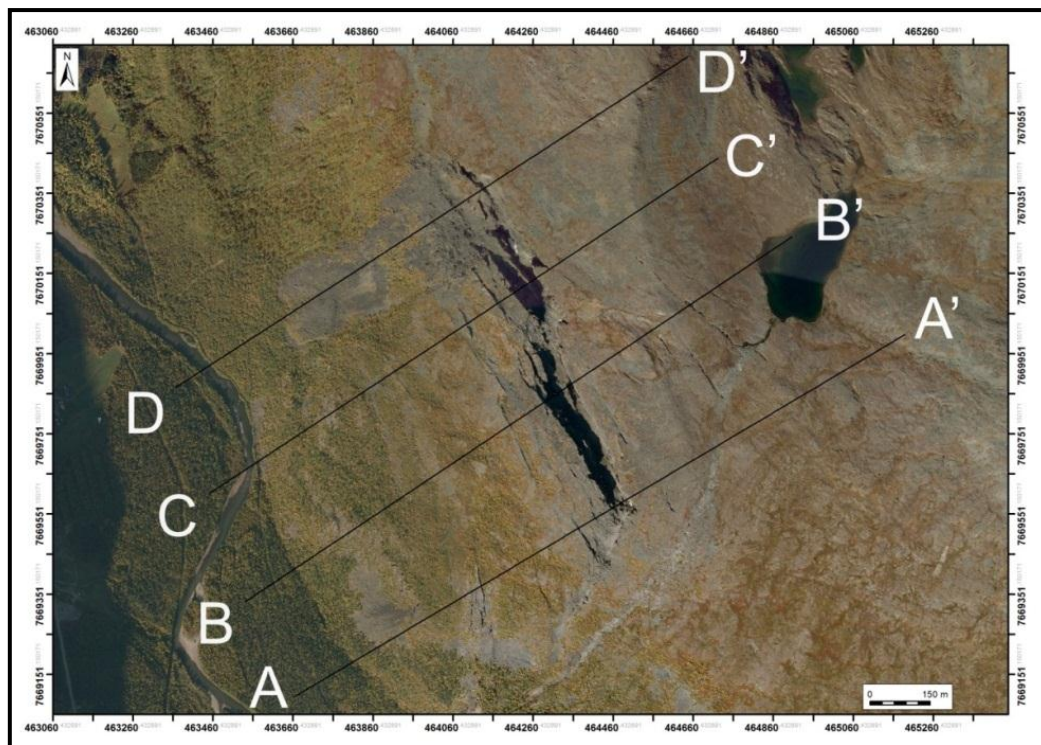
**Figure 5.1:** Location of the four main cross-sections through the study RSF area shown in Figs. 5.2 and 5.4.

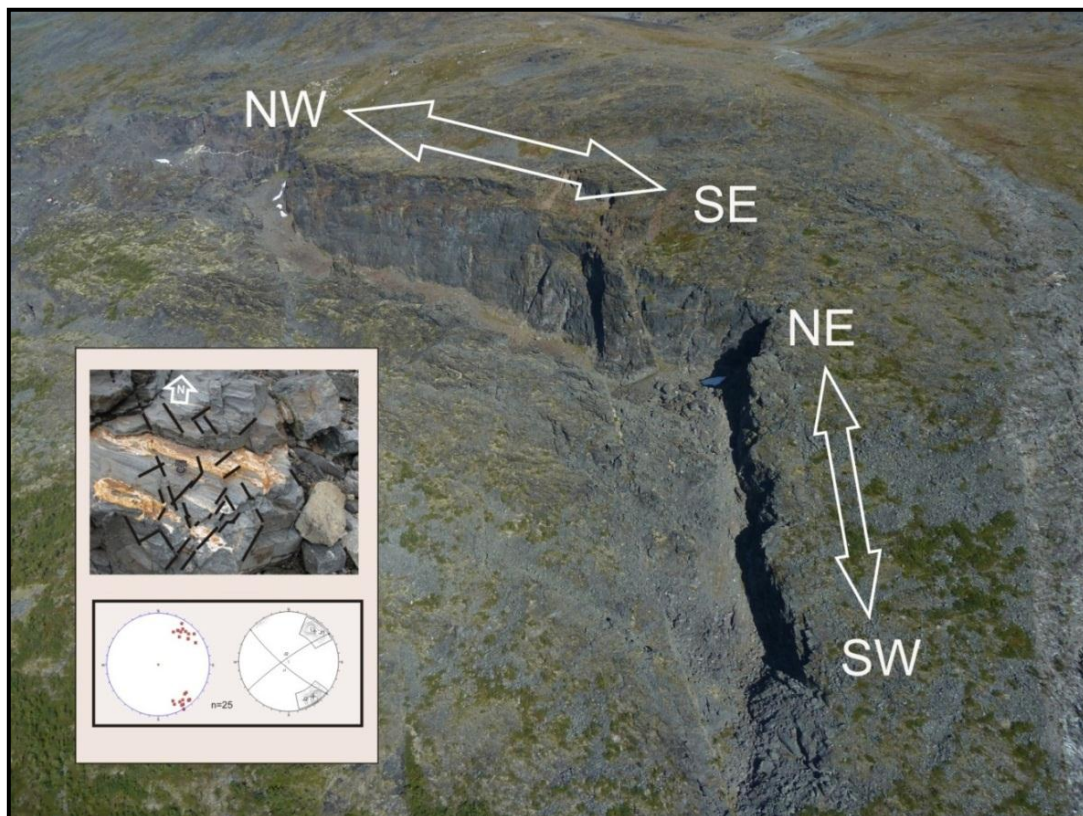
**Figure 5.3:** The southern lateral scarp striking NE-SW and the Back scarp striking NW-SE, showing the similar directions as seen on the small scale analyses inserted photo. (Modified background photo Bunkholt, 2011)

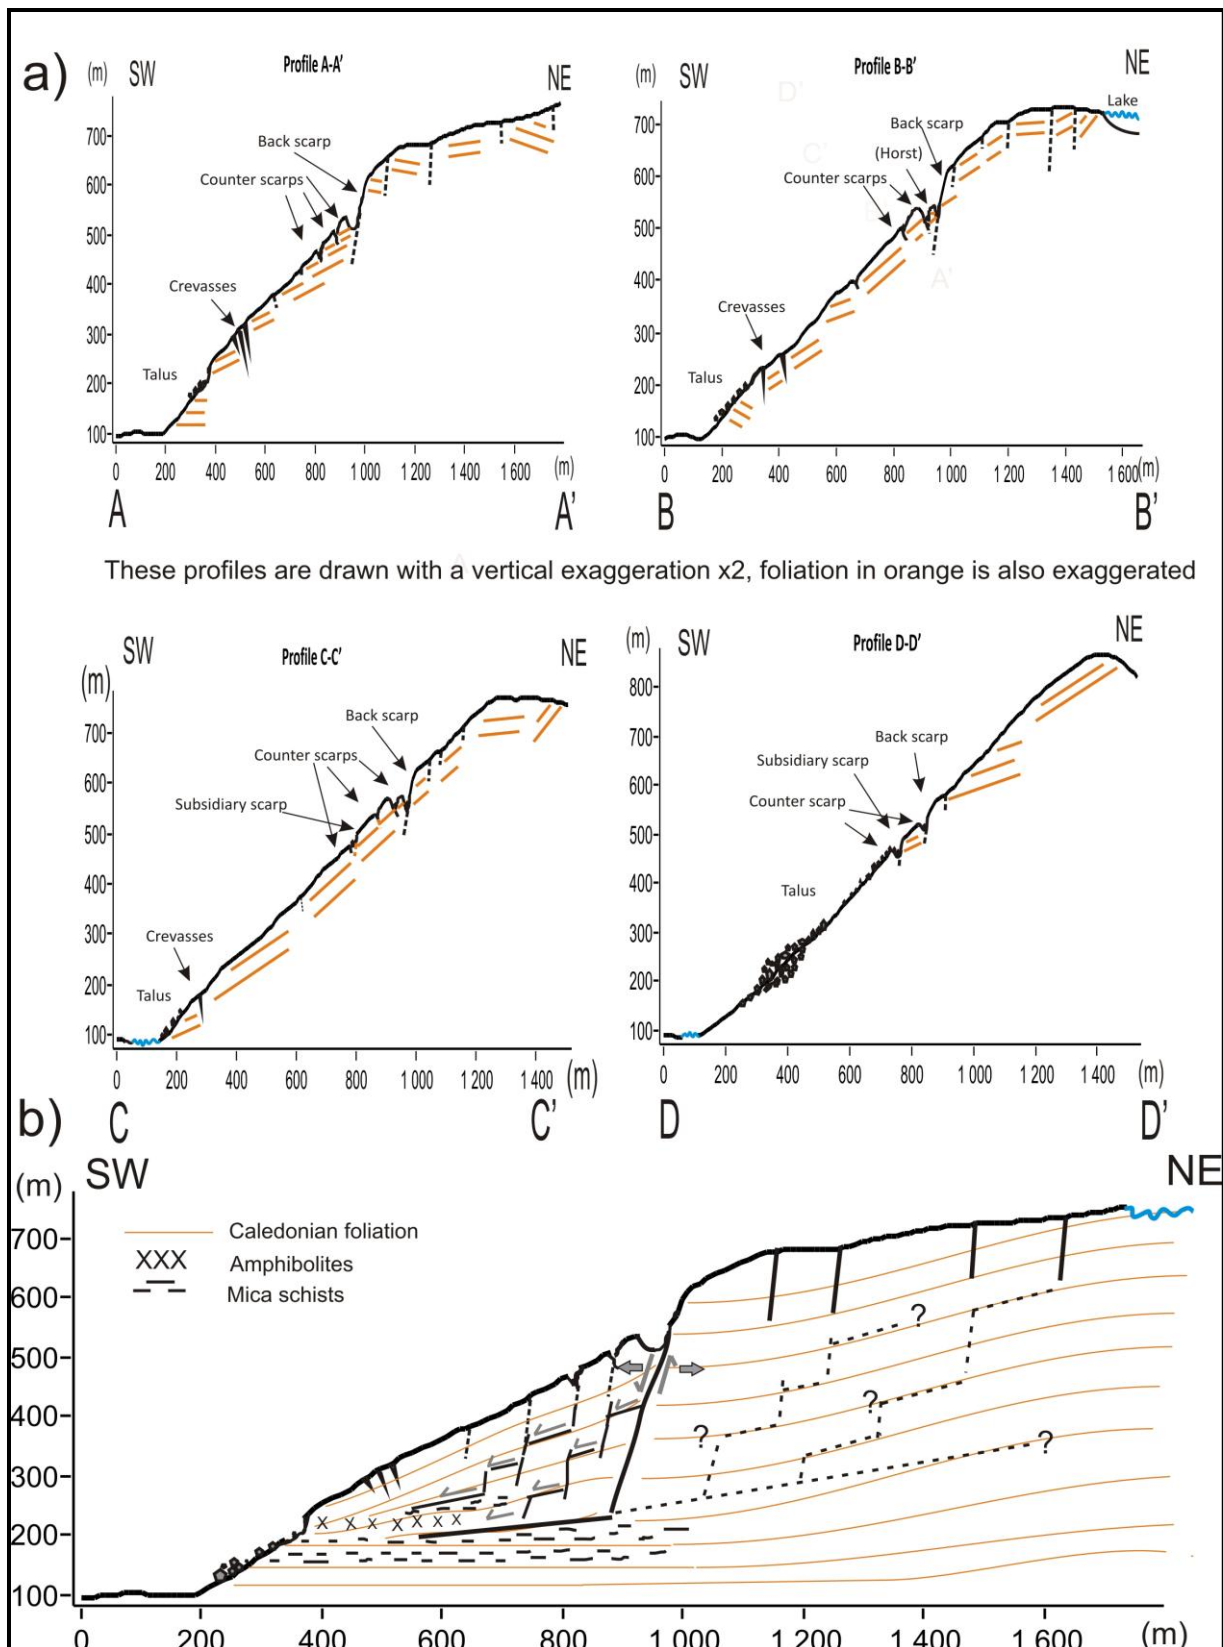
**Figure 5.4:** a) Illustration showing four profiles (1:2) over the whole potential RSF area; major morpho structures are labeled. Major fractures observed in the area are marked with vertical dashed lines. b) An geological model over Hompen RSF, and potential detachments. I) listric planar II) a listric step-wise geometry, vertical fractures connecting weakness structures into a step-wise geometry (Blikra et al., 2006a).
