Identification of Challenges and Hazards associated with Cruise Traffic and Evacuation in the Arctic

—
Tord Nese & Raymond Dalsand

Master thesis in Technology and Safety in the High North - June 2016

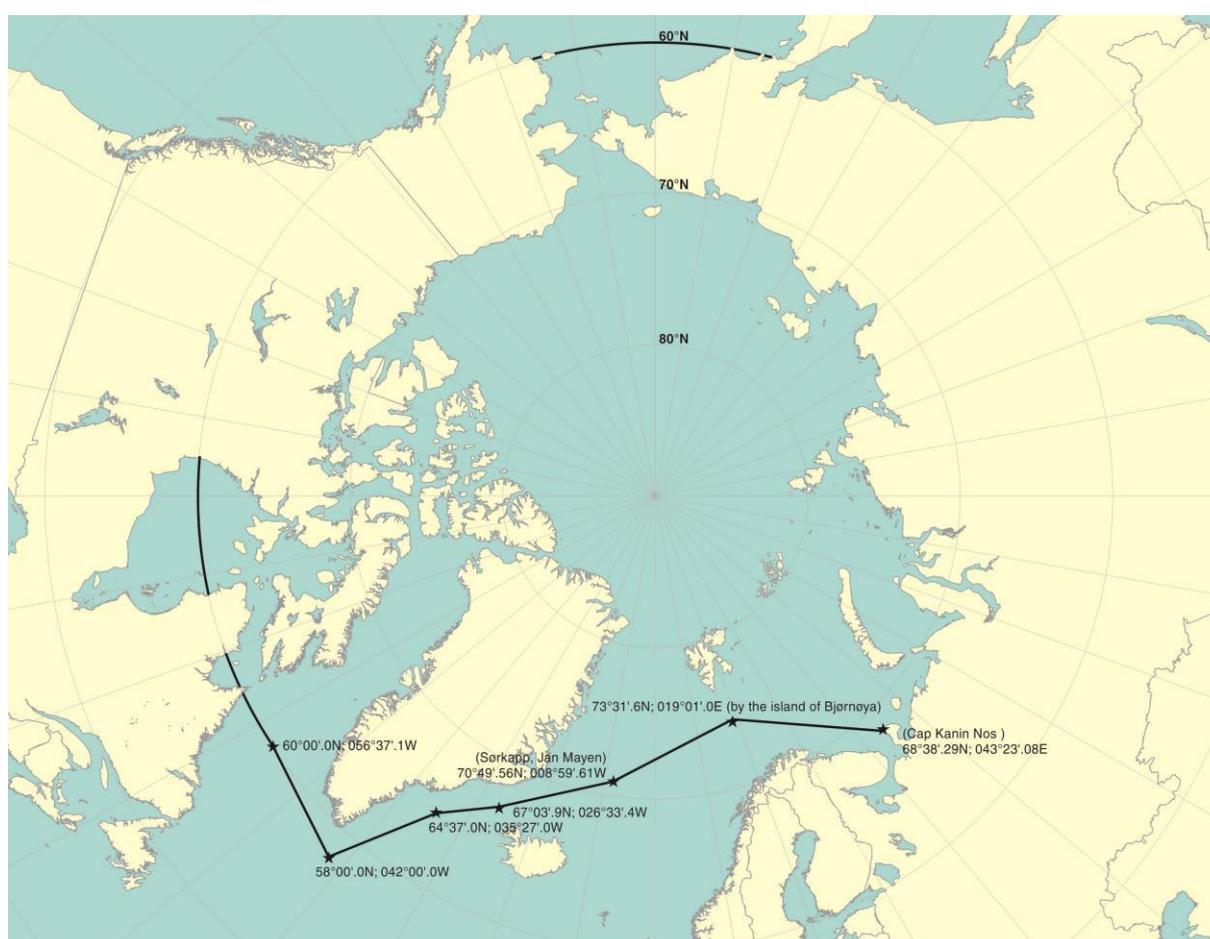
Figure 6: Polar Code Arctic boundary (IMO - Polar Code, 2014)

IMO defines the arctic boundaries somewhat different from the 10°-isotherm-area. The main difference is that the Polar Code boundary is adjusted due to warmer waters in the North Atlantic. As Figure 6 shows, the boundary is located at 60 degrees north in the Bering Sea. To include all of Greenland it shifts slightly to the south, following the east coast of Greenland, via the island of Bjørnøya, to an intersection point with the Russian arctic coast in the Barents Sea. Areas that are ice-free throughout the entire year is not included, which means that neither Iceland, Norway nor the Kola Peninsula is considered within the Polar Code area (ACCESS, 2015).

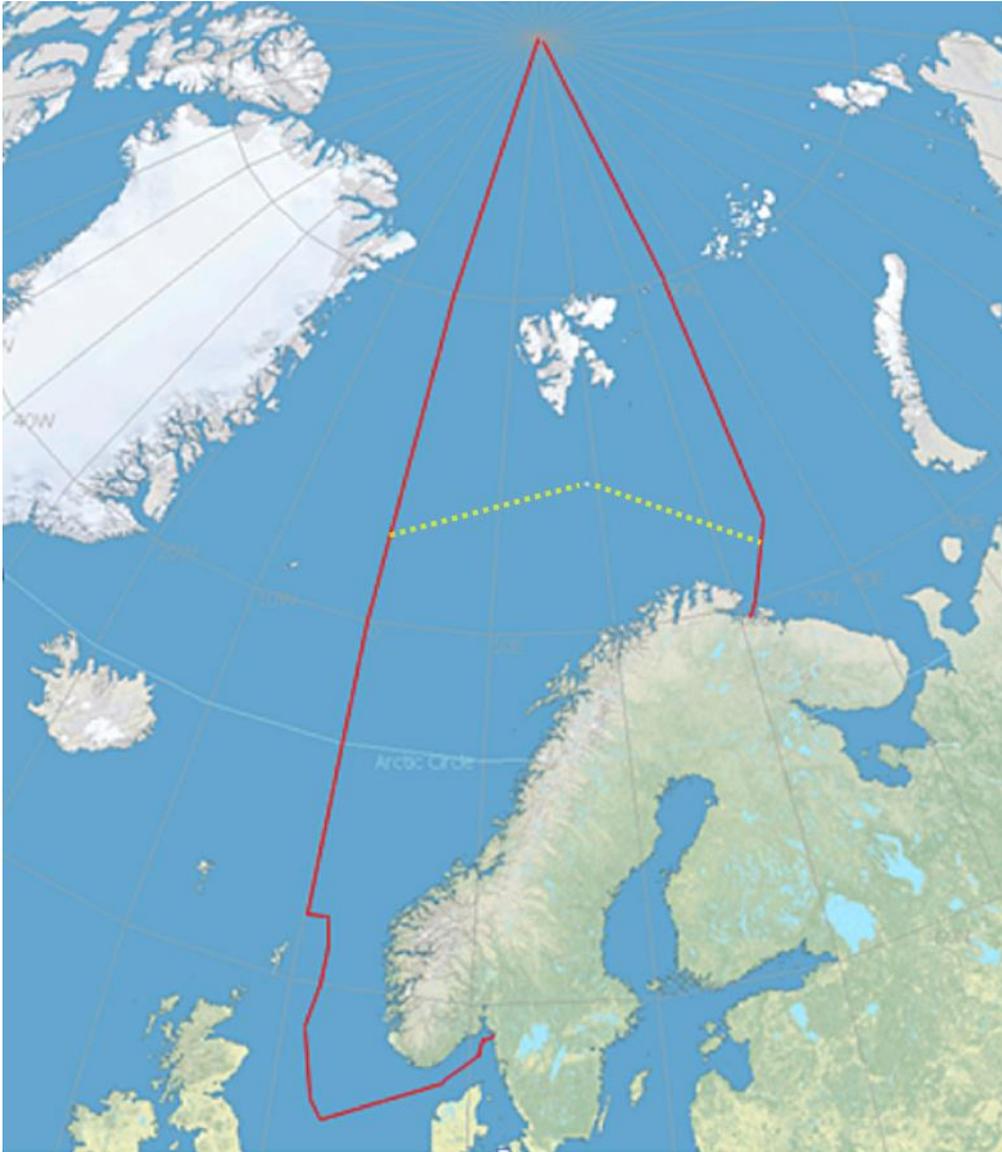
Figure 7: The Norwegian rescue service's area of responsibility (red line) combined with Polar Code boundary (yellow dotted line) – Adapted from BarentsWatch (2013)

The Norwegian rescue service's area of responsibility in the Arctic is extensive, covering parts of the Norwegian Sea, Barents Sea, Greenland Sea, Svalbard and stretches all the way to the North Pole (BarentsWatch, 2013). The Norwegian area of responsibility is presented in Figure 7. Combined with

the Polar Code arctic boundary, as illustrated with a yellow dotted line, this forms an arrowhead-shaped zone centered on the Svalbard archipelago.

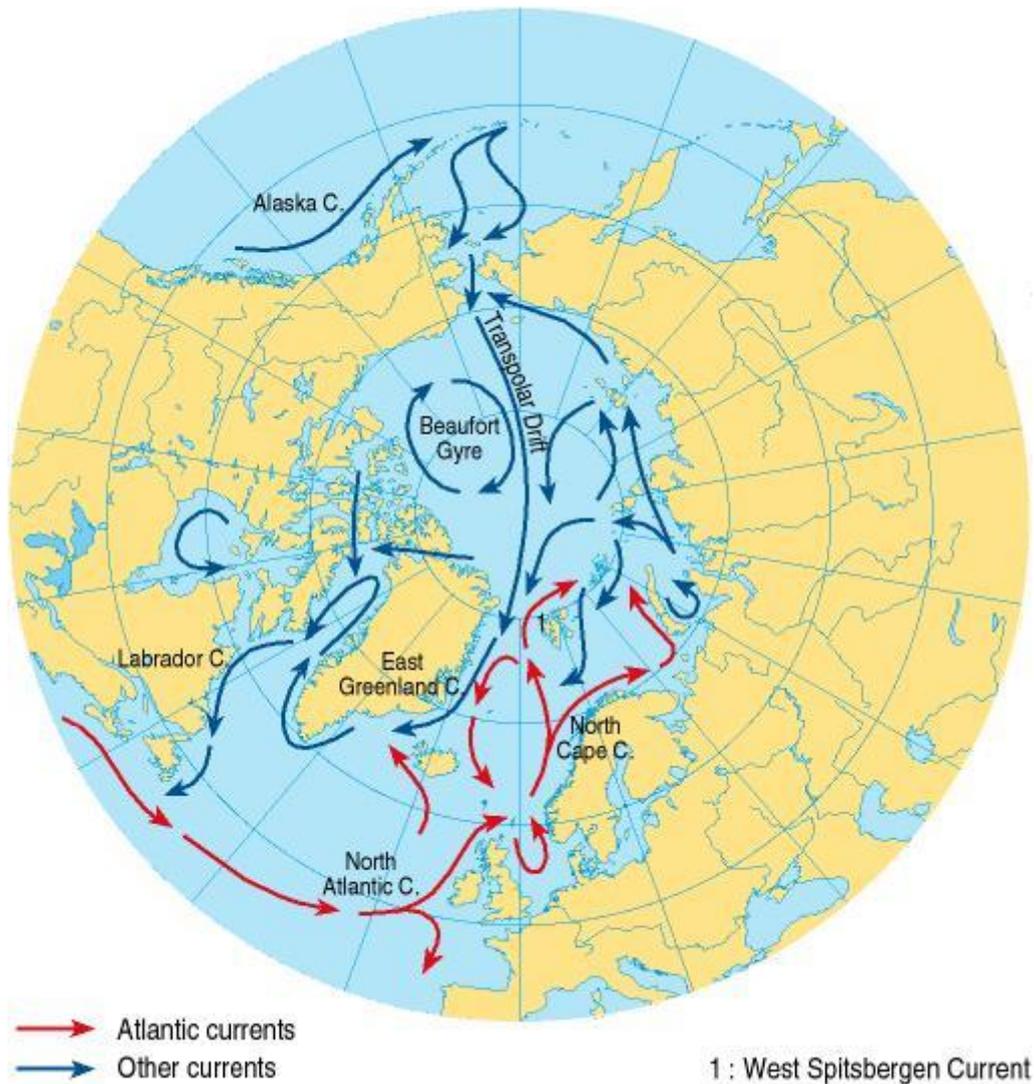
Figure 8: Surface ocean currents in the Arctic (UNEP/GRID-Arendal, 1997)

Other contributions to the water masses in the Arctic Ocean comes from the Bering Strait, as well as fresh water from the large rivers in Russia and Canada. This fresh water inflow is the reason why the uppermost 45 meters of the Arctic Ocean water column has a lower salinity than the lower-lying water. The surface ocean currents in the Arctic is illustrated in Figure 8.

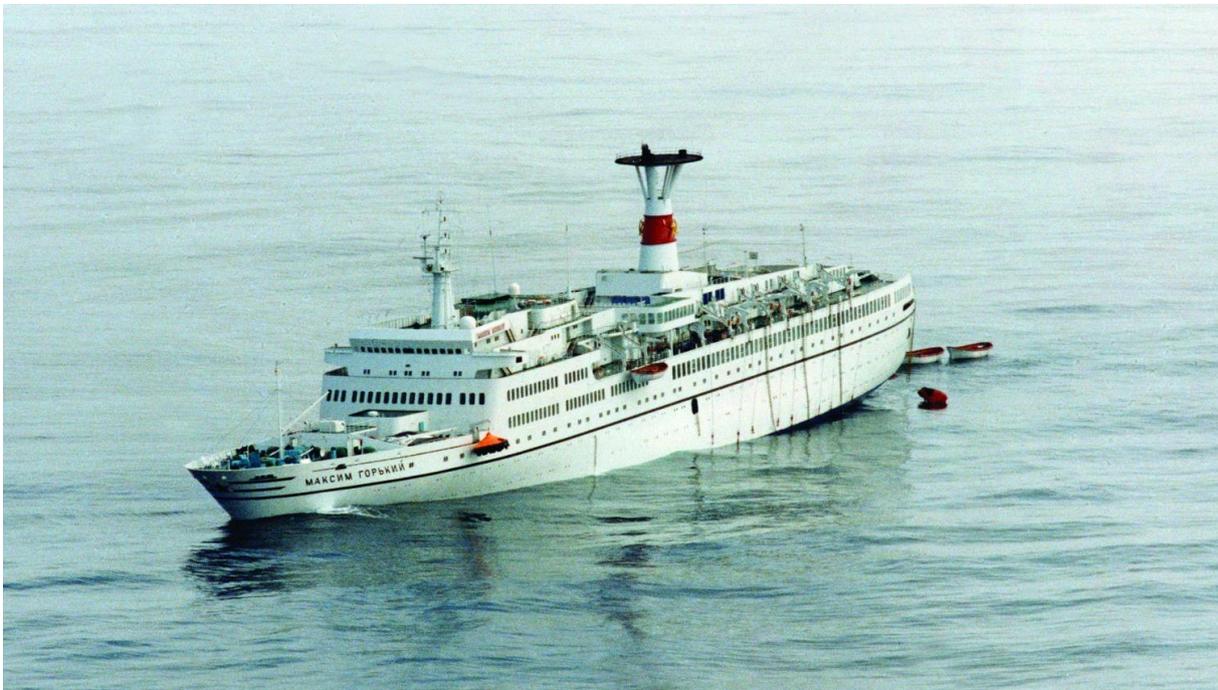
Figure 15: TS Maxim Gorkiy taking in water.

Maxim Gorkiy were trying to save the ship by asking for pumps and other aids to keep the ship afloat. After all of the evacuated passengers had been either picked up by KV Senja or transported to Longyearbyen by helicopter, the crew of KV Senja shifted priorities to help keep TS Maxim Gorkiy from sinking. Divers from KV Senja helped the crew from TS Maxim Gorkiy put a tarp around the ship to help prevent water from leaking into the ship. They also lent them pumps to keep the ship stable in the water. The ship can be seen listing in Figure 15. Two Russian helicopters came from Barentsburg with additional pumps to help stabilize the ship. After this KV Senja went back to Longyearbyen with over 500 passengers and around 200 of the crew from TS Maxim Gorkiy. There were no people severely injured or killed during this accident. The cruise ship TS Maxim Gorkiy was able to get back to Longyearbyen for temporary repairs. The ship was fully repaired in a shipyard in Germany and back in cruise duty in August that same year.

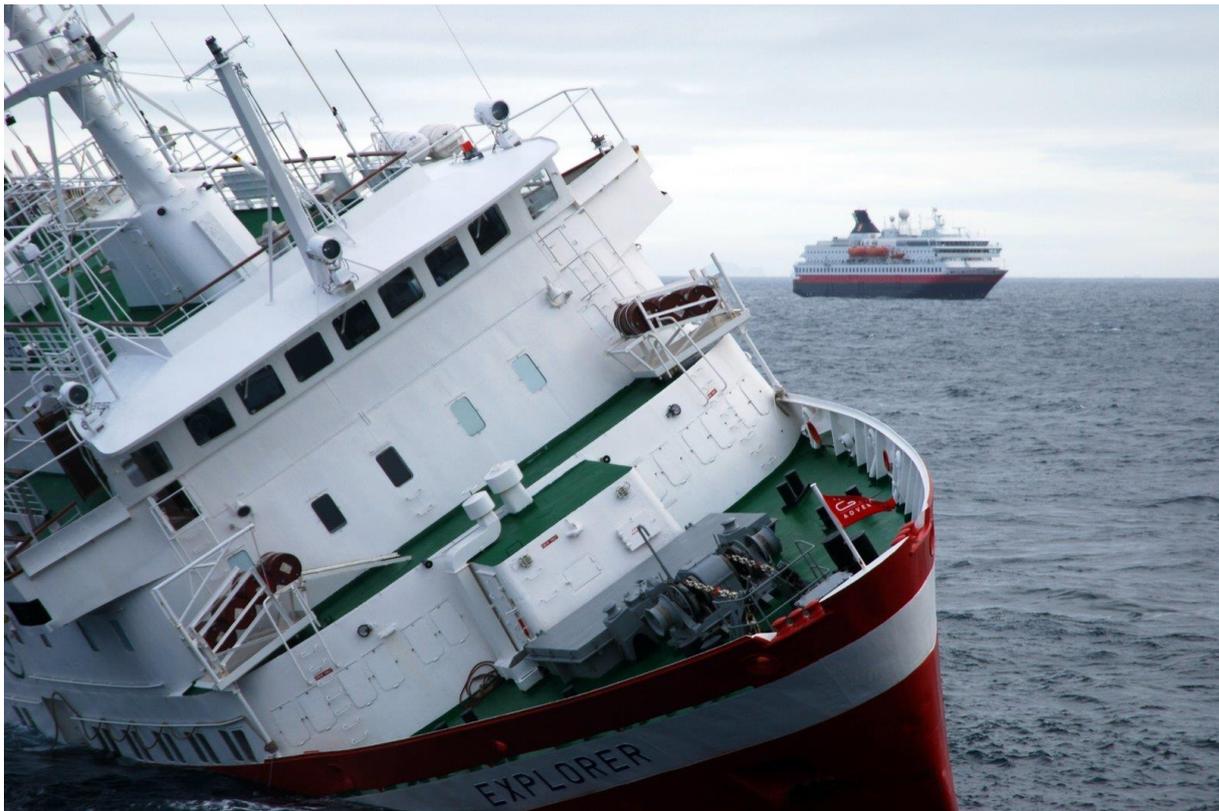
Figure 16: MS Explorer sinking with MS Nordnorge in the background (Gonzalez, 2007).

The Master of the ship had many years of experience from the Baltic Sea but this was his first mission as Master in Antarctic waters. Fellow crewmembers and passengers expressed concern about the speed in which the vessel was moving through the ice field. The Master was under the impression that he was moving through thinner first-year ice, and that the speed was unproblematic for these conditions. As the ship approached what crew and passengers have described as “a massive wall of ice”, the Master was confident the ship could ram through it. When the ship collided with the wall of ice, it came to a complete stop. As the Master was explaining to a fellow crewmember that they had to ram the ice repeatedly to go through it, the alarm sounded. Several cabins were flooding and the crew worked for a number of hours trying to stop the leak and to stabilize the ship using pumps. When the ship lost power, the Master ordered the ship to be abandoned. Figure 16 shows the ship sinking.

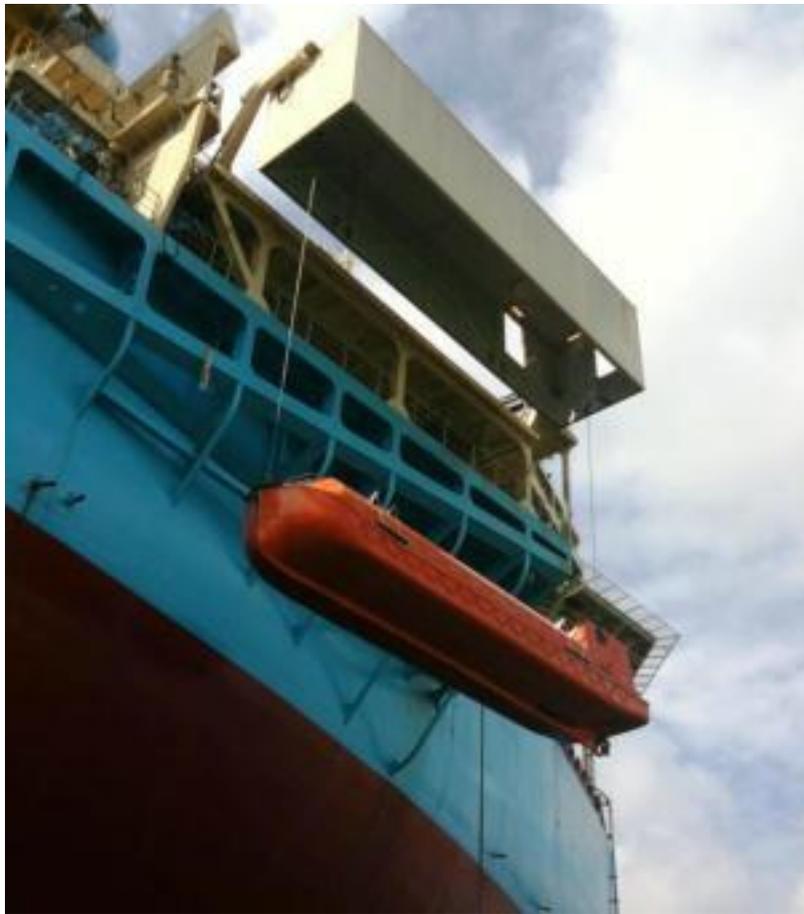
Figure 20: Boat-In-A-Box in launch position during lowering (Nadiro, 2011)

Regarding development of lifeboats and life rafts for use in the Arctic, it is sensible to look at recommendations and solutions developed for the offshore petroleum industry. Although most installations and vessels within the petroleum industry use freefall lifeboats, drop launch may be obstructed by sea ice when operating in arctic areas. It is possible to use the same lifeboats in such conditions, but they have to be lowered using the davit instead of being dropped. Arctic conditions present challenges not only to the operation of lifeboats, but also to storage and launching. Icing of the lifeboat when stowed in the cradle, and of the launching systems necessary to put the boat on water, may render the boat immobilized. These problems are relevant for all types of lifeboats and launching systems exposed to arctic conditions. There are several possible solutions to the icing problem, such as using heating elements to prevent freezing of mechanisms, or enclosing the lifeboat and arrangements partially or completely (Olje- og energidepartementet, 2012).

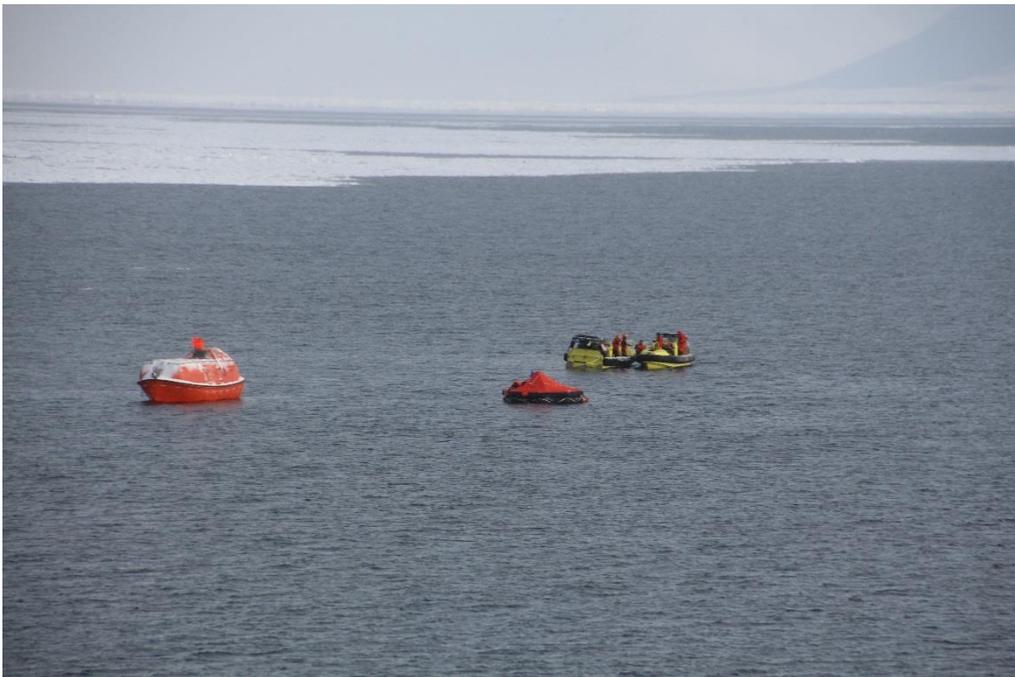
Figure 25: The lifeboat, life raft and MOB boats. Photo © Trond Spande

hours later, at which time the sensors and devices were turned off. Figure 25 is from the phase one test.

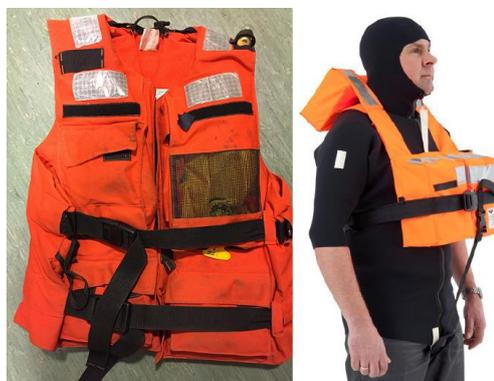
The Kamp Vest is the standard type lifejacket used by the Coast Guard. It features an integrated neoprene hood. Figure 27 shows the lifejacket.

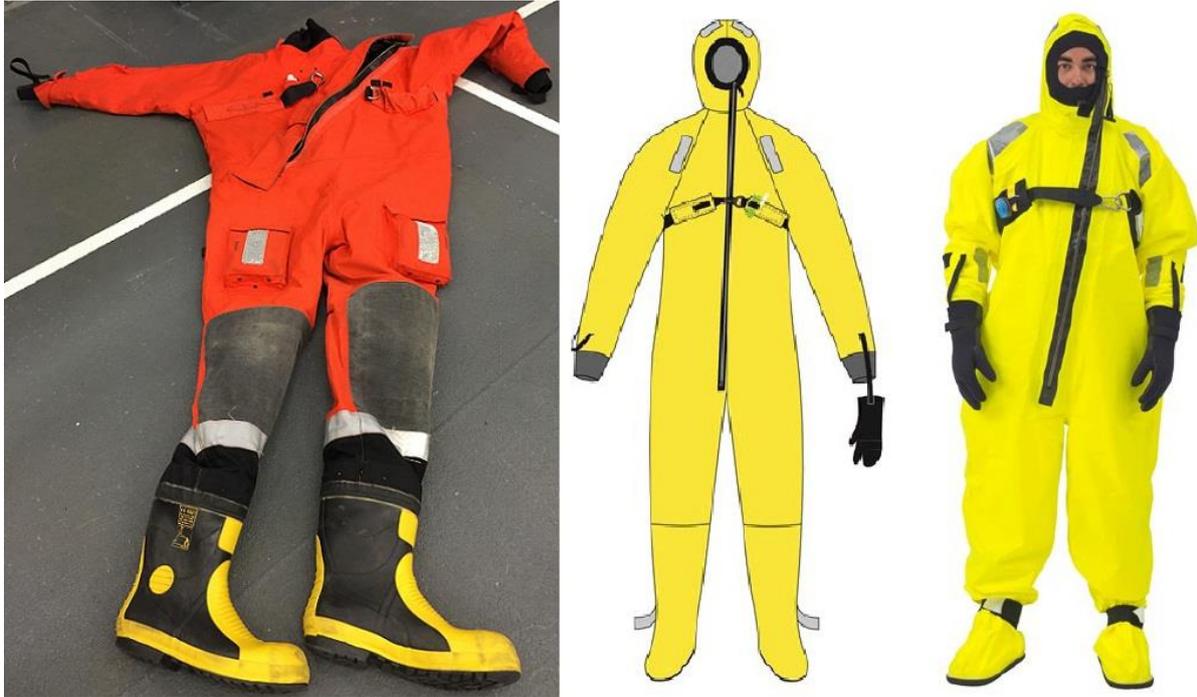
Figure 28: Left: Nordkapp suit, photo © Erik Johan Landa. Middle: Viking PS5003. Right: Viking PS5002.

The Viking PS5003 is an insulated immersion suit with outer material made of polyurethane coated nylon. It has a thick polyester lining with material weight 300 g/m². The suit has fully integrated boots and semi-integrated neoprene gloves. Figure 28 shows the suit (Viking Life-Saving Equipment, 2016b).

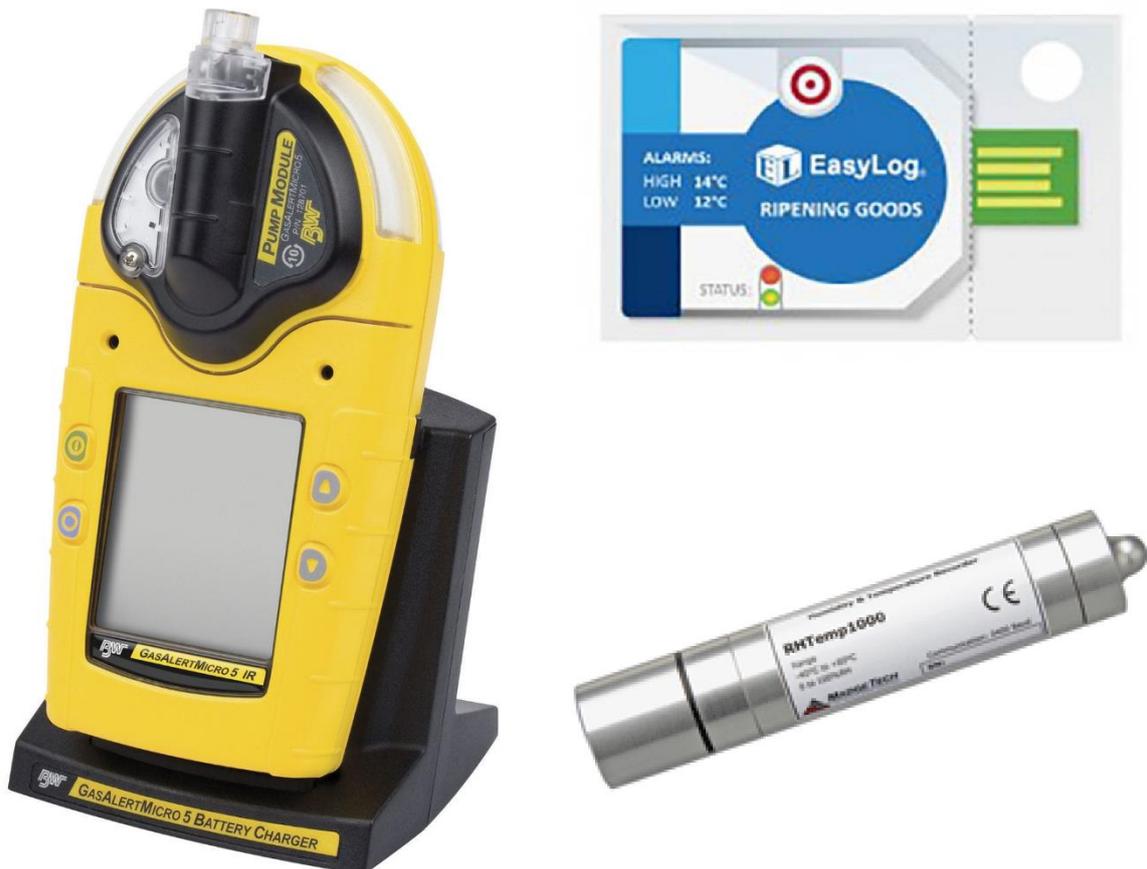
Figure 30: Logging equipment used during lifeboat test. Left: GasAlertMicro 5 IR gas detector. Top right: EasyLog EL-CC-1-003 temperature logger. Bottom right: RHTemp1000 humidity & temperature data logger

The following subchapters presents the various logging equipment that was used during the lifeboat test, including specifications and placement inside the lifeboat. The equipment can be seen in Figure 30, their placements inside the lifeboat can be seen in Figure 31.

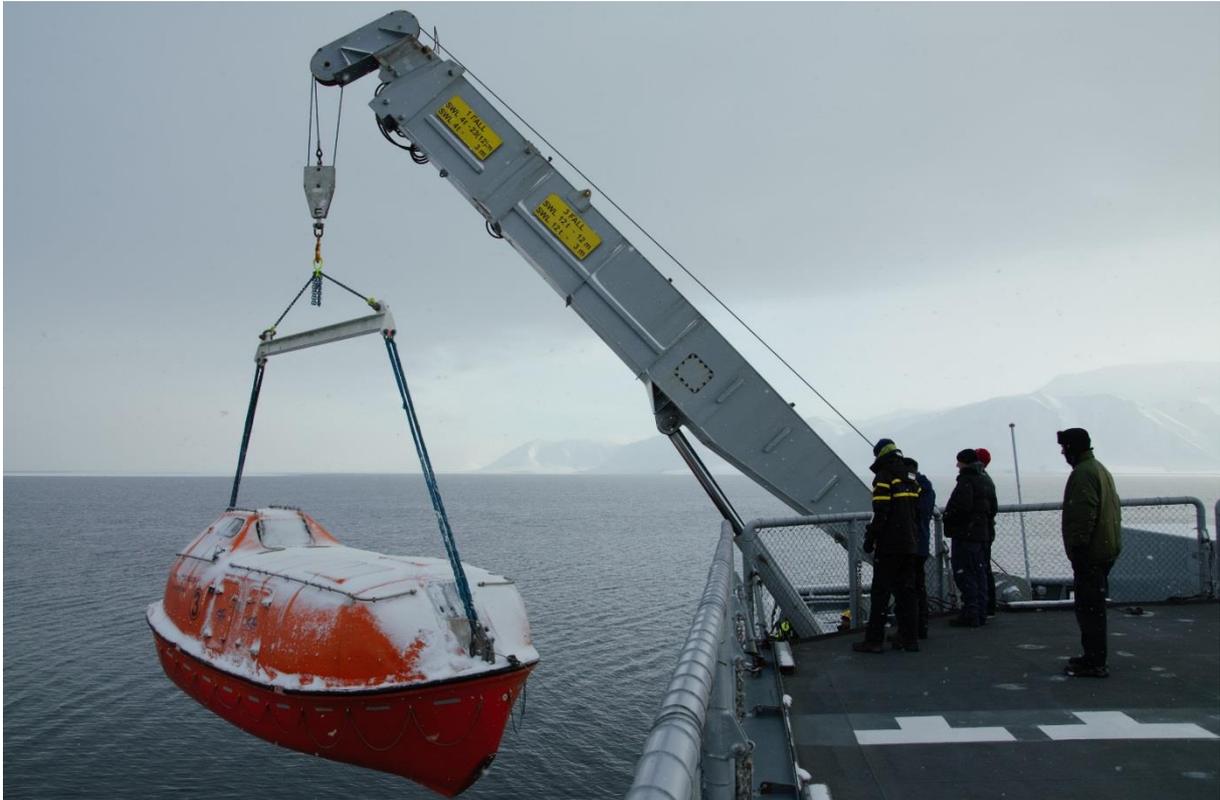
Figure 40: Lifeboat being lowered into the water with the deck crane. Photo © Jan Erik Jensen

The lifeboat was launched from the aft deck of KV Svalbard using the deck crane, as seen in Figure 40. Transport between KV Svalbard and the survival crafts was carried out using the two MOB boats, and

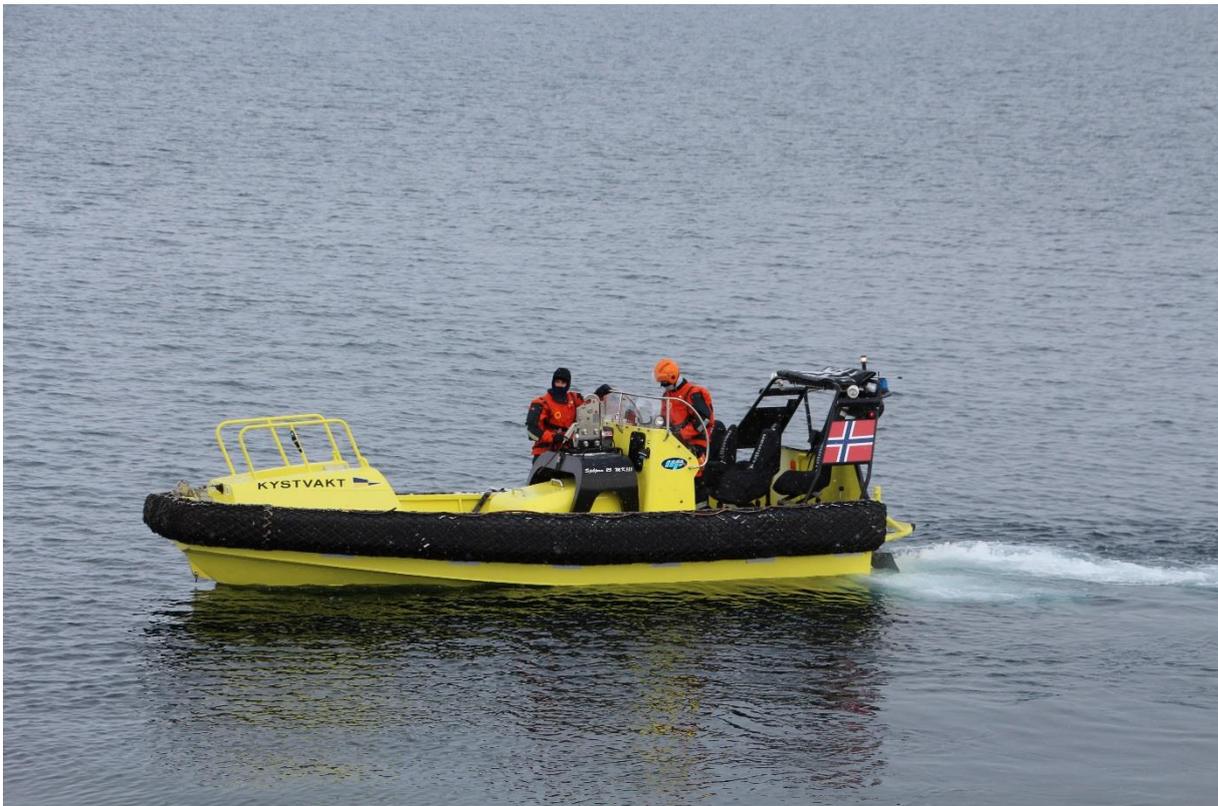
Figure 41: MOB boat used during test. Photo © Trond Spande

The test started Sunday 24th of April, at approximately 09:40, when all participants had been transported to the lifeboat with the MOB boats, depicted in Figure 41. The first hour or so was eventful, with many things happening. The participants found themselves places to sit, and since the number of people onboard was far from the total capacity of the lifeboat, the interior was rather spacious. The majority of the occupants chose to sit in the rear section of the lifeboat, where most of the activity was happening and the windows in the coxswain position provided light. The participants that was wearing the Viking TPA were also sitting in the rear, and since wearing these rendered them rather immobile, they mostly stayed in that area until disembarkation.

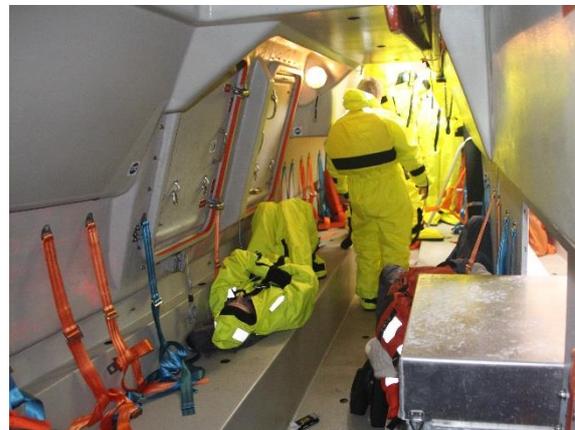
Figure 42: Lifeboat test participants in survival suits. One trying to sleep. Photo © Trond Spande

participants wished to sleep, while others wanted to be social, the lifeboat was divided into two zones. The forward zone was dedicated to those who wanted to sleep, and the aft zone was for those who wanted to be awake and social. Figure 42 shows the inside of the lifeboat.

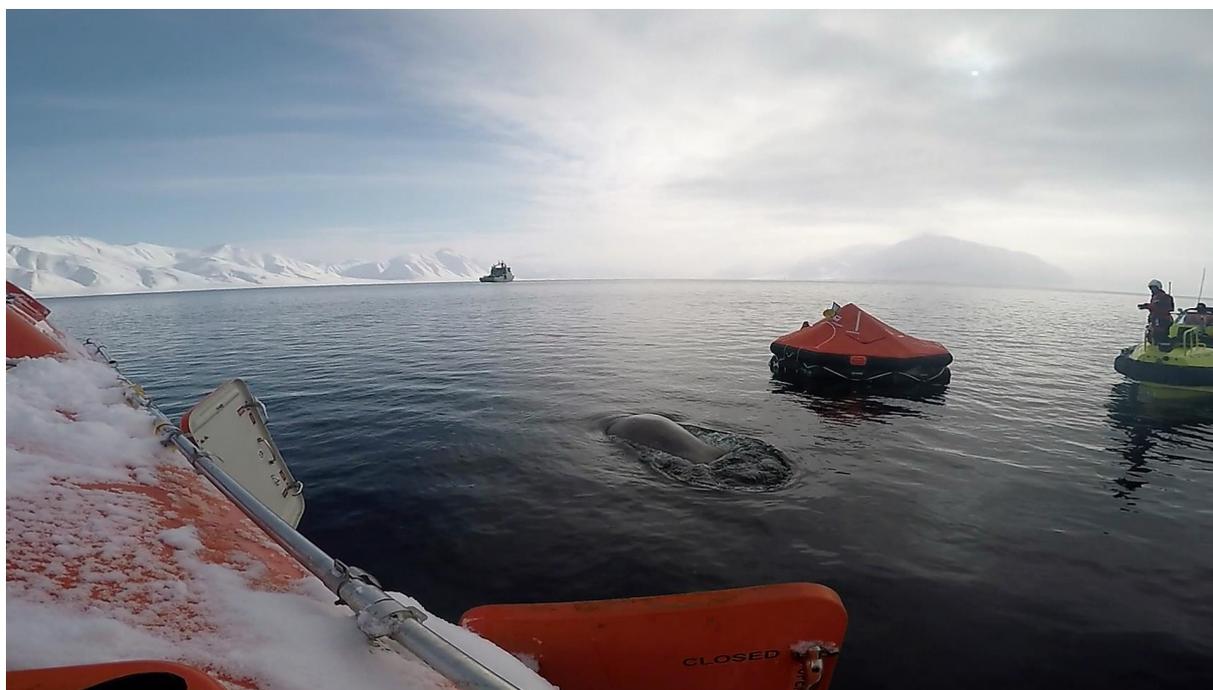
Figure 43: A walrus came close to the lifeboat and life raft during the test. Photo © Tord Nese

Around 13:45, a large walrus started to show interest in the lifeboat and life raft, which was attached to the lifeboat by a rope. It surfaced multiple times, on some occasions within only a couple of meters from the raft. The MOB boat was present throughout this episode, and succeeded in chasing the animal away after a few attempts. For the occupants in the lifeboat, this experience was mostly entertaining, but it seemed to be somewhat disturbing for the life raft occupants. They had very limited view from inside the raft, and only thin sheets of rubber separated them from the nearby walrus. Figure 43 shows the walrus between the lifeboat and the life raft.

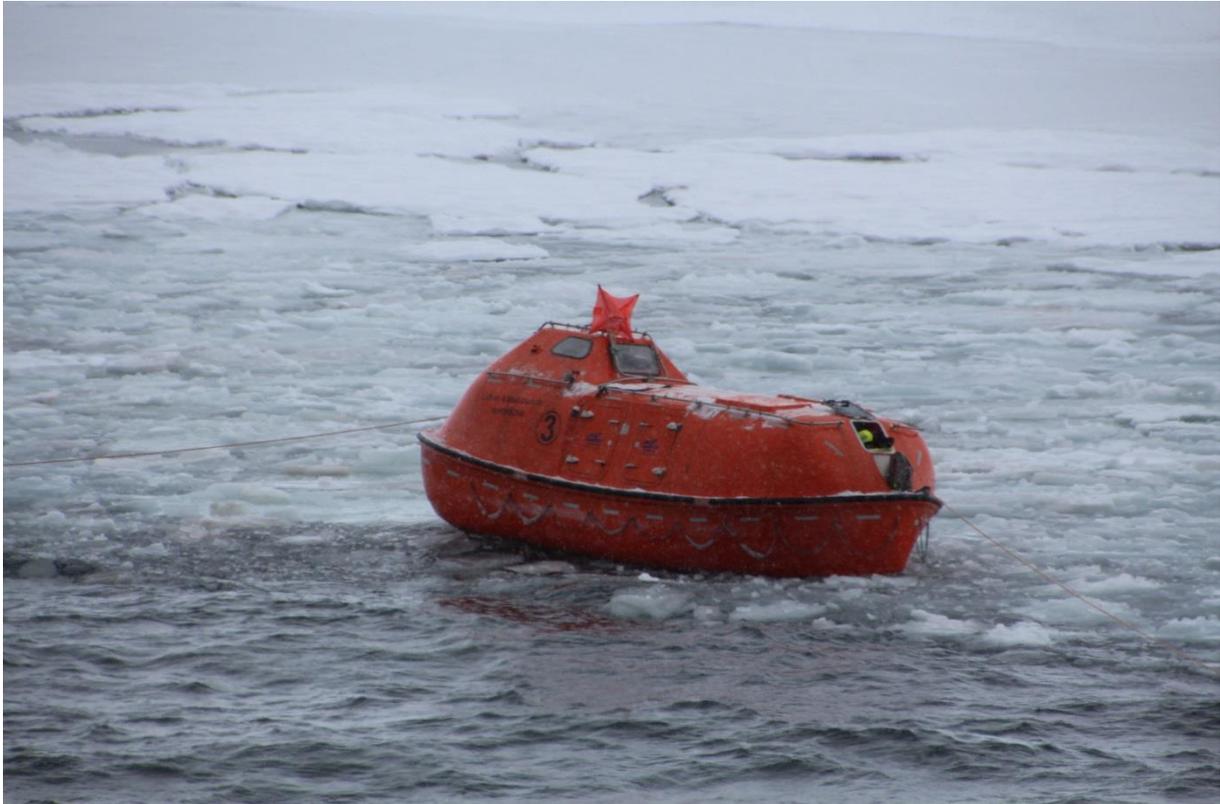
Figure 44: Lifeboat drifted into a belt of ice during the test. Photo © Trond Spande

Around 08:00 in the morning, the lifeboat drifted into a belt of ice as seen in Figure 44. By then, the wind had picked up as well, and there were more waves than previously. This caused the boat to roll, and the ice hitting and scraping along the hull was clearly audible. As the test was nearing the end, there were discussions among the participants whether it would have been possible to survive for several more days in the lifeboat. It was commonly agreed that it would have been possible to survive for some days, but that it would become harder and harder to find motivation to perform physical activity in order to stay warm. It was also mentioned that in a real situation, the motivation to stay alive probably would have made a big difference compared to the motivation during the test.

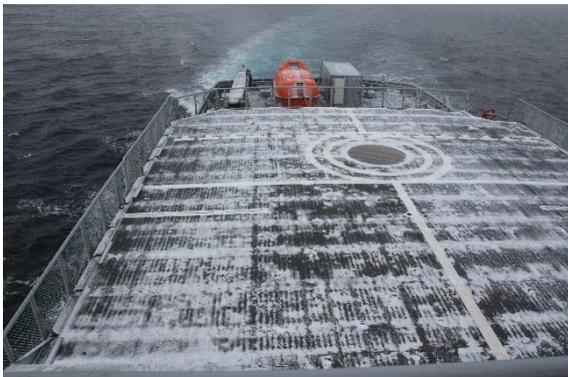
*Figure 50: Snow accumulation on deck of KV Svalbard.
Photo © Trond Spande*

In an evacuation situation, getting to the lifeboat can be hazardous if the walkways are unsheltered and slippery due to ice and snow accumulation. Cruise passengers are often elderly persons that can have a difficult time moving around. They can also be in need of some sort of assistance. In these cases, a slippery walkway can be a daunting task to maneuver through safely. The Polar Code requires exposed escape routes to be accessible and safe when taking into consideration the potential for icing of structures and snow accumulation. This can be achieved with sheltered walkways. Figure 50 shows snow accumulation on the deck of KV Svalbard.

If these cannot be sheltered, heated walkways where ice and snow cannot accumulate can be another solution. Making sure the walkways are covered with friction material is another measure that can help fulfill the Polar Code, but ice and snow would have to be removed manually throughout the journey. As some passengers might need assistance getting to their muster station, they will most likely need assistance getting into the lifeboat. This will

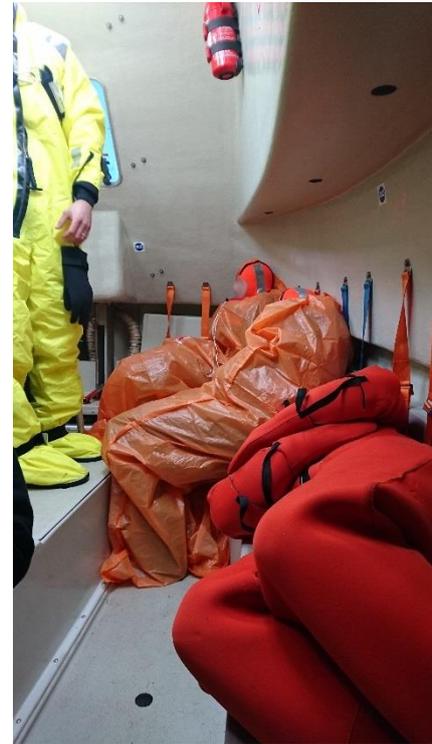
Figure 51: Lifeboat test participants wearing various PPE. Photo © Tord Nese

which muster station to go to in case of an evacuation. The Polar Code requires that all passengers are provided with adequate thermal protection and a PSK that, in combination with life-saving appliances, provide sufficient thermal insulation to maintain their core temperature and provide sufficient protection to prevent frostbite of all extremities. The fact that every passenger needs a PSK will put a strain on the lifeboat regarding sufficient space to accommodate its maximum capacity of persons together with their PSK. This will require lifeboats that were certified for a certain amount of passengers, to be re-evaluated and certified for an appropriate amount of passengers with room for their PSK. The Polar Code requires that life-saving appliances shall provide space to accommodate persons equipped with thermal protection adequate for the environment, and the thermal protection they need will most likely be in each passengers PSK. Figure 51 shows various PPE.

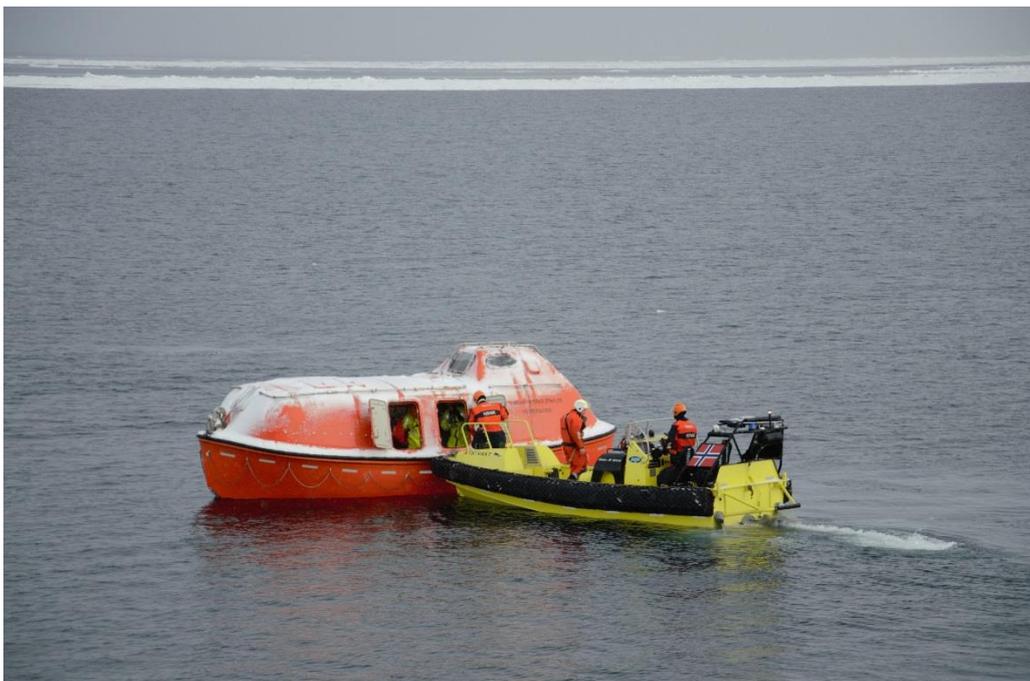
Figure 56: Lifeboat together with the MOB boat used as rescue vessel in the test. Photo © Jan Erik Jensen

Being rescued from the lifeboat onto a rescue vessel or into a helicopter can also be risky. As of now there are not really any set ways of doing it, it all depends on the rescue vessel and the lifeboat design. An example from the test is shown in Figure 56. A possible design measure that can be taken is to have large hatches that facilitate easy rescue operations, especially if passengers are injured and need to be taken out on a stretcher. A problem that came up during SARex phase two was the fact that with a crowded lifeboat, it became hard for rescue personnel to evacuate the most injured people first since they had no room to operate in. They were forced to get the people that were able to help themselves off first so they had room to handle the people that required assistance. Solutions to these problems are hard to come by, and more research is needed on this topic.
