Part C: Hard Testing and Verification – Test report

Project: Wire Gear for Small Rotary Actuator

Contracting Authority: Kongsberg Space Systems

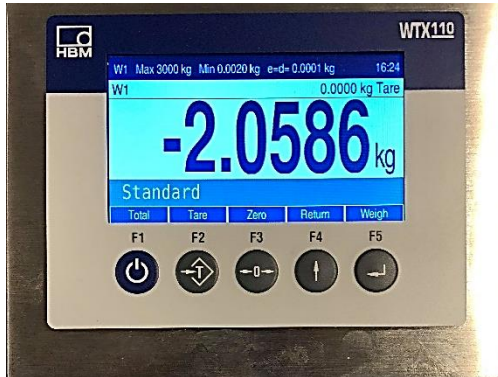
Figure 4: Tensioning monitor

The test rig is the developed SRA from Part B. Recall an output shaft of 140 mm in diameter, and an input shaft of 14 mm with a pitch of 1,75 mm, 12 turns. With a total angular friction of 345,6 mNm and surface roughness of N5. The test rig and equipment's are illustrated in Figure 4 to Figure 6

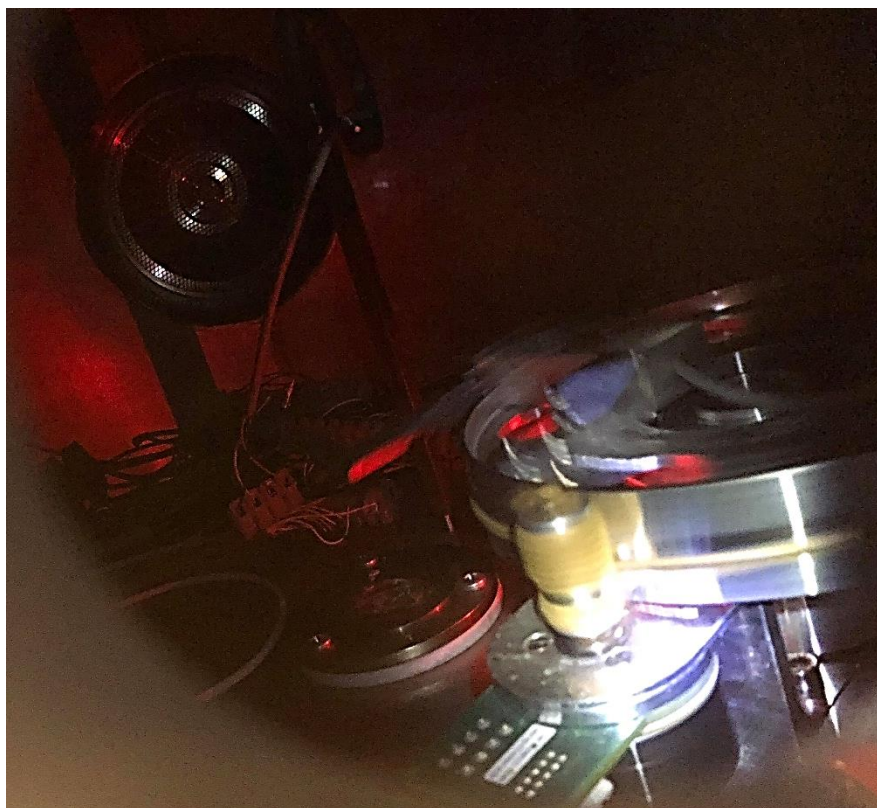
Figure 7: WG-SRA during test

Figure 7 shows the WG-SRA during test inside the vacuum chamber. Representative, electrical component and electrical guide are present. Note the steel beam to hold the electrical wire for the load cell to counter “flexing” fatigue.
