## **Engineering geology of the Jettan rockslide, Kåfjorden**

GEO-3900 Master's thesis in Geology, May 2020

The unstable rock slope (URS) Jettan is located at Nordnesfjellet in Kåfjorden municipality in Troms and Finnmark County, 800 m above the fjord. The rockslide has an estimated volume of  $6 \text{ Mm}^3$ , and moving at a rate of up to  $50 \text{ mm a}^{-1}$ . Jettan is considered a “high risk object” within the Norwegian unstable mountain framework. This is due to the potential displacement wave impact to housings, infrastructure and industry. As such there has been a scientific interest in the site since 1999 generating several studies, reports, investigations and theses. Continuous monitoring began in 2007.

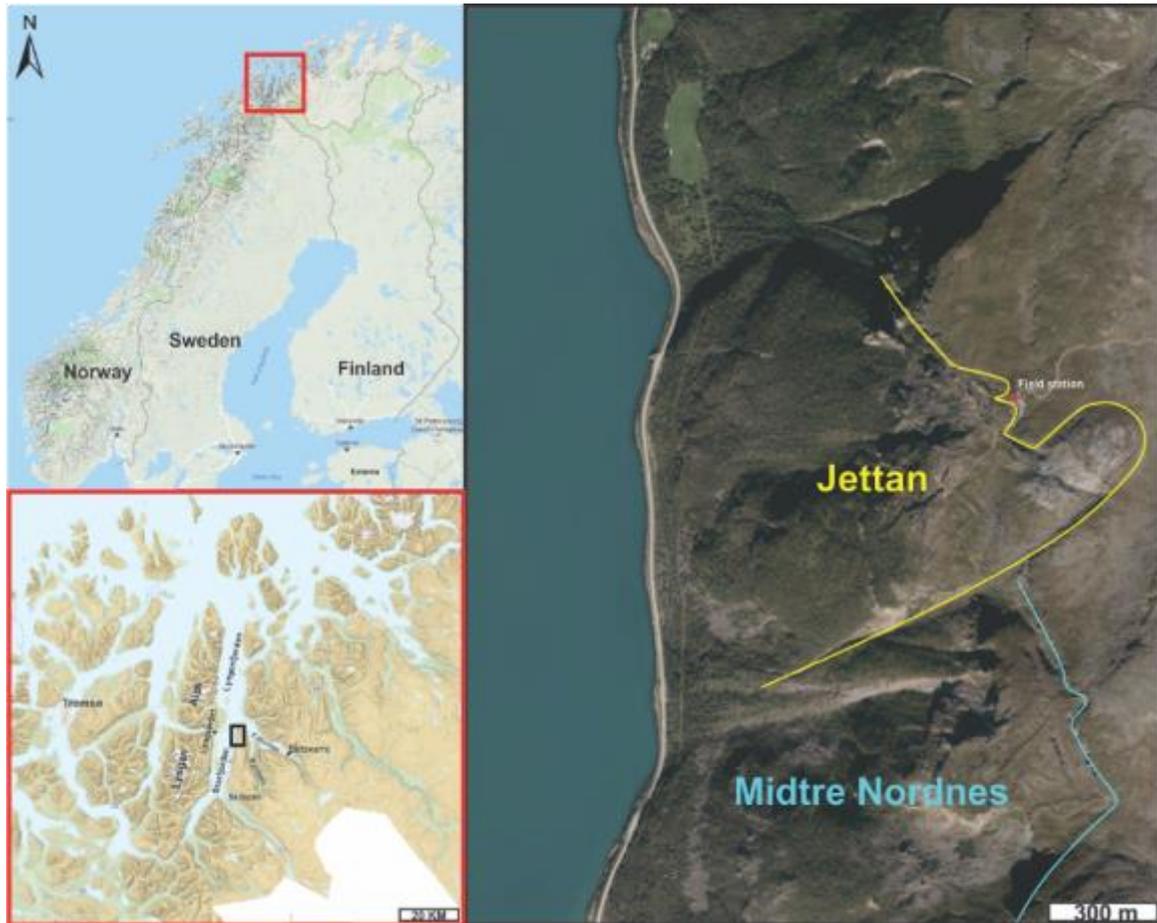
Figure 1: Left: Location of the Jettan rockslide on the western side of Nordnesfjellet mountain, in Troms and Finnmark county in northern Norway. The black rectangle shows the location at Nordnesfjellet. Right: URs are delineated using backscarps, and field station location is indicated. Based on 2016 aerial photograph (Google, 2019; Kartverket, 2016, 2019).

Jettan is a part of Nordnesfjellet mountain in Troms and Finnmark county (figure 1). The unstable area is located between 0 and 800 m asl on the W-facing slope of the mountain. Jettan neighbors two other URSs at Nordnesfjellet, Midtre Nordnes and Indre Nordnes, forming a complexly deforming mountain ridge. The mountain ridge is bound by Storfjorden on the western side, and Kåfjorden and Manndalen valley on the eastern side. The fjords merge north of Nordnesfjellet, where they become Lyngenfjord, which is traced northward to the continental shelf. The Lyngen Alps stands out with the highest mountains in the area, including some peaks over 1800 meters. Nordnesfjellet is less dramatic with a flat mountaintop at 900 m asl and is therefore considered as part of the paleic surface. Below the URS the main road connecting Troms and Finnmark (E6) used to pass, but a tunnel has now been constructed going through Nordnesfjellet. This has resulted in less traffic in the impact hazard zone.

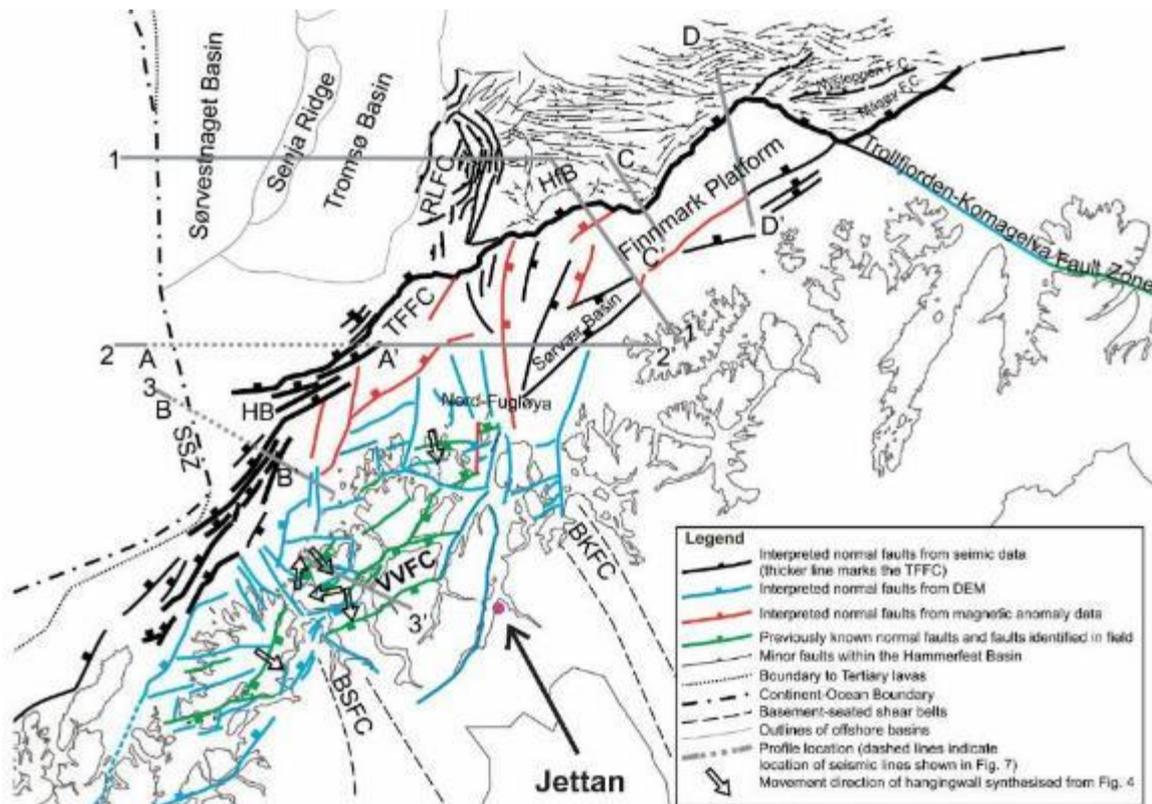
Figure 3: Mapped Post-Caledonian normal faults in Northern Norway. Modified from Indrevær et al. (2013)

There are two major fault complexes seen in Northern Norway with a post Caledonian origin, the Vestfjorden-Vanna and the Troms-Finnmark fault complexes (Indrevær et al., 2013). They are characterized by moderate to steep dipping normal faults trending NNE-SSW and ENE-WSW found partly onshore and partly offshore, and they are bound by a major horst, the West Troms Basement Complex (WTBC) (Indrevær et al., 2013). Northward from the southern part of the Troms-Finnmark fault complex the Ringvassøya-Loppa fault complex is displayed showing an N-S trend (figure 3). Indrevær et al. (2013) suggested that the faulting was happening on pre-existing Precambrian and Caledonian structures in the bedrock as for example ductile shear zones and lithological boundaries.

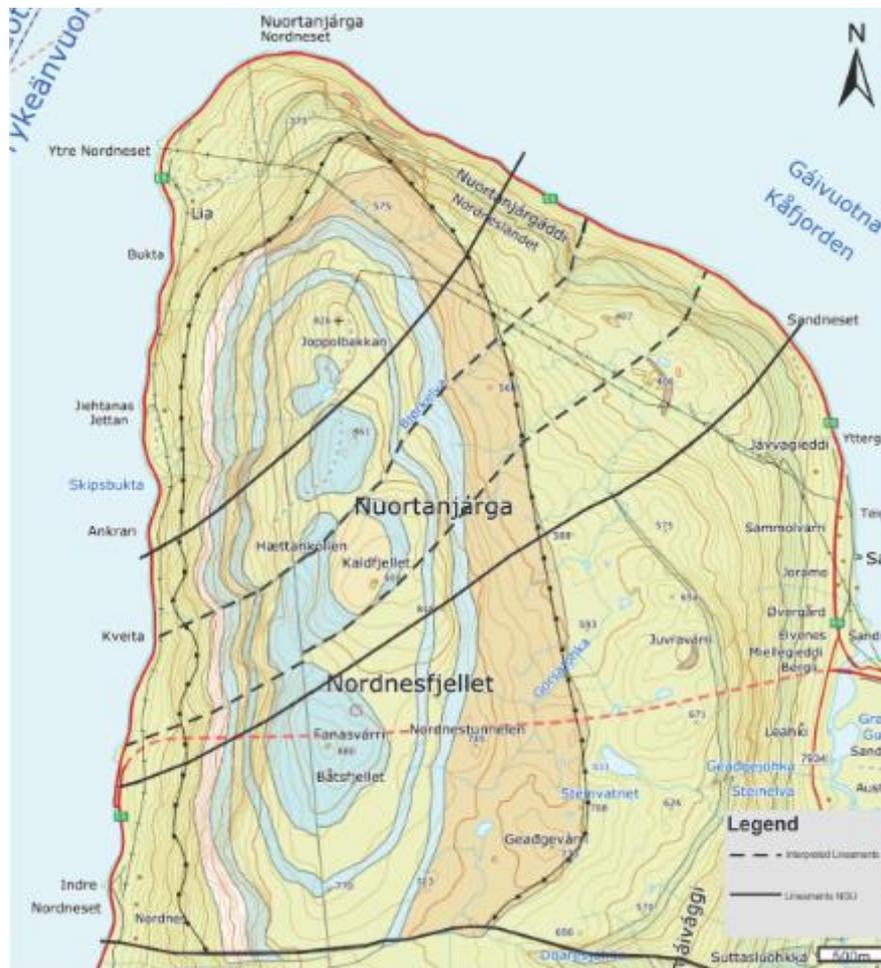
Figure 4: Lineaments and bedrock map at Nordnesfjellet. Modified from NGU (2019c).

At Nordnesfjellet two lineaments striking E-W to WNW-ESE one along Innerbuktlia and one at Indre Nordnes from Lyngenfjorden to Manndalen, and several lineaments striking NE-SW is mapped (figure 4) (Zwaan, 1988). From field investigation and aerial photos several other lineaments were found (figure 4). The lineaments at Nordnesfjellet has been interpreted as faults from the fact that at least some of them show a discontinuity in the lithology.

Nordnesfjellet is divided by a major nappe boundary separating the Nordmannvik and the Kåfjord nappe, and is comprised of three dominant lithologies: garnet quartz mica gneiss, calcite silica gneiss and marble (figure 4) (NGU, 2019c). The garnet quartz mica gneiss is expressed as a blastomylonite or as more schist when it contains a higher mica content (Skrede, 2013). In areas with high mica content the rock has fractured along big, flat foliation surfaces. Where it has been exposed for weathering, the rock is more weathered and decomposed (Skrede, 2013). The calcite silica gneiss consists of layers that are either carbonate rich or silica rich, ranging from a few centimeters to 10's of meters thick (Skrede, 2013). The rock is exposed in bands throughout the whole area with greater thickness in the lower scarps (figure 9) (Skrede, 2013). The marble is found in the upper most part of the unstable area, and as a lens in the steep back scarp, a displaced block and Jettankallen in the northwest (figure 9) (Skrede, 2013). In the URS different ductile deformation structures are present in various scale, as blastomylonites in the garnet mica gneiss, sheet folds in quartz layers, boudins (from centimeters to meters) in calcite silica gneiss and minor folds in amphibole rich calcite silica gneiss layers (Skrede, 2013).

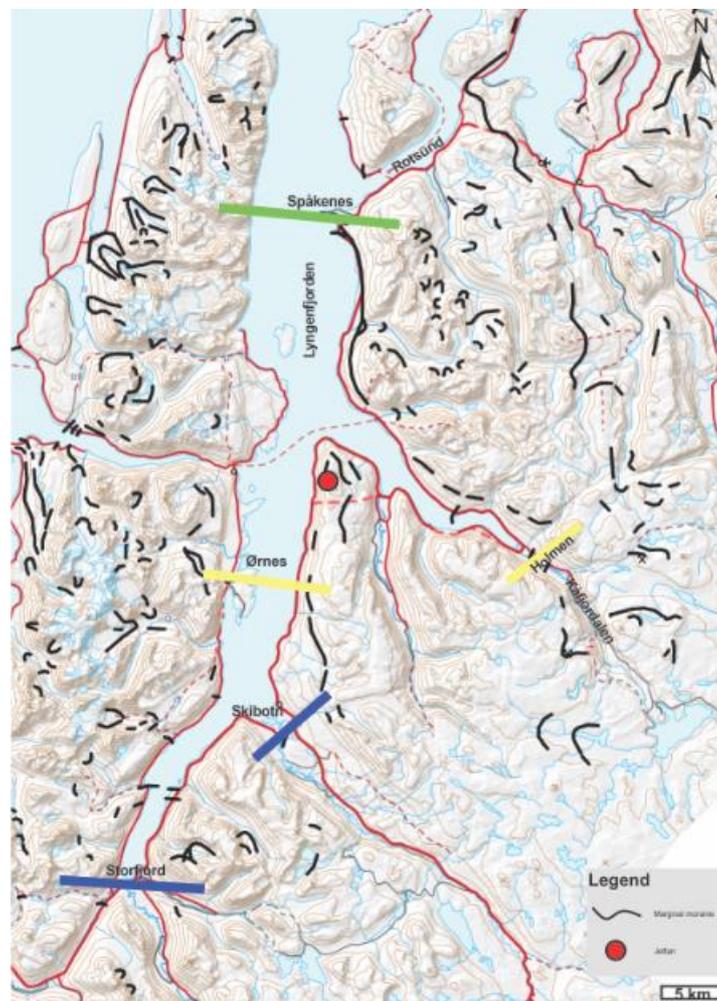
Figure 5: The ice front position during the deglaciation and marginal moraines. Green line = Tromsø-Lyngentrinnet, yellow line = the Ørnes event and blue line = the Skibotn event. Modified from NGU (2019a) (CORNER, 1980).

At Nordnesfjellet marginal moraines are mapped on both slope aspects, with a more dominant moraine morphology on the eastern side (figure 5). The moraine ridges are mapped at 700 m asl in the south and 500 m asl in the northern outer end of the peninsula (NGU, 2019a). One of these moraine ridges is seen at Jettan, where it has collapsed into a big fracture (Blikra & Christiansen, 2014).

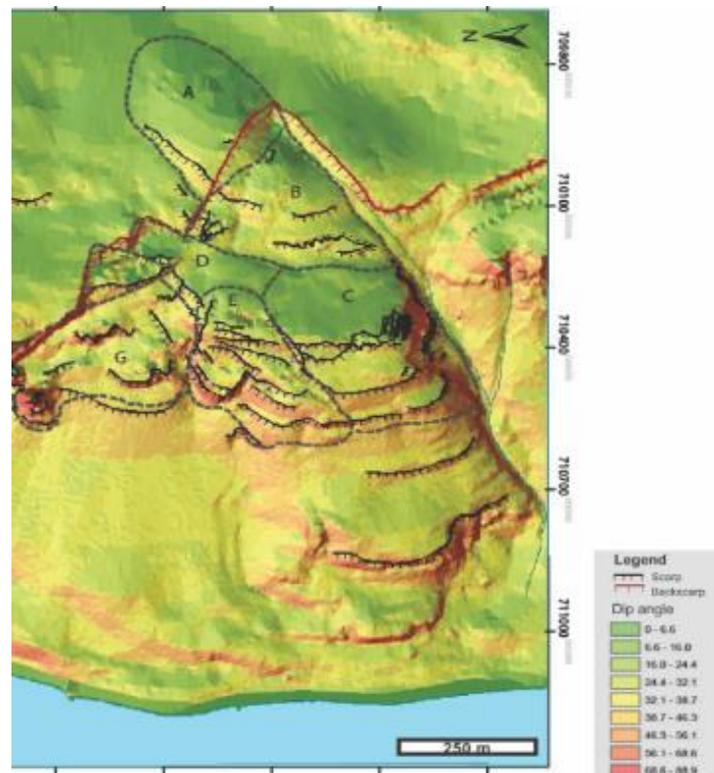
Figure 7: Scarps and dip angle at Jettan with the different domains used by Skrede (2013). Modified from Skrede (2013).

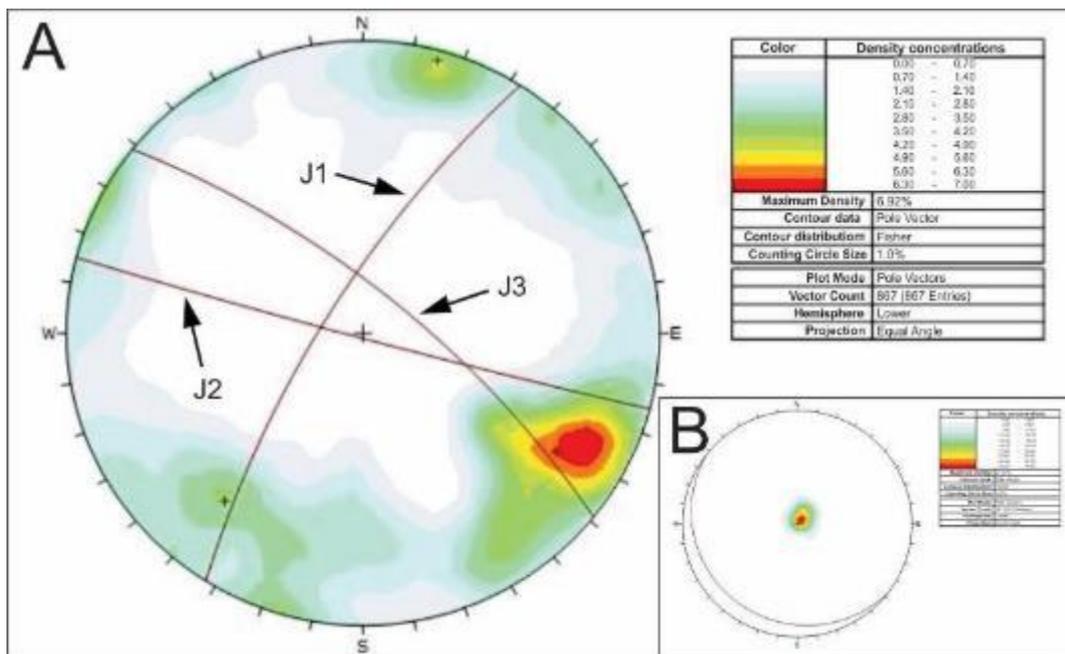
Figure 8: Stereographic plot of the structural measurements at Jettan. A) Joint measurements visualized as contour plot with great circles representing the main joint sets. B) Measurements of foliation visualized as contour plot. Modified from (Nystad, 2014).

Three main joint sets are found at Jettan (figure 8). The most dominant joint set (J1) is oriented NE-SW dipping  $55-90^\circ$  towards NW, and because of its steep dip it is also dipping towards SE. Joint set two (J2) is oriented ESE-WNW dipping  $50-90^\circ$  towards N and  $60-90^\circ$  towards S. The last joint set (J3) is oriented NW-SE dipping  $70-90^\circ$  towards SW and NE (Nystad, 2014). Additionally there are two joint sets oriented NNE-SSW and NNW-SSE (table 2) (Skrede, 2013). The persistence of the joints has a dominating planar trend with constant dip angle.

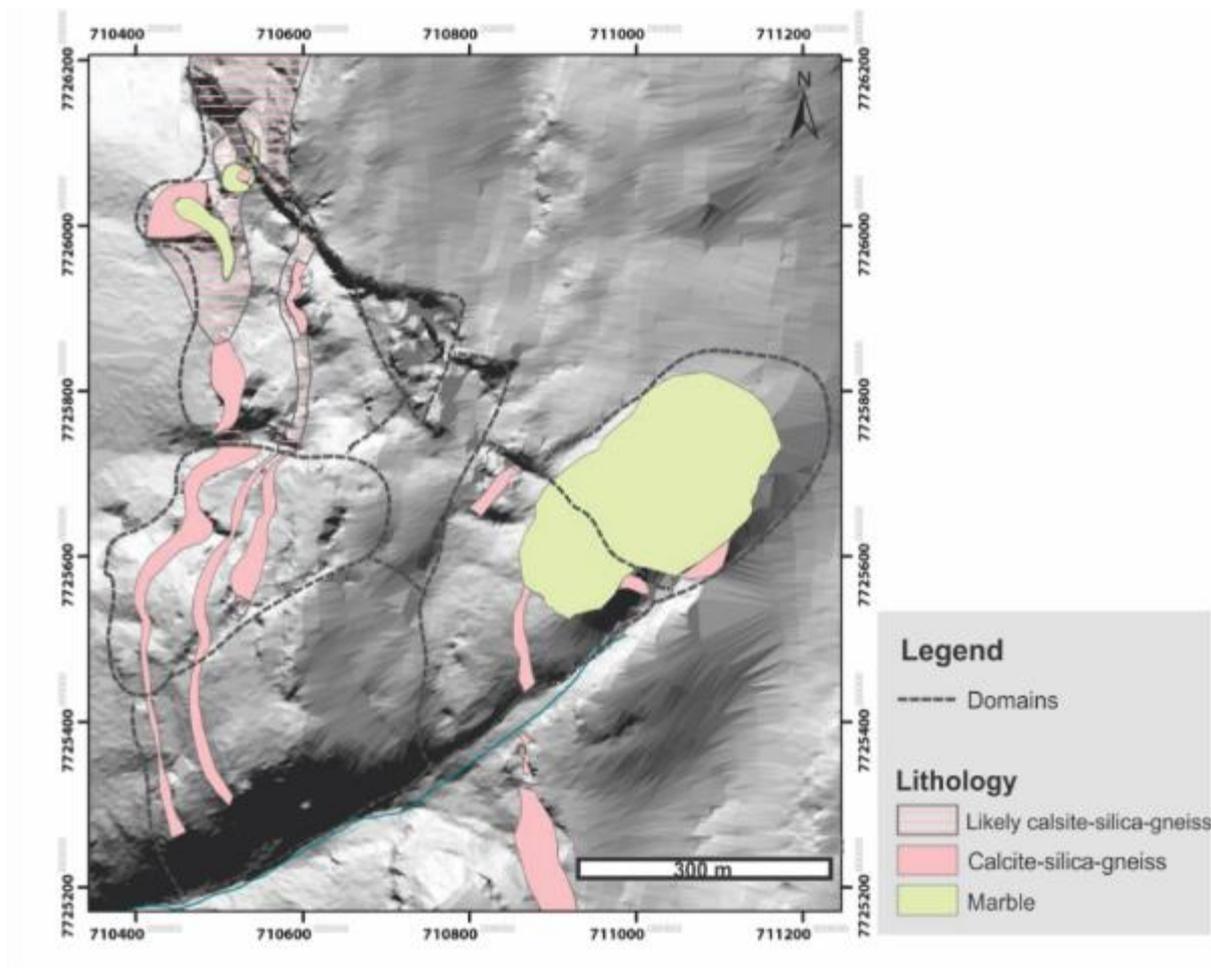
Figure 9: Bedrock map of Jettan, non-colored consists of garnet-quartz-mica-gneiss (Skrede, 2013).

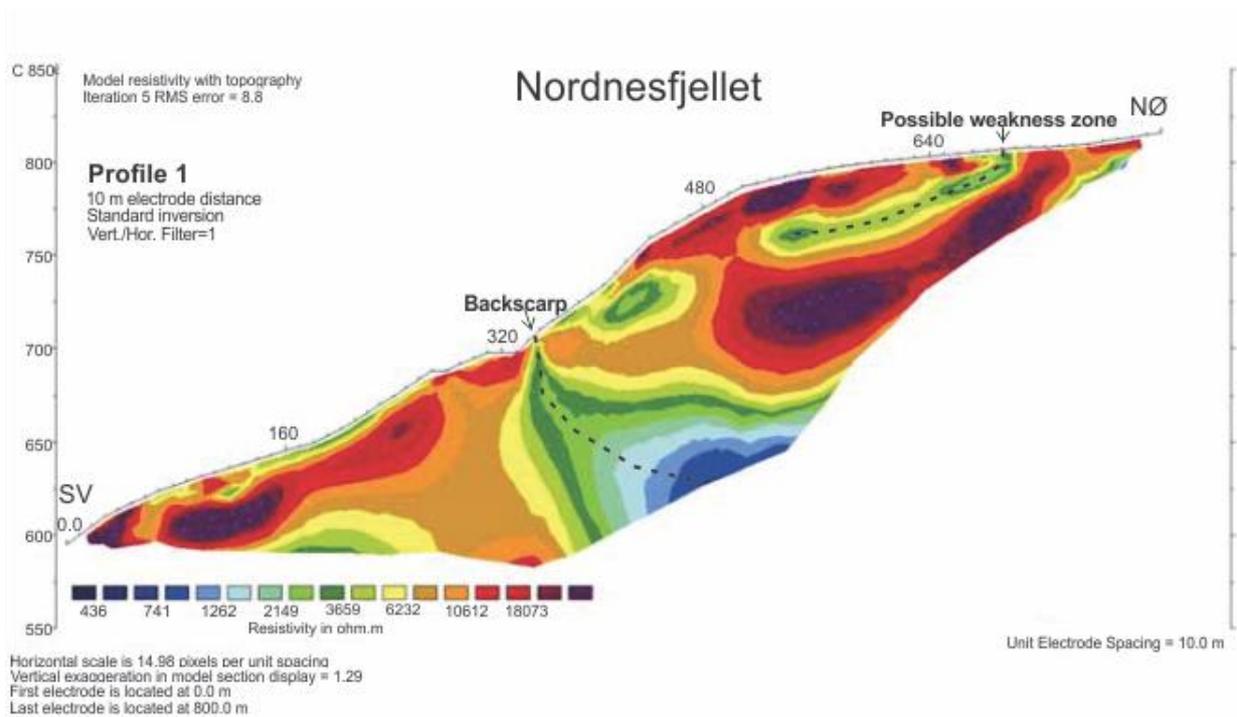
Figure 10: 2D resistivity profile showing resistivity in depth. Blue color resembles high resistivity, red to purple color low resistivity. The backscarp and a possible weakness zone is marked. Location of profile is seen in figure 13. Modified from Tønnesen and Dalsegg (2004)

Geo-radar measurements revealed a zone of cupped and shallow fractures/shear zones below blocks NE of the main weakness zone seen in resistivity profile 1 (Tønnesen & Dalsegg, 2004). This zone has a gentle dip towards west and it could be an indication of very slow movement. West and southwest of the main weakness zones in each profiles, geo-radar measurements indicates several sub-horizontal reflectors that could indicate crushed/fractured zones or layering (Tønnesen & Dalsegg, 2004). Heavily crushed rock down to 50 m, and moderately crushed rock down to 150 m below surface, measured normal to the terrain (Rønning et al., 2008).

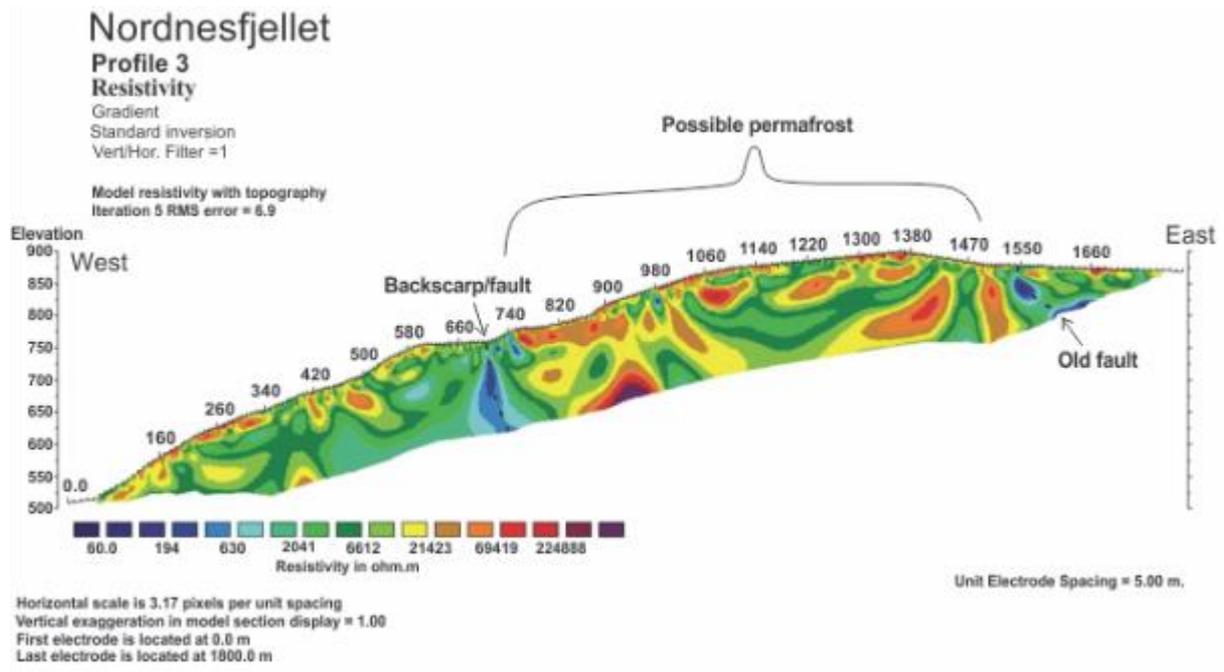
Figure 12: 2D resistivity profile showing resistivity in depth. Blue color resembles high resistivity, red to purple color resembles low resistivity. The backscarp, old fault and possible pockets of permafrost is marked. Location of profile is seen in figure 13. Modified from Rønning et al. (2008).

Tønnesen and Dalsegg (2004) could not find any reliable evidence that permafrost is to be found in the URS, while Rønning et al. (2008) possibly found pockets of permafrost to the SE of the NE-SW striking fault outside of the URS (figure 12). High resistivity values inside the URS have been interpreted as drained rock masses close to the surface (Rønning et al., 2008). Because of the steep and chaotic terrain no measurements were done in the lower part of the slope, and as a consequence no lower boundary was found in the unstable area (Rønning et al., 2008).

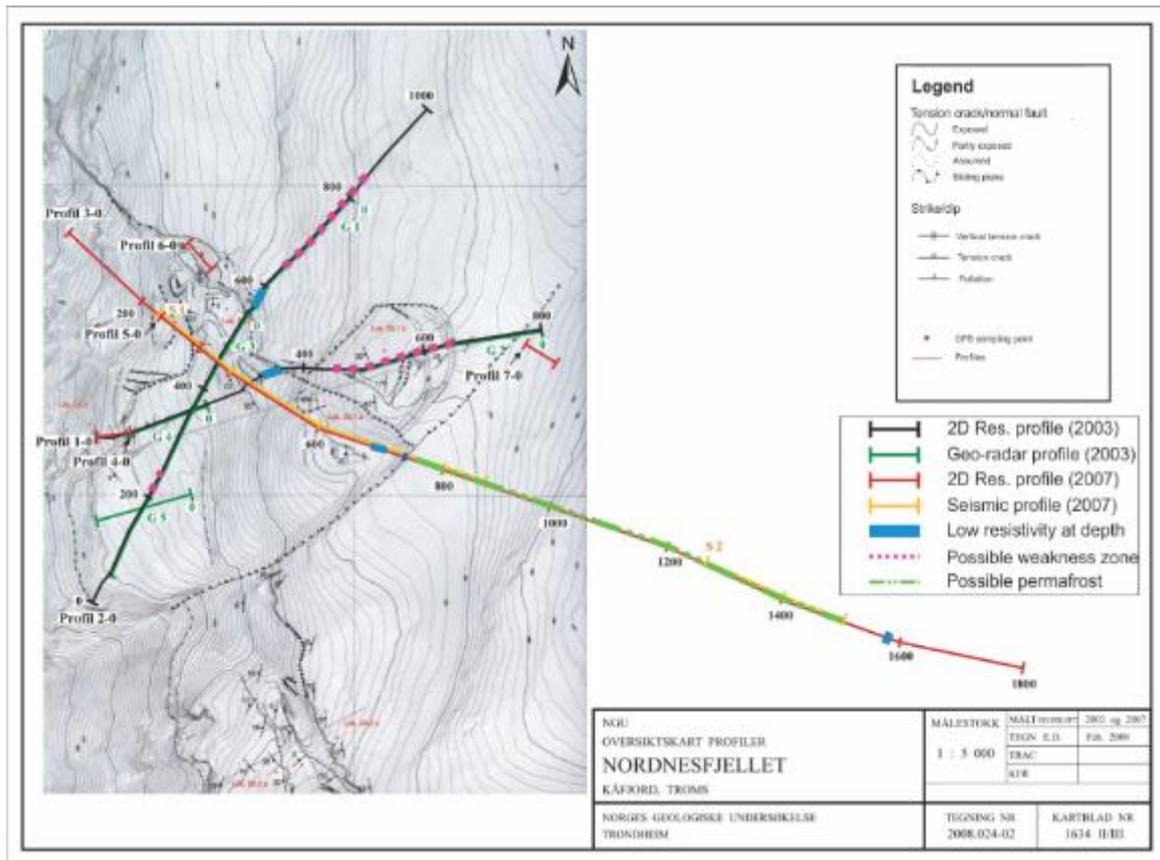
Figure 13: Geophysical investigations done at Nordnesfjellet in 2003 and 2007. Low resistivity at depth (blue boxes) is referred as weakness zone and backscarp. Modified from (Rønning et al., 2008).

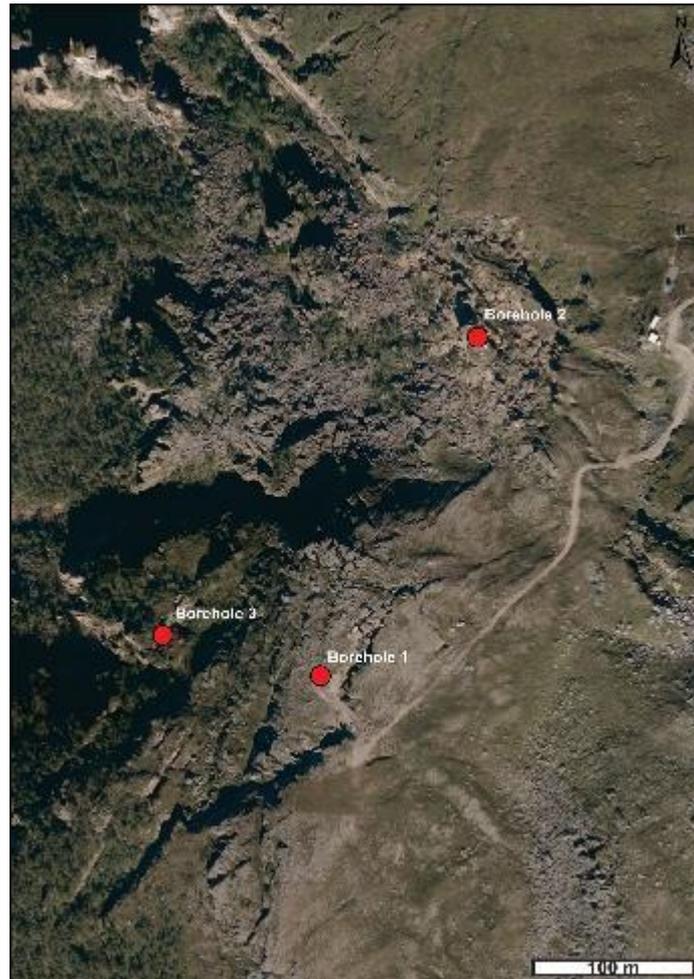
Figure 14: Location of boreholes at Jettan (Kartverket, 2016).

Three cores have been drilled at Jettan (figure 14). The aim was to get a greater understanding of how the unstable area is moving and constrained by looking at bedrock type, fracture frequency and zones where movement could or is happening. The cores were logged and an optical televiewer (OTV) was used to image the boreholes from the inside. Rock quality was later tested for cores taken from borehole 1 and borehole 3.

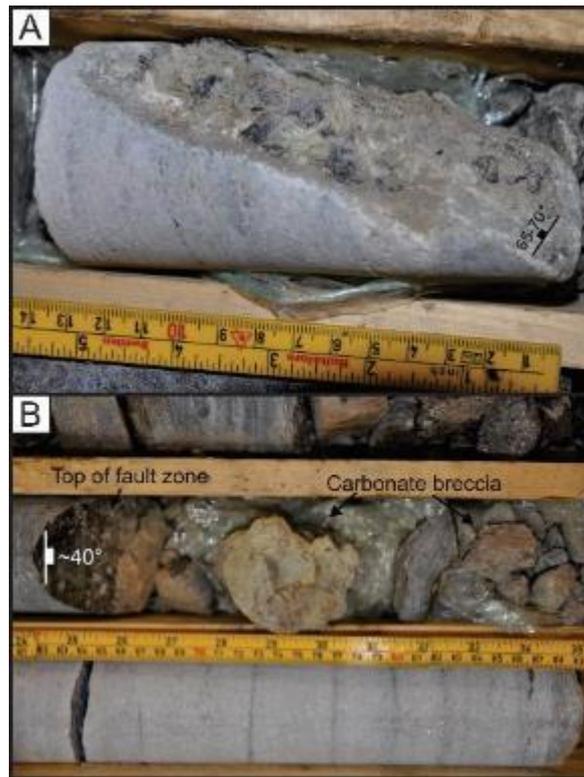
Figure 15: Old fault plain at 45.5 m bgl with a dip between 65° – 70° seen as the main zone of displacement containing a layer of breccia. B) Fracture at the top of the fault zone with a dip around 40°. The fault zone contains carbonate breccia and possibly clay. Modified from Ganerød (2013).

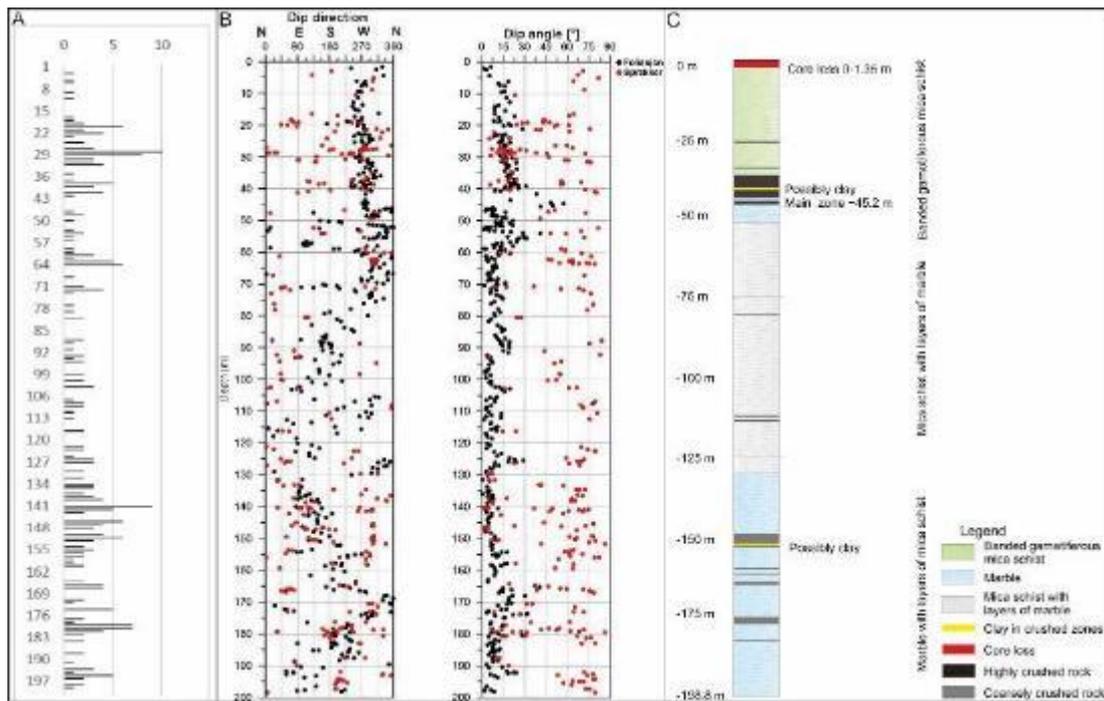
Figure 16: Borehole 1. A) Fracture frequency. B) Dip direction and dip angle for foliation (black) and fractures (red). C) Lithologies and crushed zones (Elvebakk, 2013; Ganerød, 2013; Nystad, 2014).

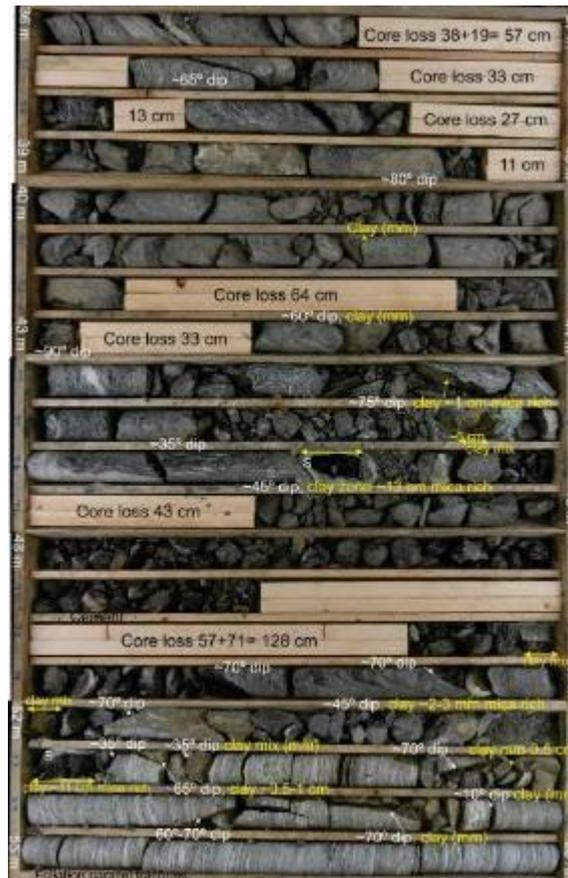
Figure 17: Main zone of crushed rock from 36-53 meter, including highly fractured and crushed rock with clay and core loss. Modified from Ganerød (2014).

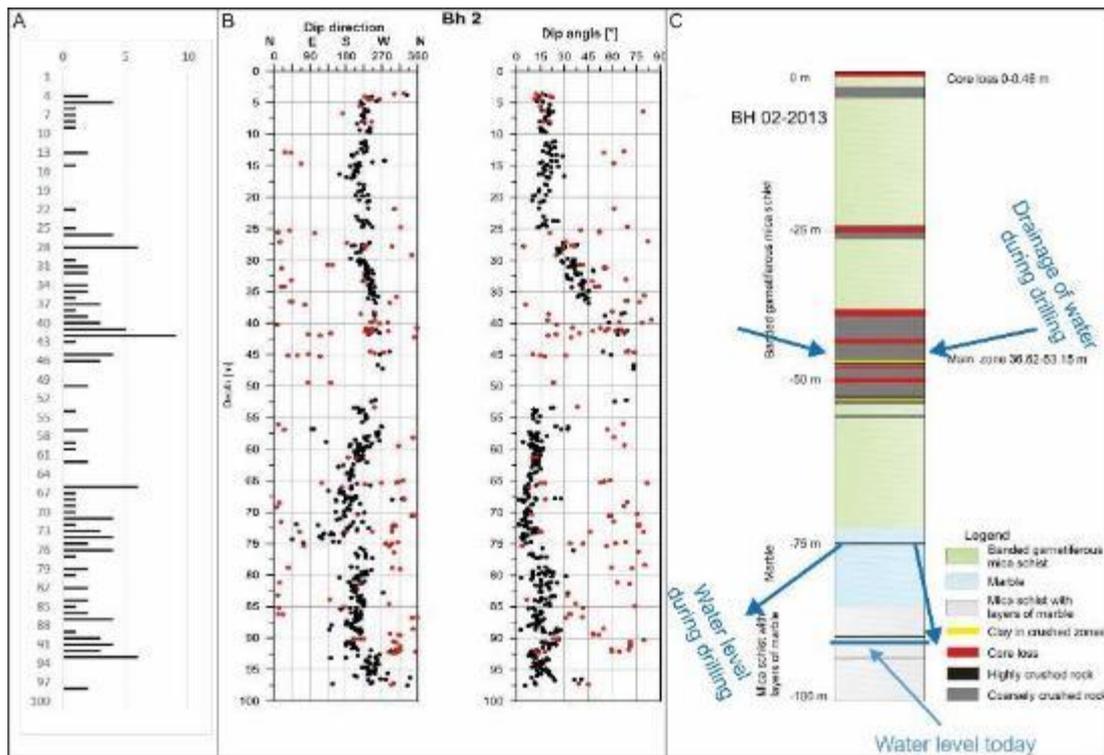
Figure 18: Borehole 2. A) Fracture frequency. B) Dip direction and dip angle for foliation (black) and fractures (red). C) Lithologies and crushed zones logged with water level during drilling (Elvebakk, 2013; Ganerød, 2013; Nystad, 2014).

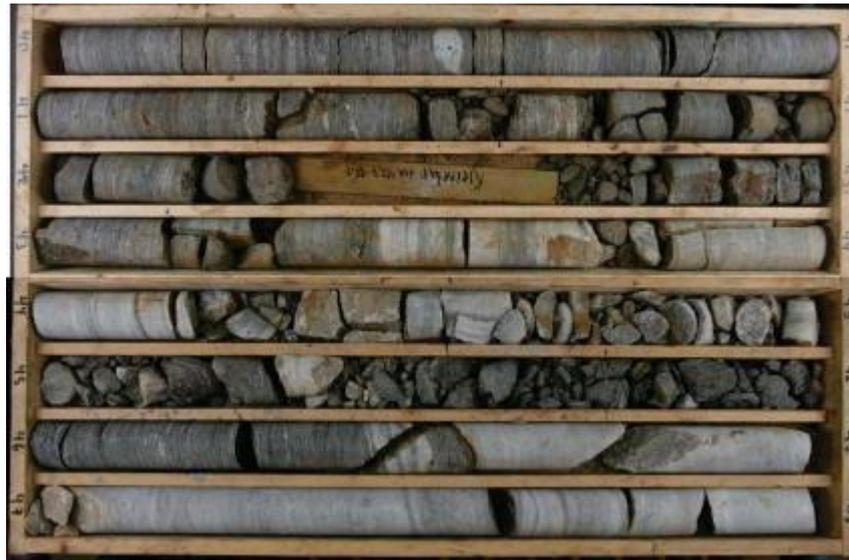
Figure 19: Main zone of crushed rock in borehole 3 at 42.3 to 46 m. Core loss is seen in the start of the zone and the rest is dominated by crushed rock. Modified by Ganerød (2014).

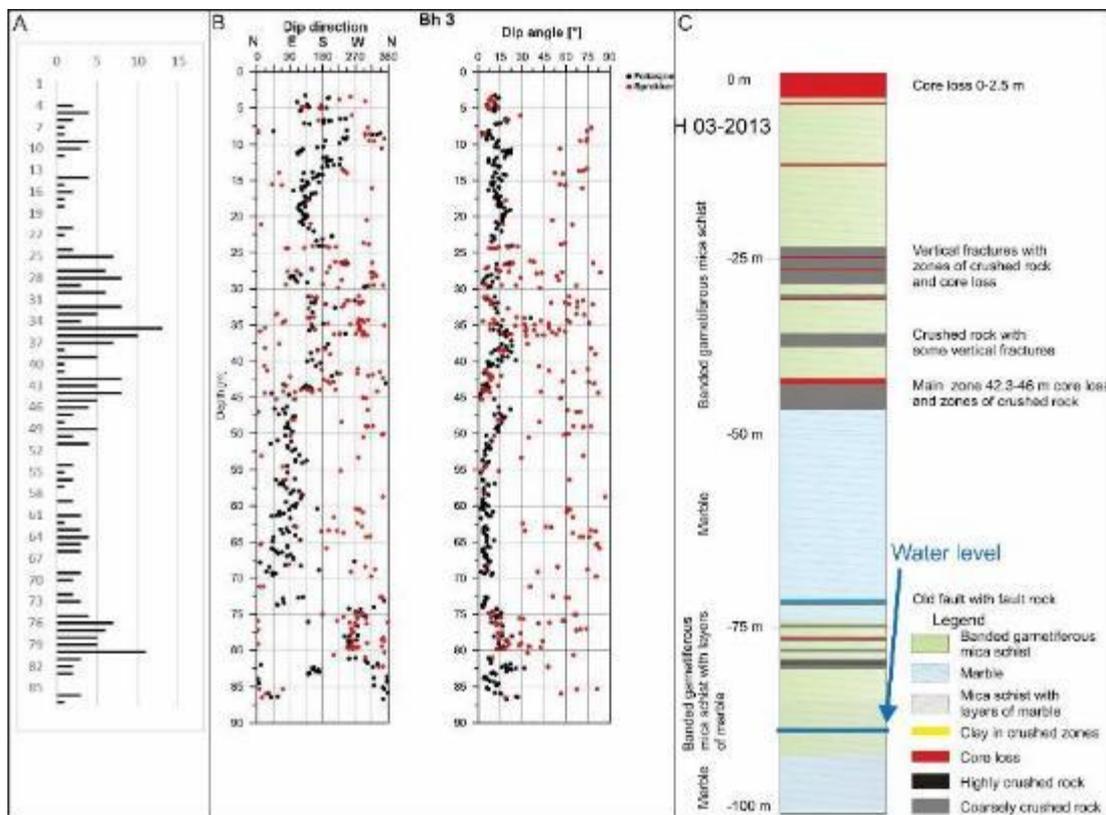
Figure 20: Lithologies and crushed zones from borehole 3. Right: Table showing the depth of bedrock type and description of the different parts. Modified from Ganerød (2014).

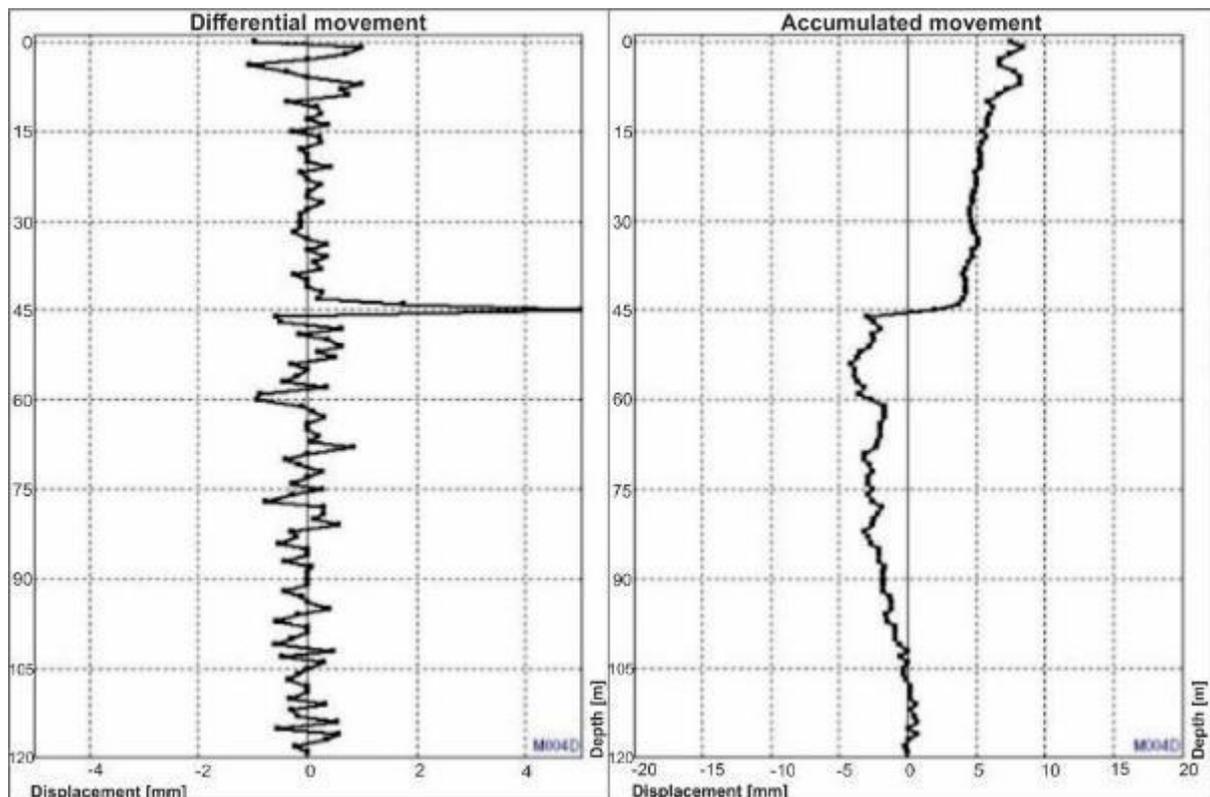
Figure 21: Left: Differential movement in the DMS-column towards 260°. Right: Accumulated movement in the DMS-column towards 260°. Modified from Nystad (2014)

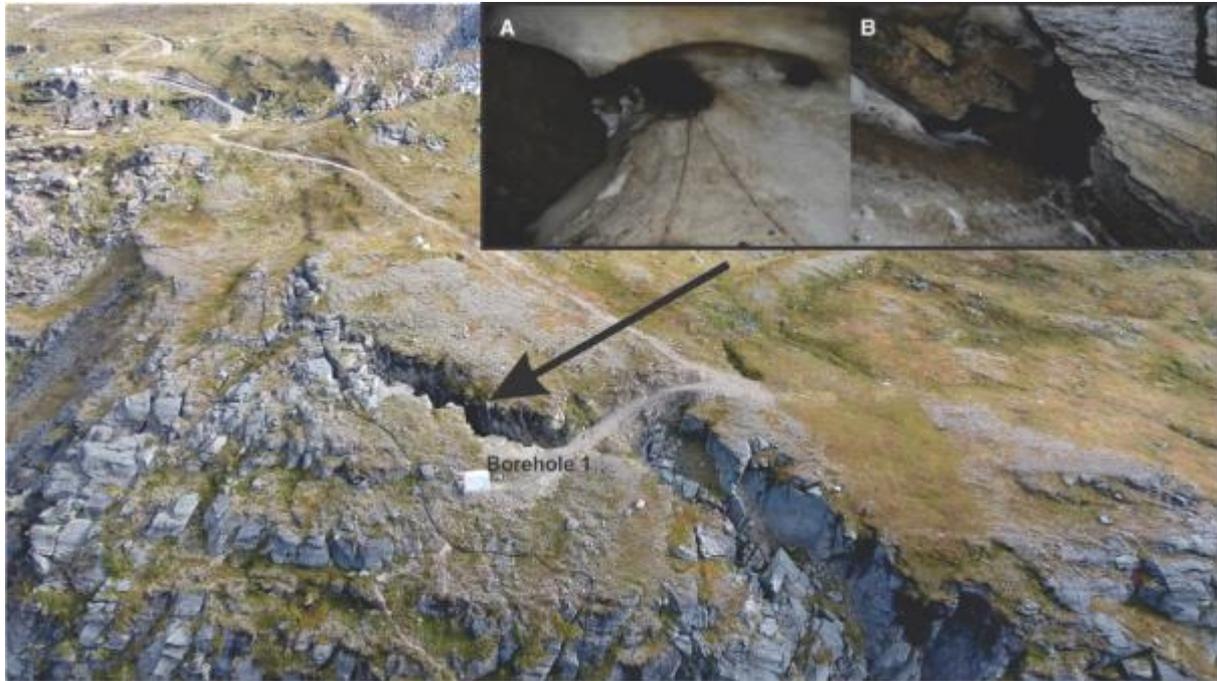
*Figure 22: Large surface fracture containing ice. A: Ice at 20-25 m depth with meltwater channels. B: Ice continuing down into a channel (Blikra & Christiansen, 2014).*

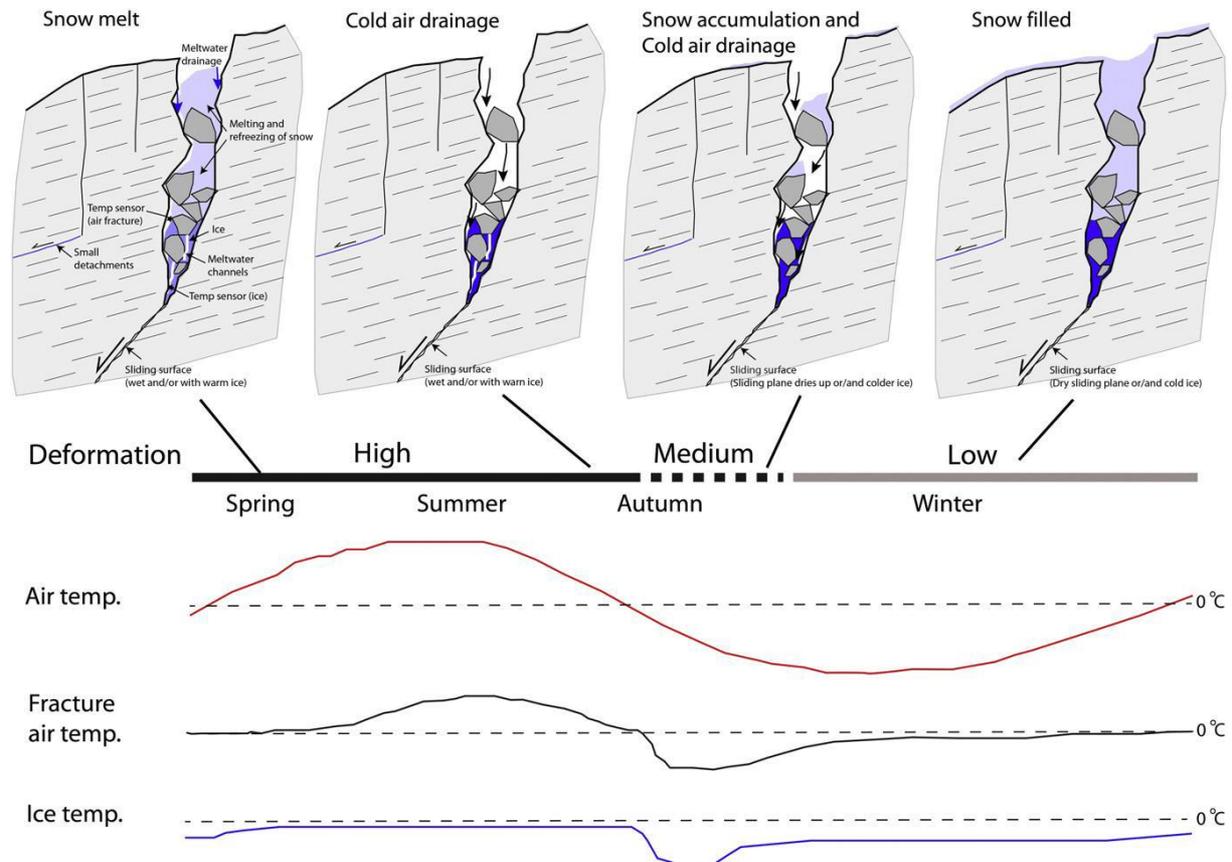
Figure 23: Permafrost controlled rockslide model. Annual deformation displayed with air-, fracture- and ice-temperature in the lower part of the backscarp (Blikra & Christiansen, 2014).

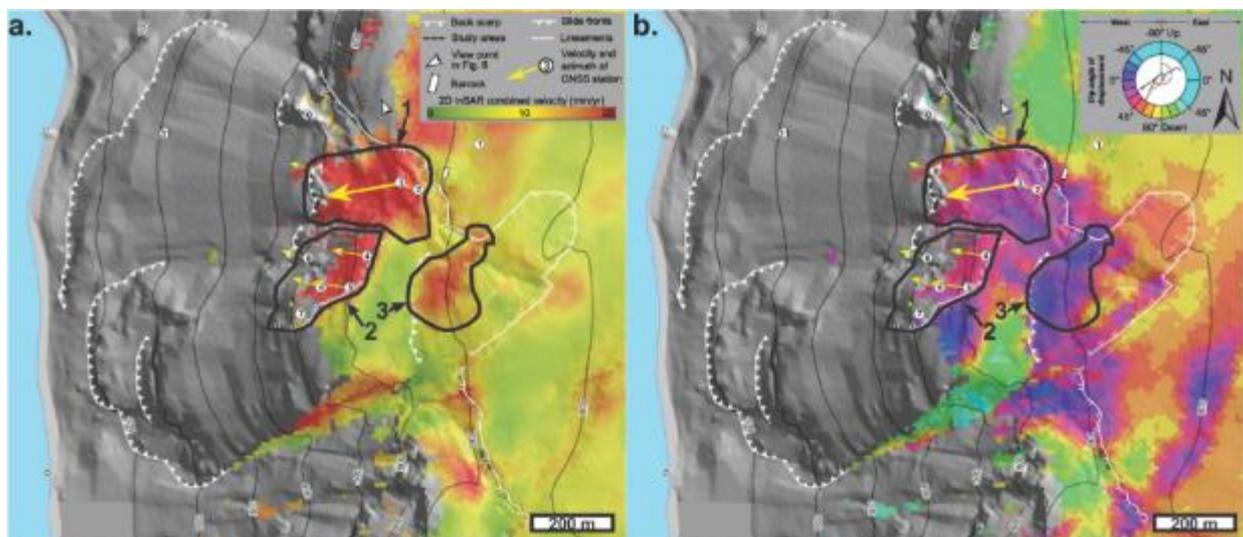
Figure 27: Mean yearly velocity from 2D InSAR data and GNSS from the Jettan rockslide. The northern (1), southern (2) and upper (3) areas with the most movement are indicated. a) Combined velocity from 2D InSAR data. b) 2D InSAR dip of displacement. Modified from Eriksen et al. (2017b).

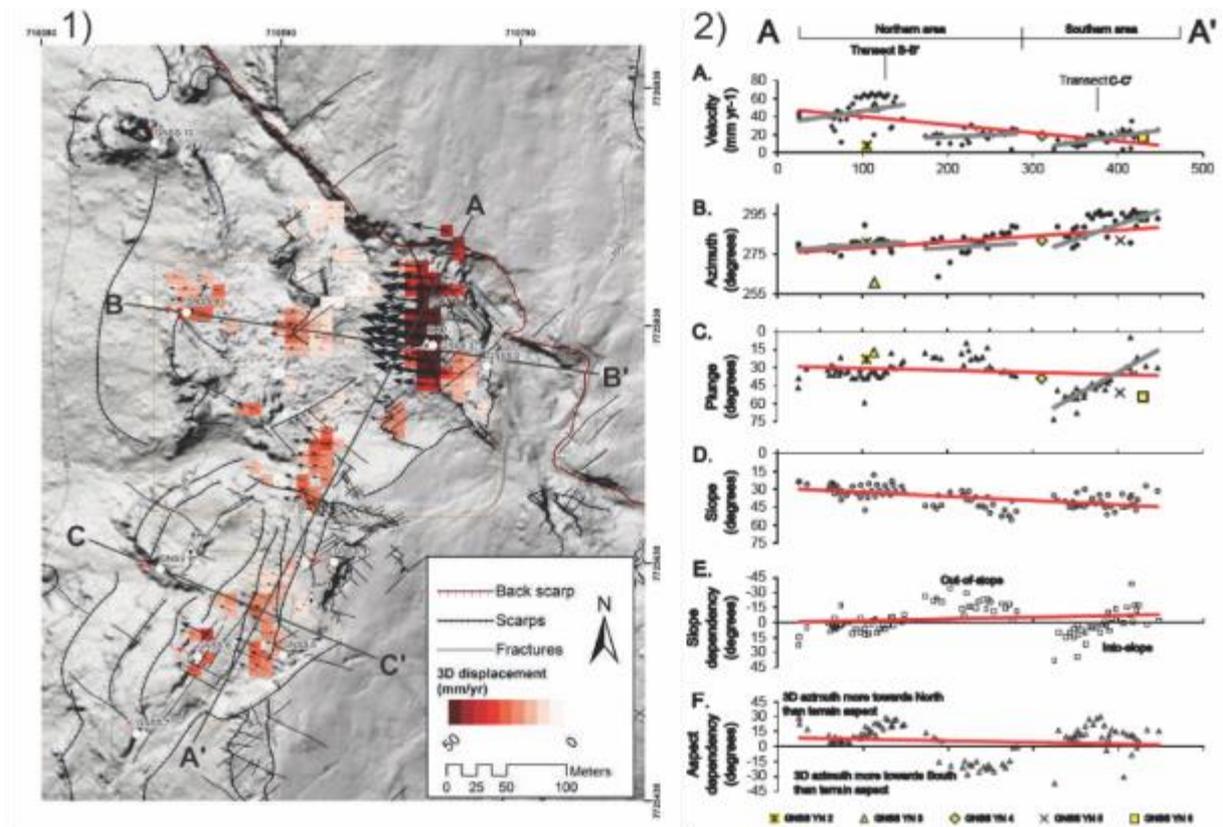
Figure 28: Displacement vectors and properties of 3D vectors along cross-section A-A'. 1) 3D displacement vectors (black arrows) and GNSS displacement (red arrows), with geological structures and geomorphological elements. 2) Properties of 3D vectors along cross-section A-A' and nearby GNSS stations, including (A) mean yearly velocity, (B) azimuth of displacement, (C) plunge of displacement, (D) slope of topography, (E) plunge of displacement compared to slope giving displacement into- or out-of-slope (slope dependency), and (F) displacement direction towards north or south compared to aspect. Gray lines indicate linear internal trends. Modified from Eriksen et al. (2017a).

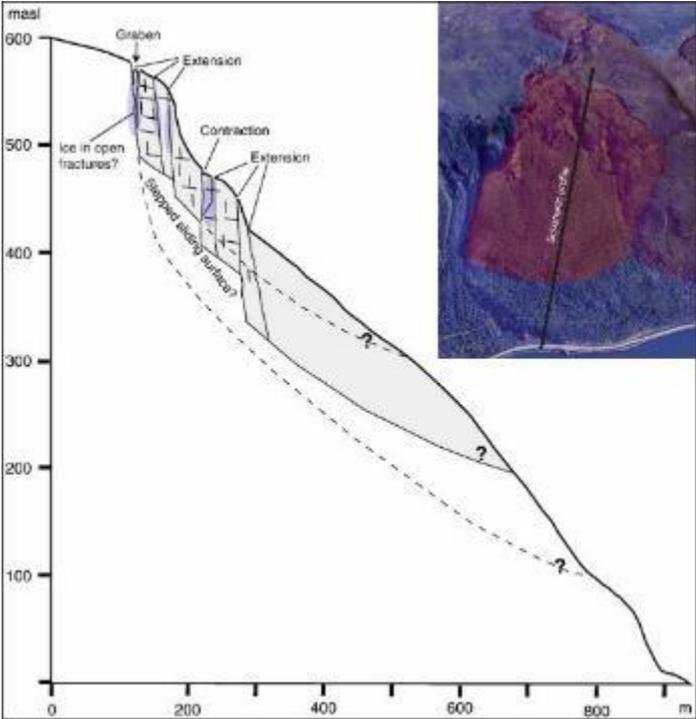
Figure 29: Cross-section indicating possible extension and contraction zones in the slope, locations where there could be ice in fractures and possible sliding surfaces. Modified from Nordvik et al. (2010).

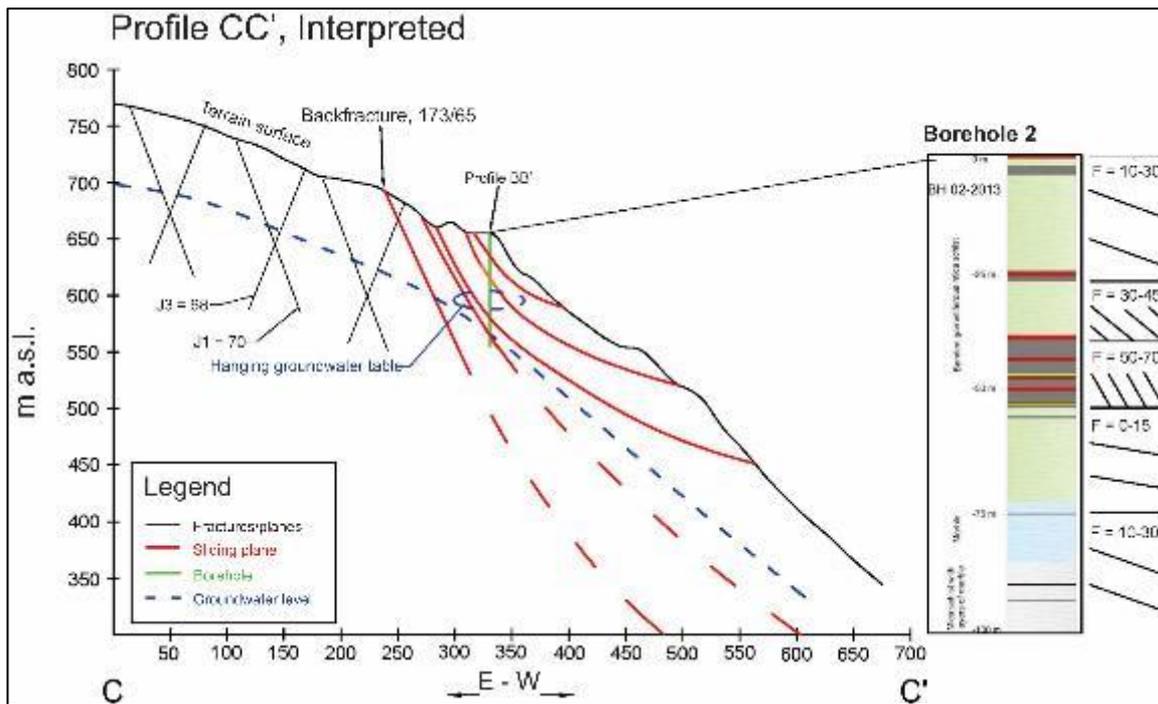
Figure 31: Profile CC. Modified from Nystad (2014).
