## **Engineering geology of the Jettan rockslide, Kåfjorden**

GEO-3900 Master's thesis in Geology, May 2020

The unstable rock slope (URS) Jettan is located at Nordnesfjellet in Kåfjorden municipality in Troms and Finnmark County, 800 m above the fjord. The rockslide has an estimated volume of  $6 \text{ Mm}^3$ , and moving at a rate of up to  $50 \text{ mm a}^{-1}$ . Jettan is considered a “high risk object” within the Norwegian unstable mountain framework. This is due to the potential displacement wave impact to housings, infrastructure and industry. As such there has been a scientific interest in the site since 1999 generating several studies, reports, investigations and theses. Continuous monitoring began in 2007.

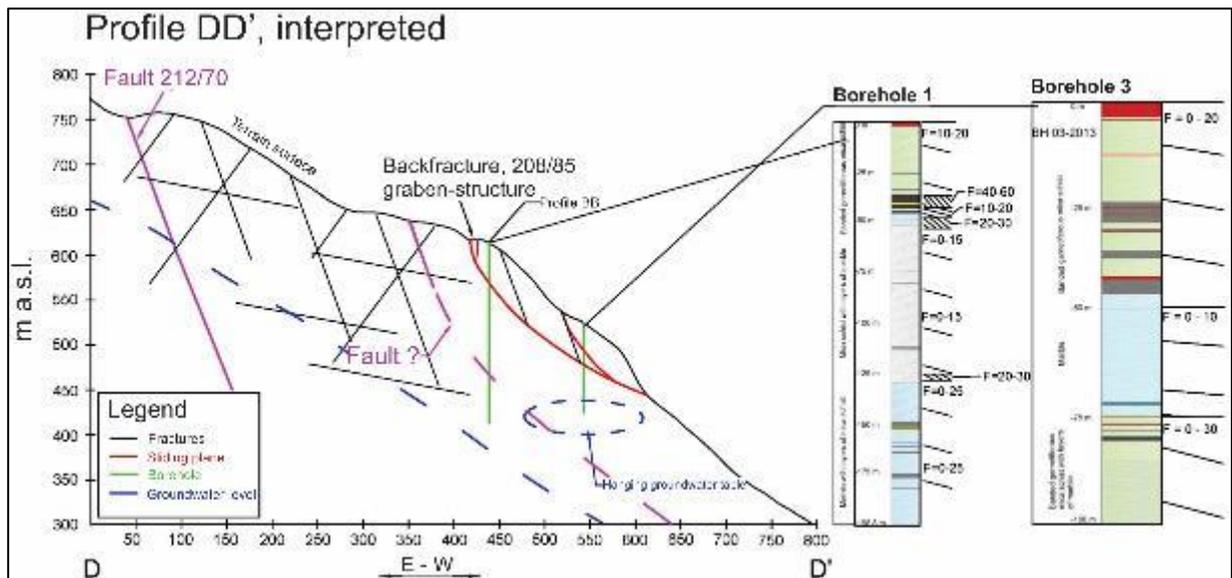
Figure 32: Profile DD'. Modified from Nystad (2014).

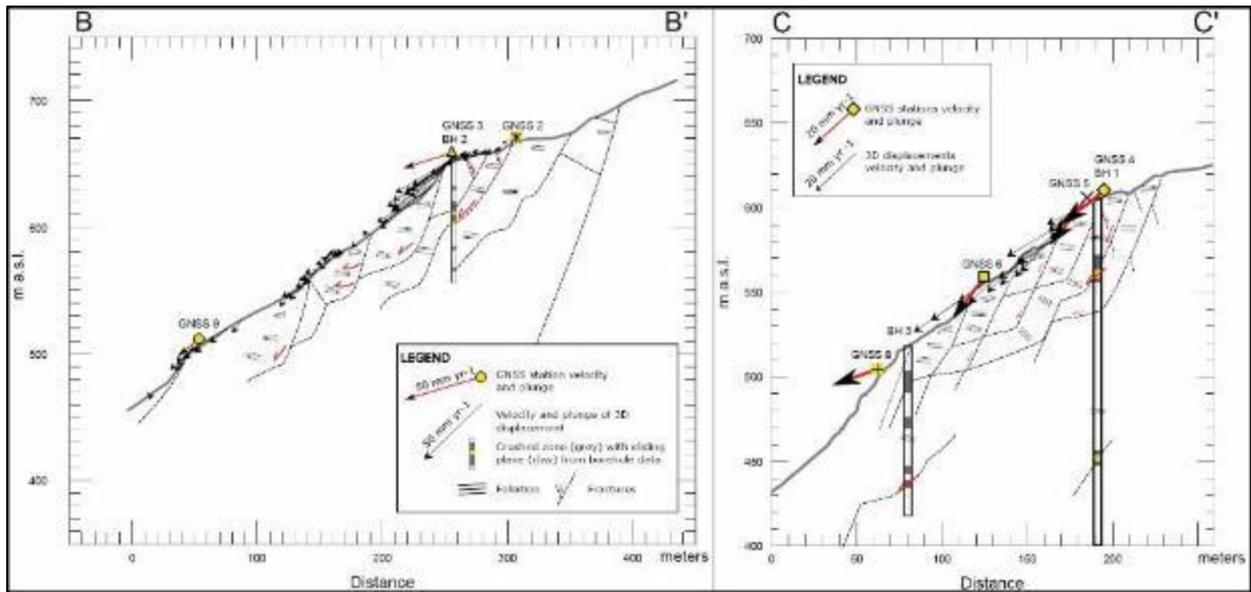
Figure 33: Profile BB' and CC' from Eriksen et al. (2017a) showing suggestions of different sliding planes, foliation and movement. Modified from Eriksen et al. (2017a).

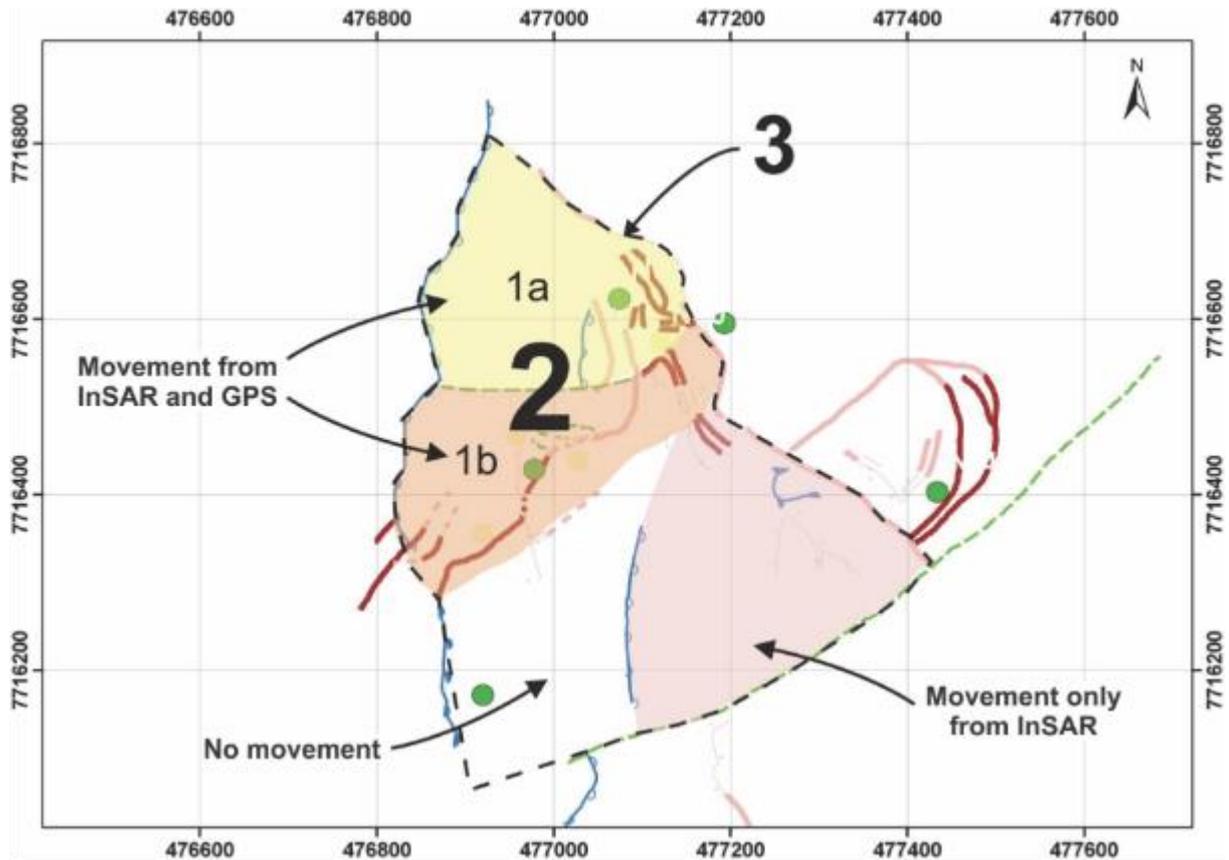
Figure 34: Failure scenario 1a, 1b and 2 location at Jettan. Modified from Henderson and Blikra (2007).

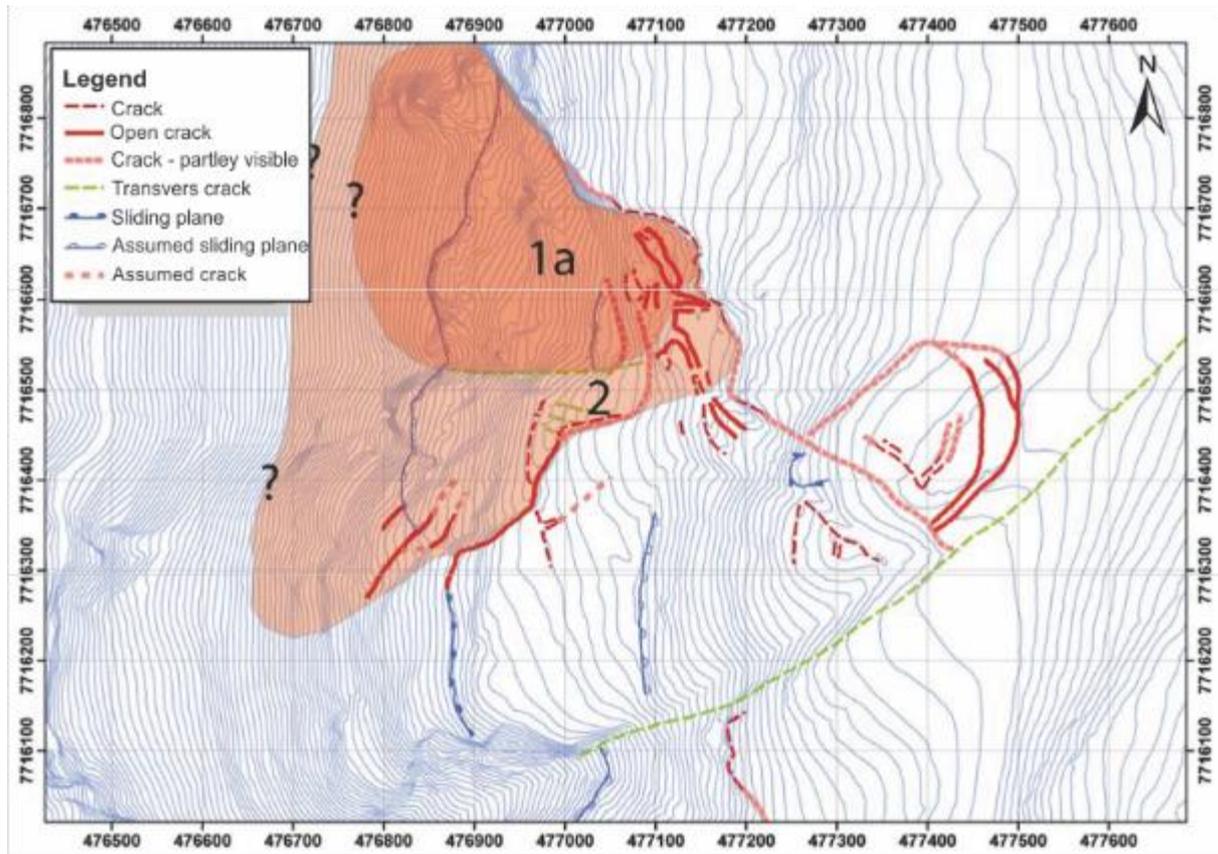
Figure 35: Map showing the two failure scenarios at Jettan. Scenario 2 includes scenario 1a. Modified from Blikra et al. (2009).

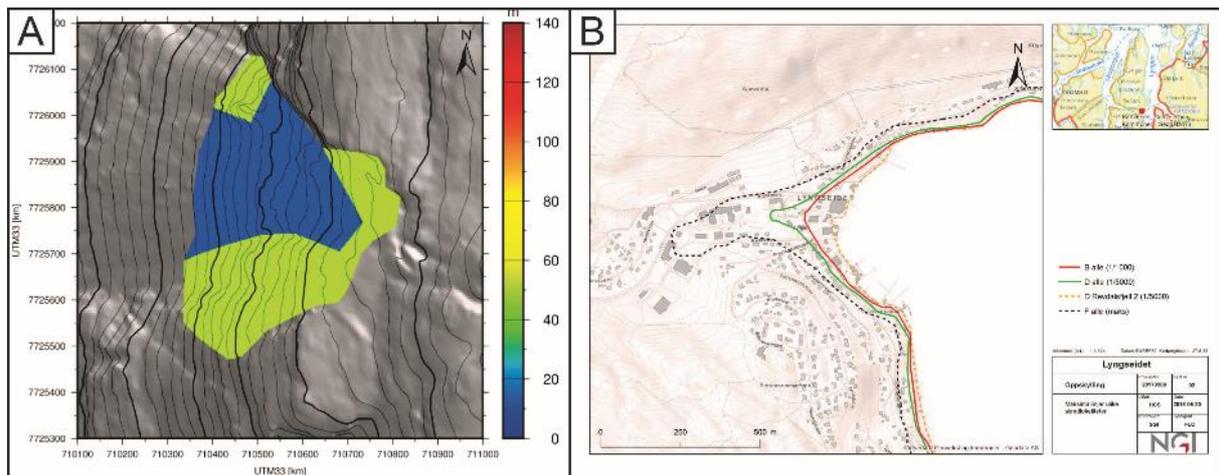
Figure 36: A) Thickness down to sliding surface at Jettan and the extent of the different scenarios used. B) Different run-up scenarios for Lyngseidet. Modified from (Glimsdal et al., 2018).

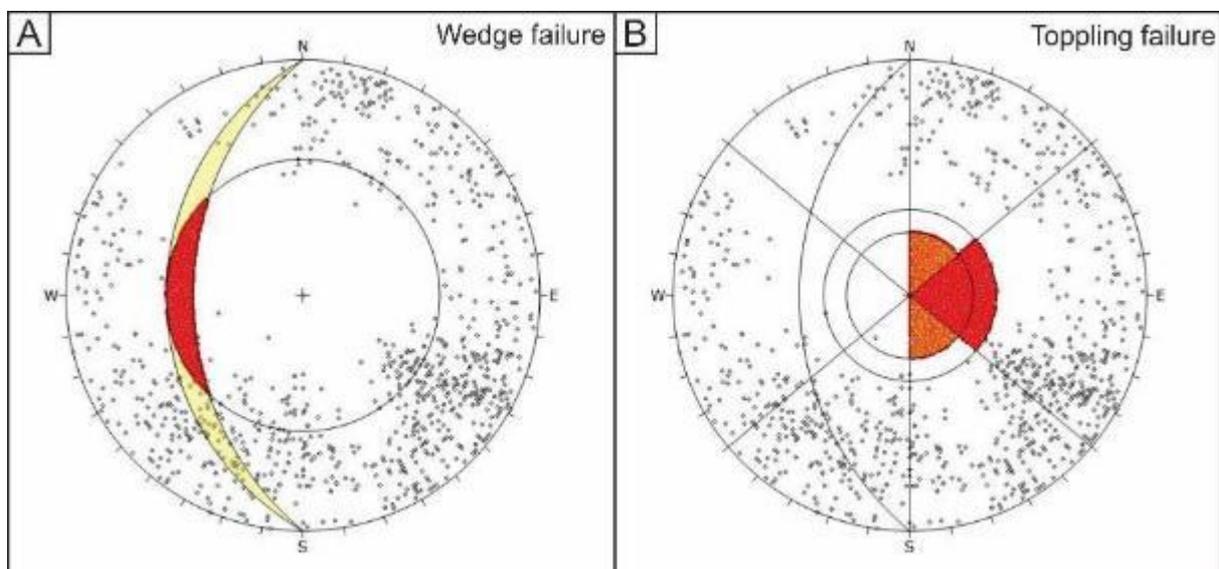
Figure 37: Kinematic analysis. A) Wedge failure is feasible as great amounts of intersections are found in the critical area (red colored area). B) Toppling failure is feasible as the foliation plots in the critical area (red colored area). Modified from Nystad (2014).

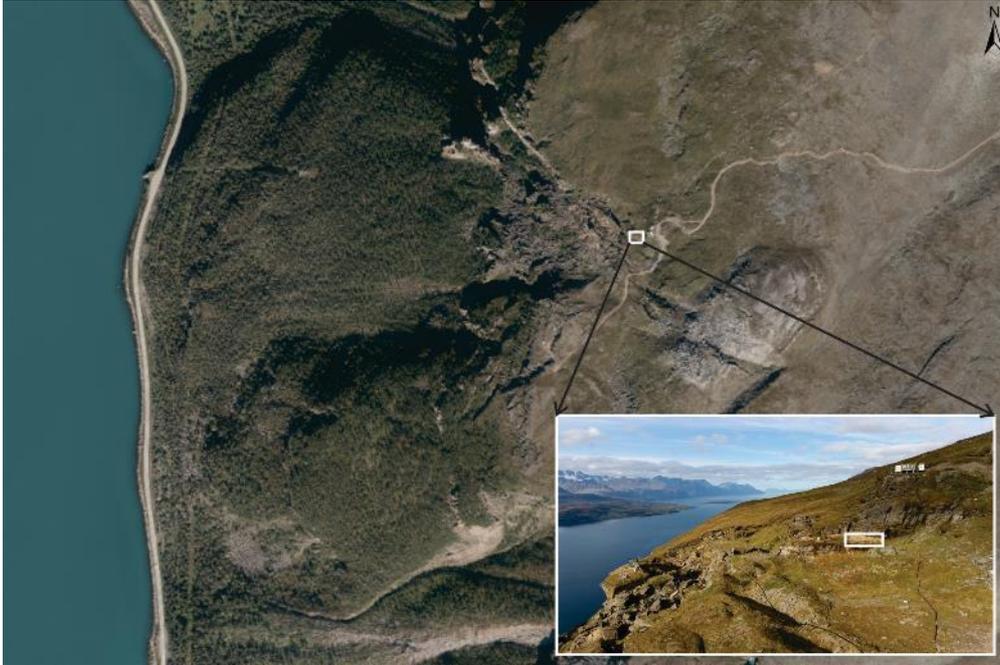
*Figure 39: Location of where the soil sample was collected.*

Ring shear testing was done on a soil sample taken from weakness zone beneath the field station (figure 39). It was tested by Geolabs Ltd, United Kingdom. Ring shear samples were reconsolidated, manually pre-sheared through one rotation and stabilized. An effective stress of 250, 500 and 750 kPa were applied during shearing.

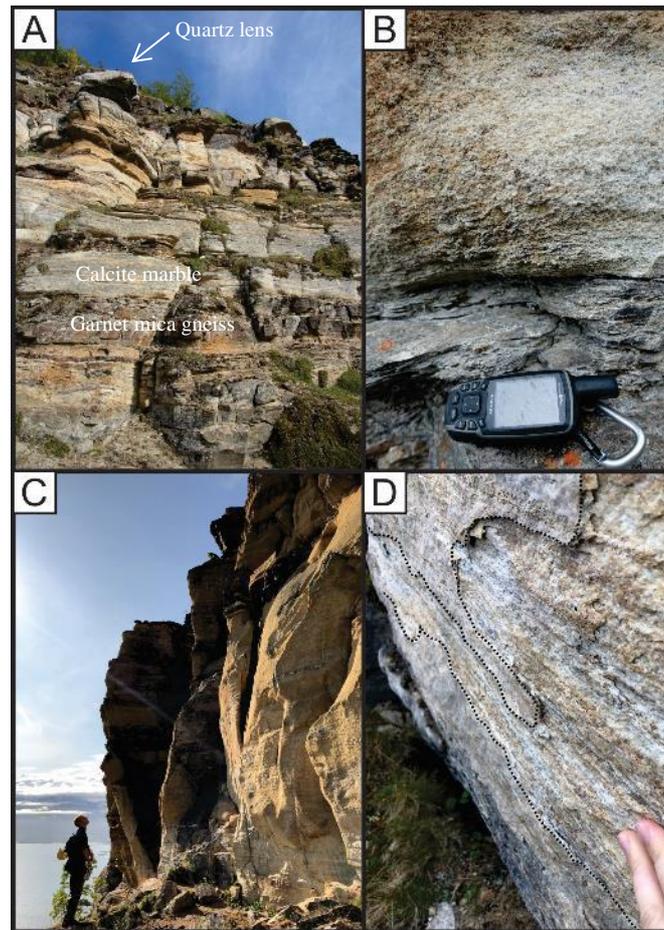
Figure 42: Calcite marble. A) Interaction between the calcite marble and the garnet mica gneiss, on top a quartz lens. B) Photo of calcite marble showing its equigranular texture. C) Large subscarp of calcite marble in the lower part of the URS. D) Outer cover on the calcite marble.

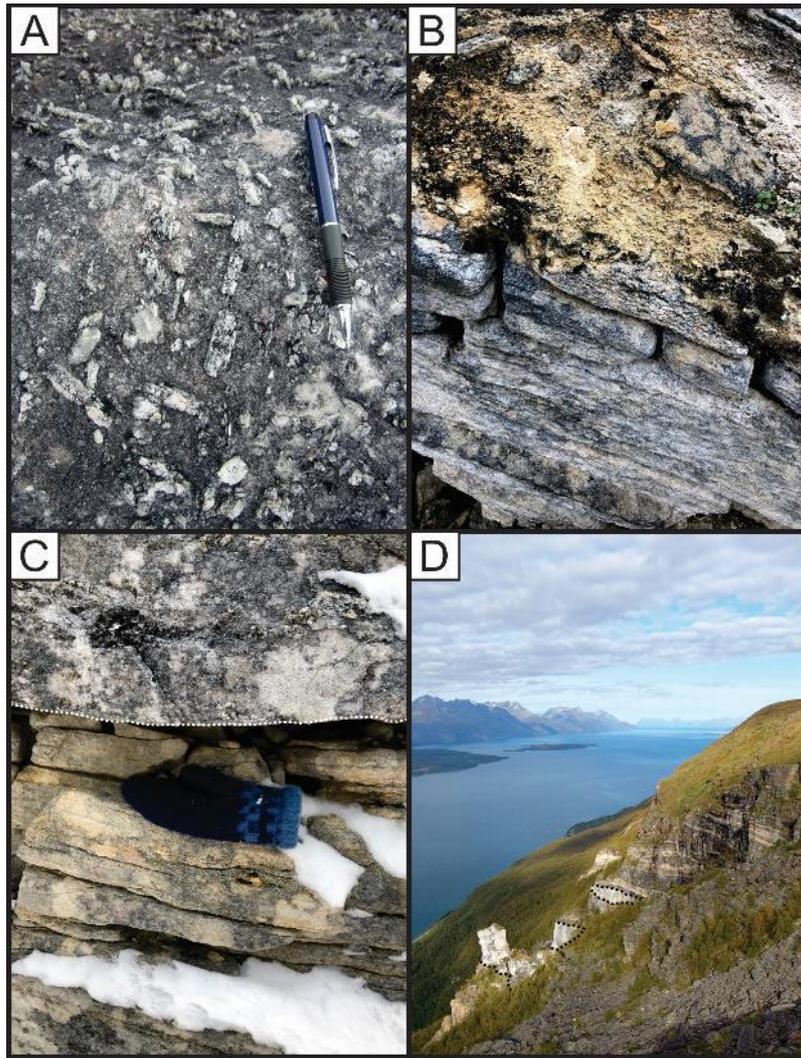
Figure 43: A) Tremolite crystals in the dolomite marble. B) Weathering resulting in disintegration of a dolomite marble with some traces of foliation. C) Distinct boundary between dolomite marble on top and calcite marble in the bottom. D) Dolomite marble seen in the lower parts of Jettankallen, displaced block and as a lens in the backscarp.

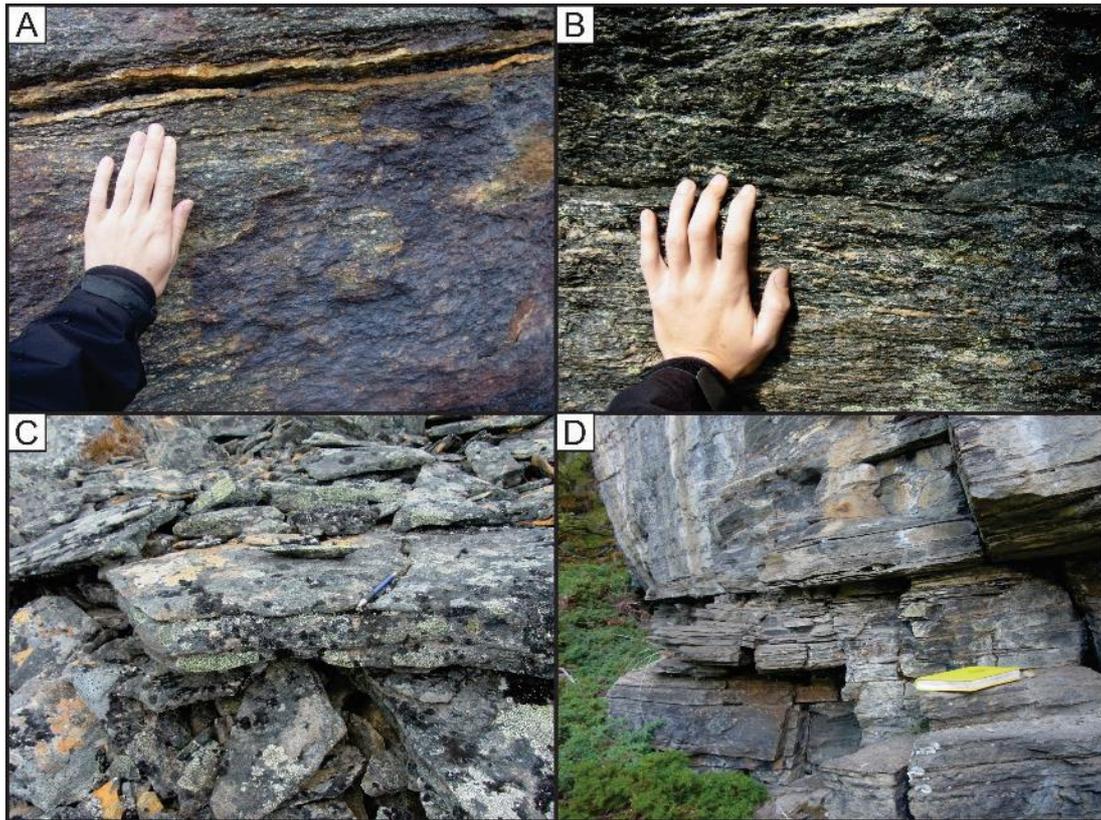
Figure 44: A) Iron coating on the garnet quartz mica gneiss, most likely as a consequence of high garnet content. B) Garnet quartz mica gneiss. C) Smaller blocks of garnet mica gneiss split by the foliation. D) Zone with higher mica content showing fractures along mica planes (foliation).

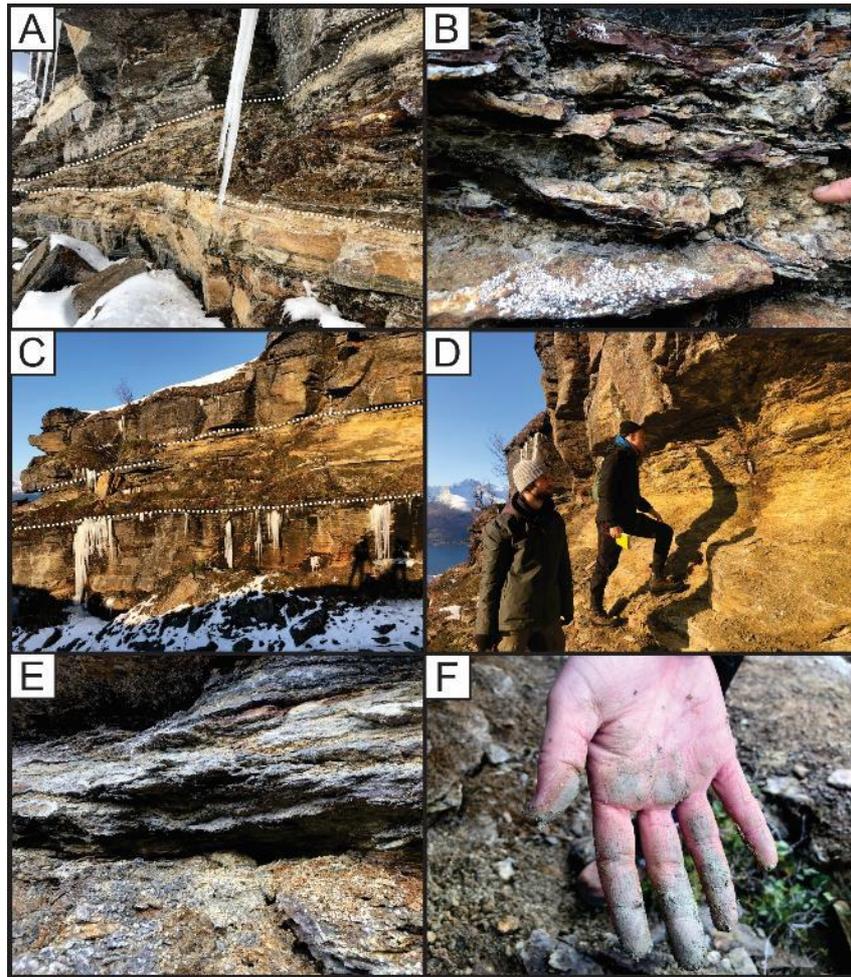
Figure 45: Filed photographs of weakness zones at Jettan. A) Sheared zone within an outcrop of calcite marble overlying garnet mica gneiss. B) Sigma clasts acting as shear sense indicators. C) Weathered foliation-parallel zone within the garnet mica gneiss. Seepage is seen as icicles at the lower part of the layer. D) Close-up of layer from C), showing location of soil sample collection from reconsolidated/ring shear testing. E) Fine sandy silt and clay layer within the garnet mica gneiss (F).

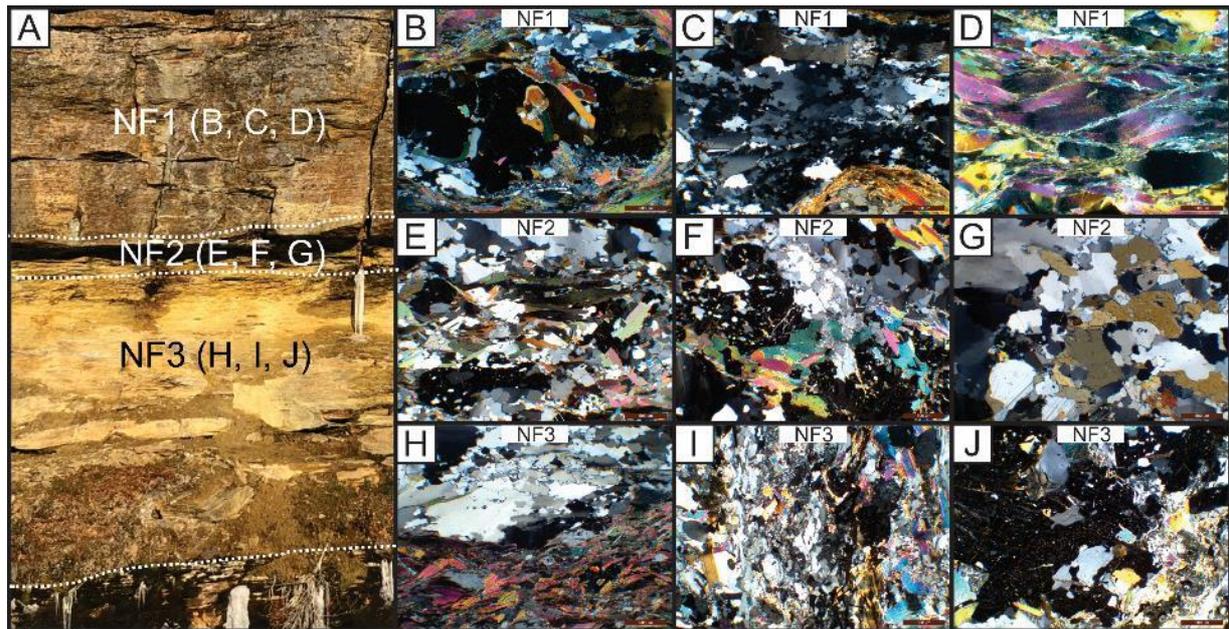
Figure 46: Thin section photos from the Jettan weakness zone in the garnet mica gneiss. A) Relatively position where the different samples are taken from. B) Matrix in the form of biotite and quartz being deflected around the garnet. C) Foliation formed by bands of quartz and biotite. D) C'-type shear bands. E) Garnet showing signs of SPO (large black grain at the bottom). F) Muscovite and garnet displaying signs of weathering. G) Amphibole (brown) in the quartz. H) Sharper and wavier grain boundaries in quartz and biotite. I) Dirty-messy quartz rich zones. J) Garnet seemingly affected by the increased weathering of the rock, "eaten up" appearance. All photos were taken under crossed polarizers.

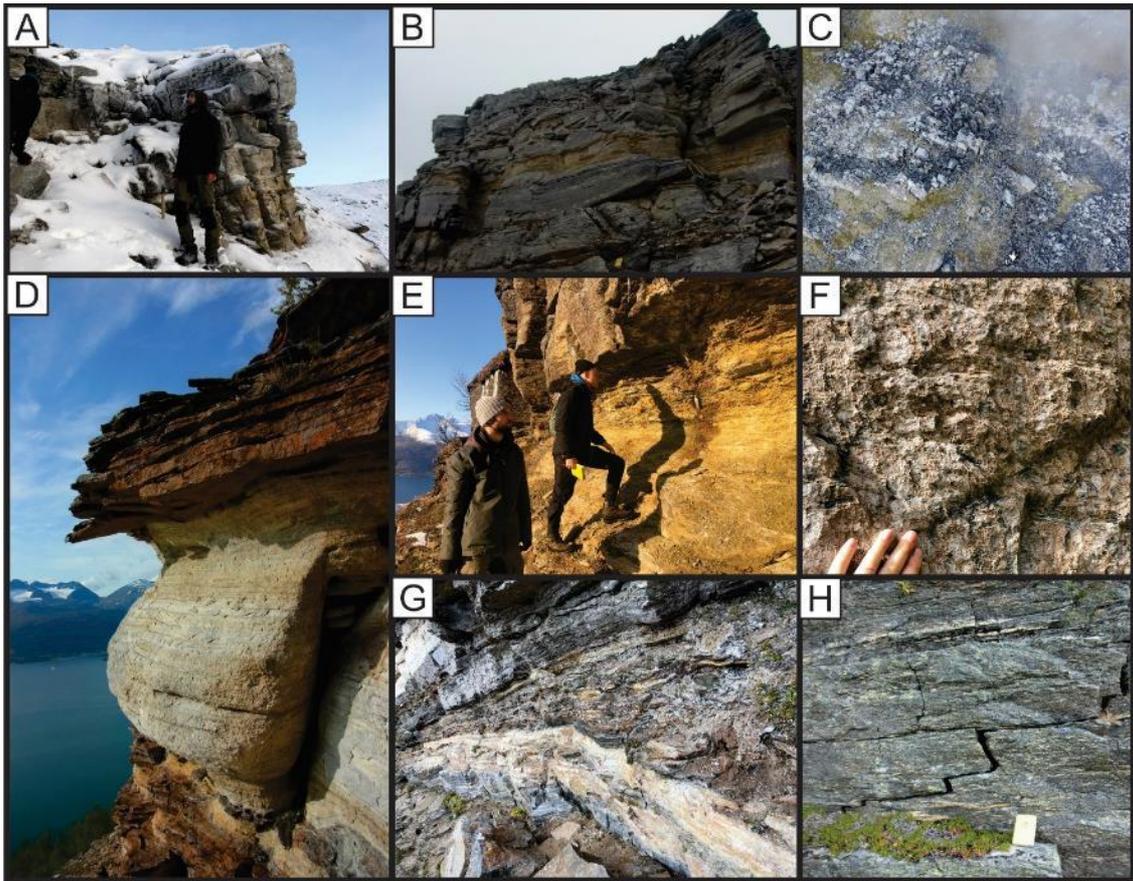
Figure 47: Rock mass units. A) Massive dolomite marble on top of interbedded calcite marble. B) Bedded dolomite marble. C) Blocky and transported dolomite marble seen from drone photography. D) Calcite marble. E) Decomposed shear zone of garnet quartz mica gneiss. F) Calcite coating on the garnet quartz mica gneiss. G) Shear zone with fragmented and deformed garnet quartz mica gneiss. H) Garnet quartz mica gneiss with stepped defect

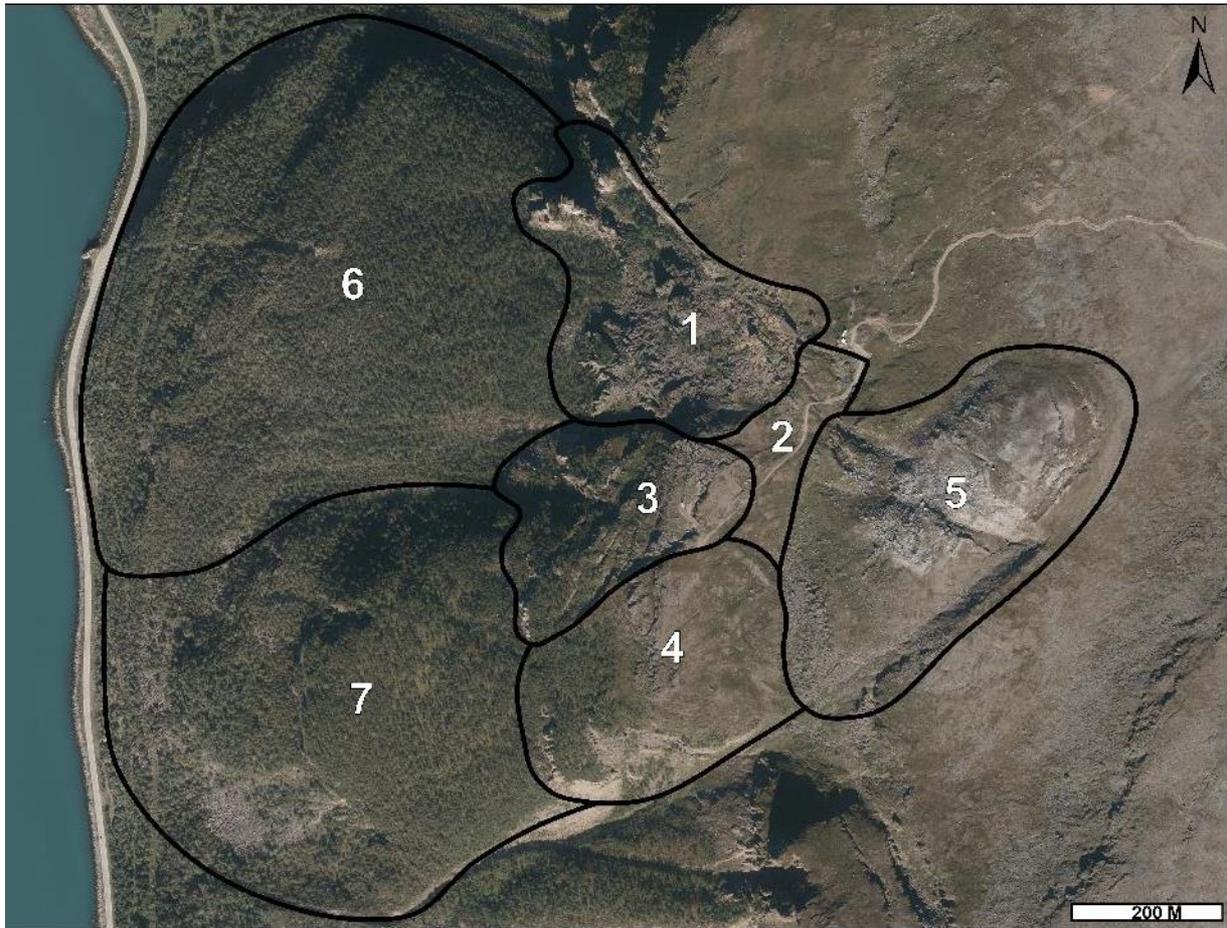
*Figure 49: Domains at Jettan.*

Based on previous work (Eriksen et al., 2017b; Skrede, 2013) Jettan has been divided into seven different domains (1-7), mainly established from movement and geomorphology (figure 49). In the following a description of the geomorphology of each domain accordingly.

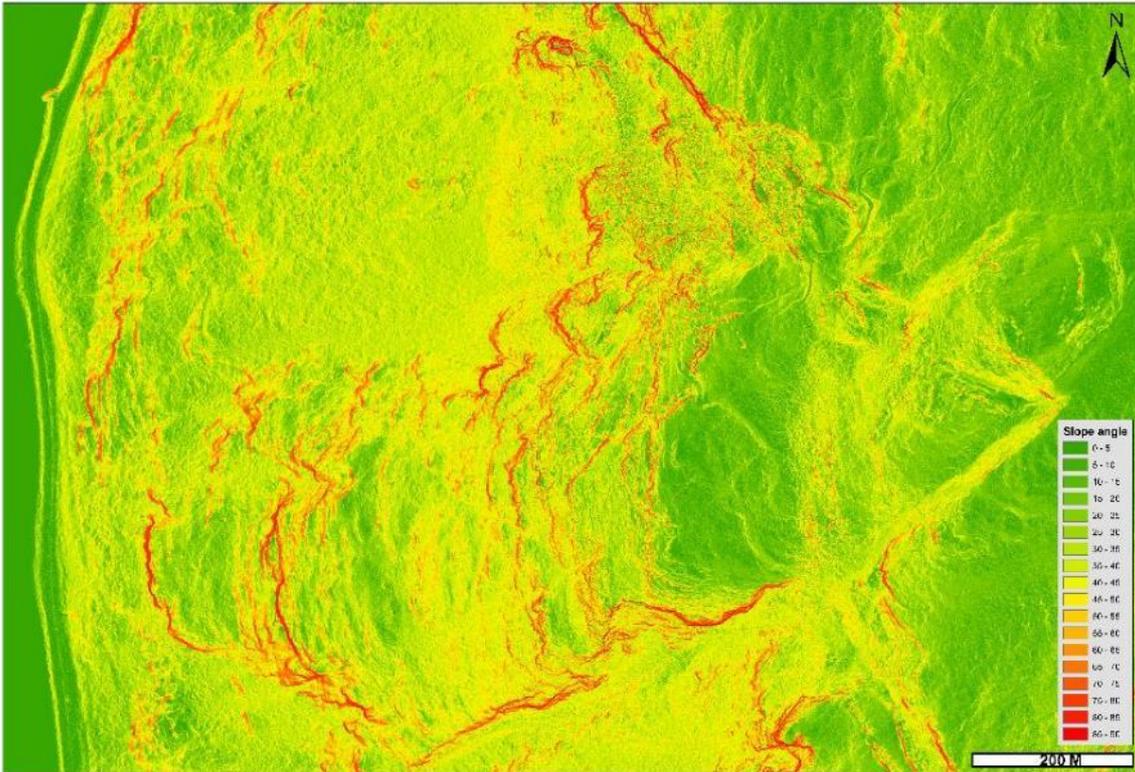
Figure 50: Slope dip map of Jettan.

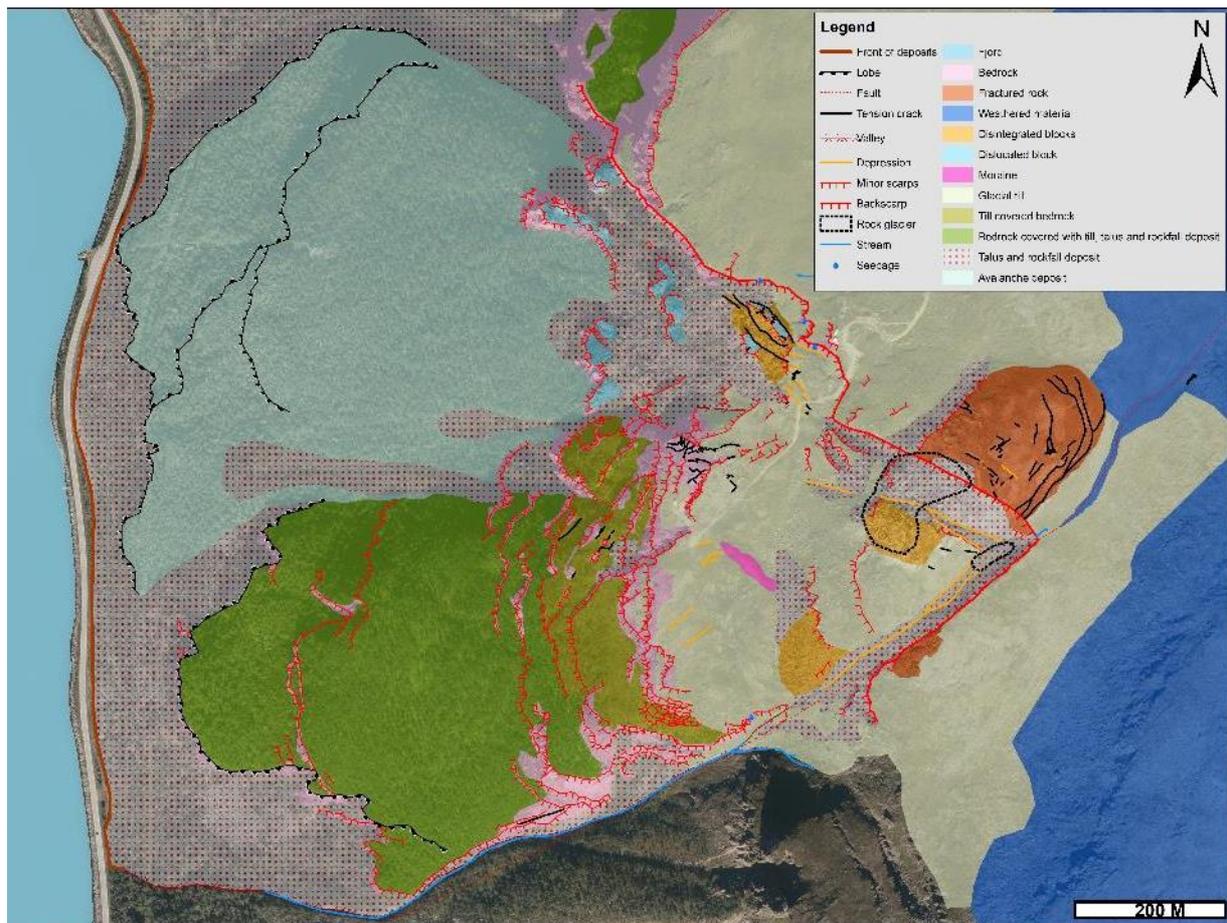
Figure 52: Geomorphological map over Jettan.

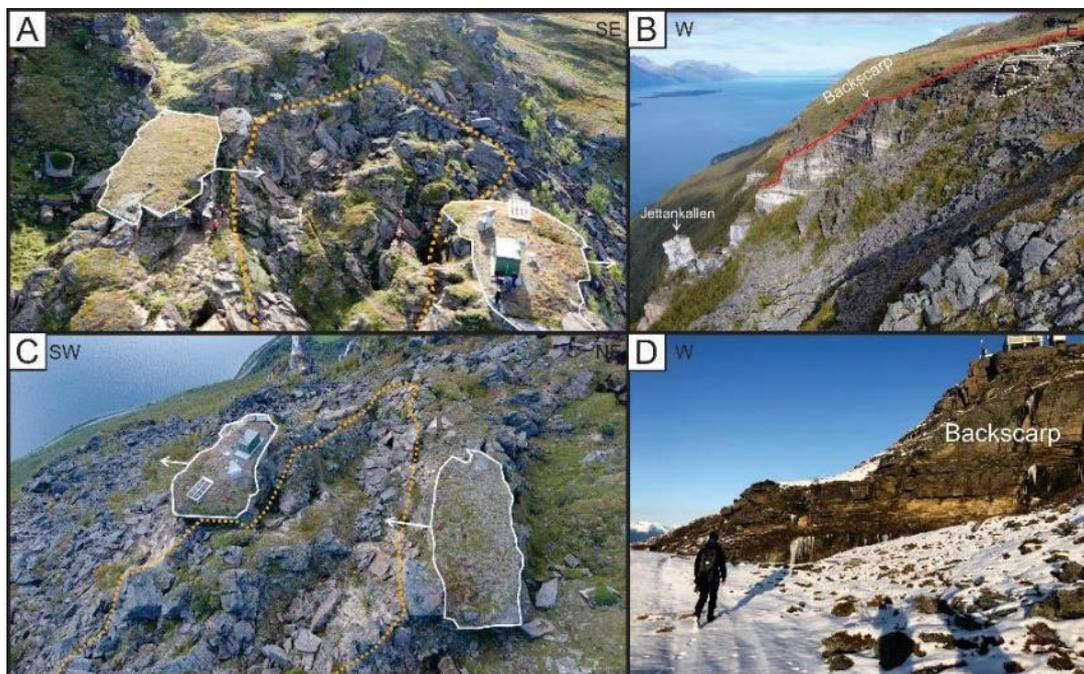
Figure 53: Domain 1. A) Drone photograph showing the two displaced blocks (white polygons) and the disintegrated blocks in between (orange dashed polygon). B) Drone photo illustrating the backscarp, Jettankallen, talus and rock fall material and the two displaced blocks. C) Drone photograph showing the two displaced blocks (white polygons) and the disintegrated blocks in between (orange dashed polygon). D) Field photograph of the upper part of the backscarp and seepage seen as ice.

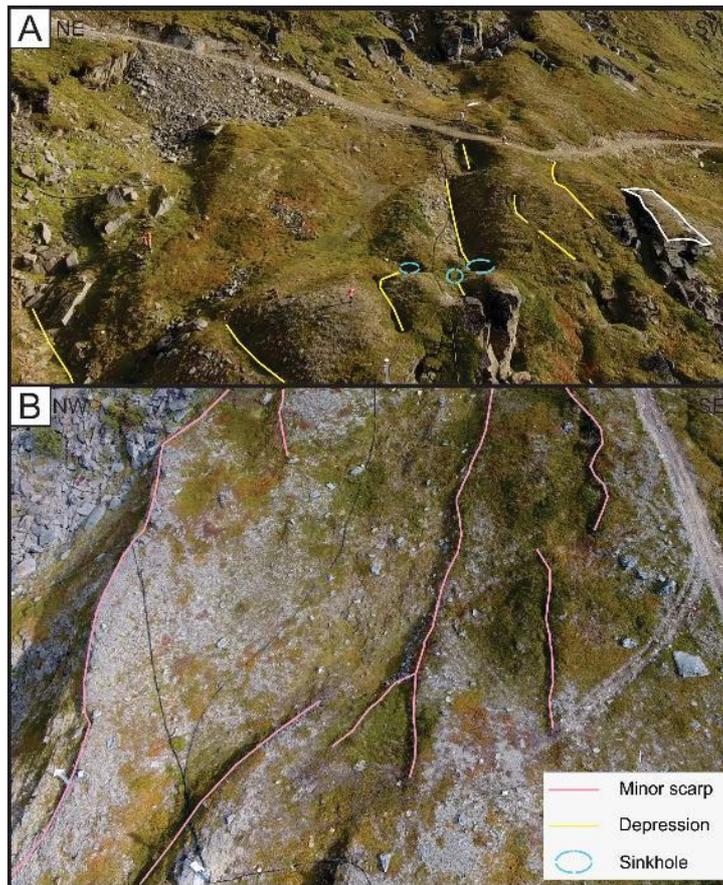
Figure 54: Domain 2. A) Drone photograph illustrating depressions and sinkholes at the northern terrace. White polygon shows a displaced block. B) Drone photograph of the southern terrace with smaller scarps and the western outer scarp.

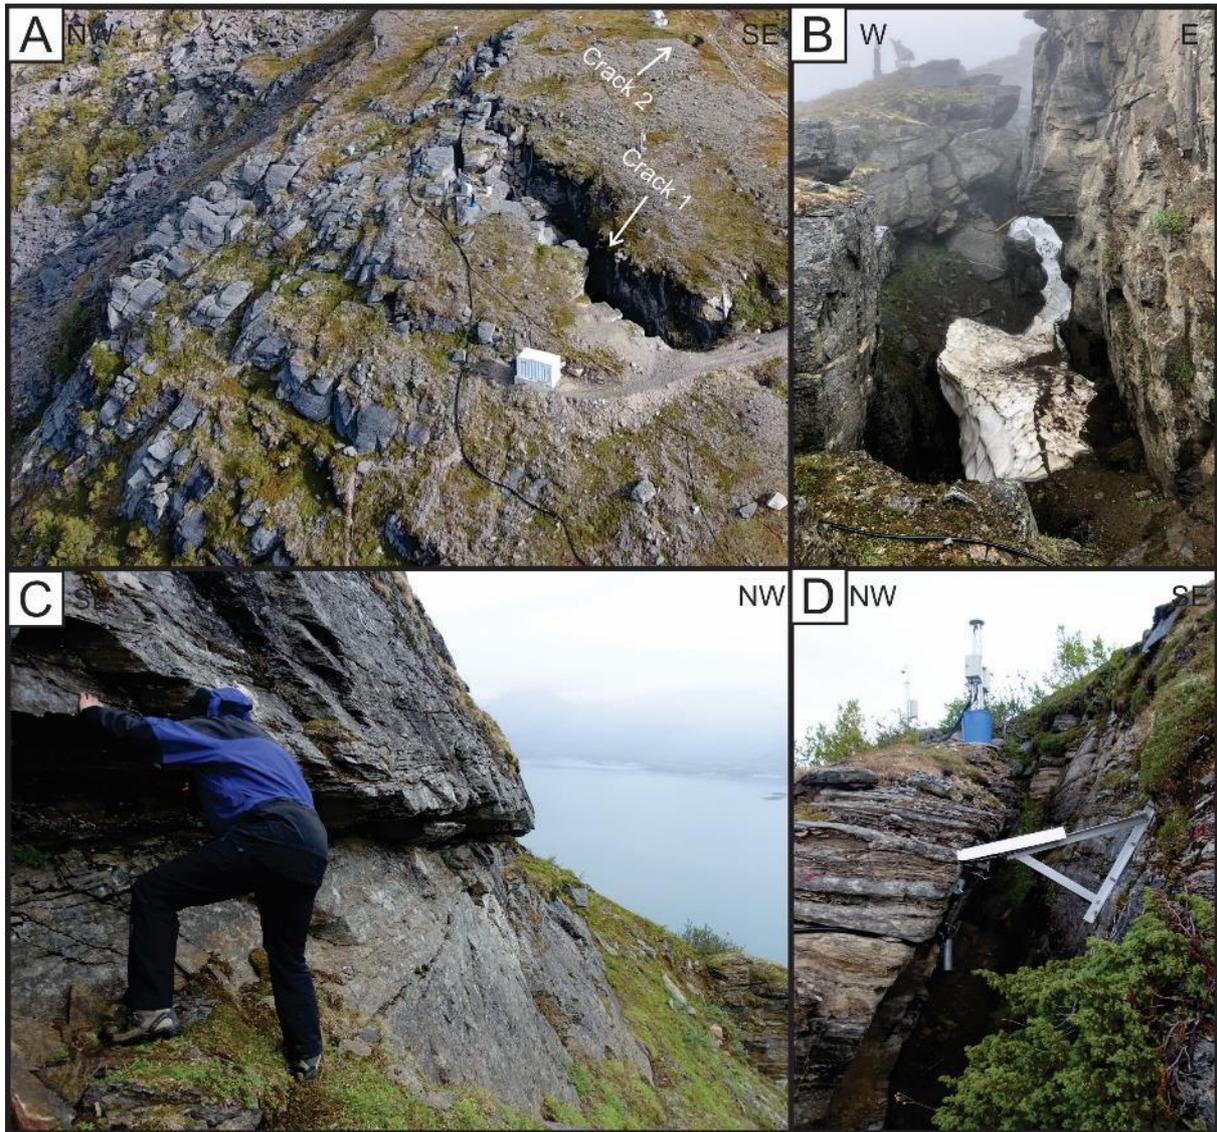
Figure 55: Domain 3. A) Drone photograph of crack 1 and sub scarps. B) Field photograph showing the snow inside crack 1. C) Field photograph of the southern boundary sub scarp of the domain and movement seen on the foliation. D) Field photograph of an open crack between two terraces in the lower part of the domain.

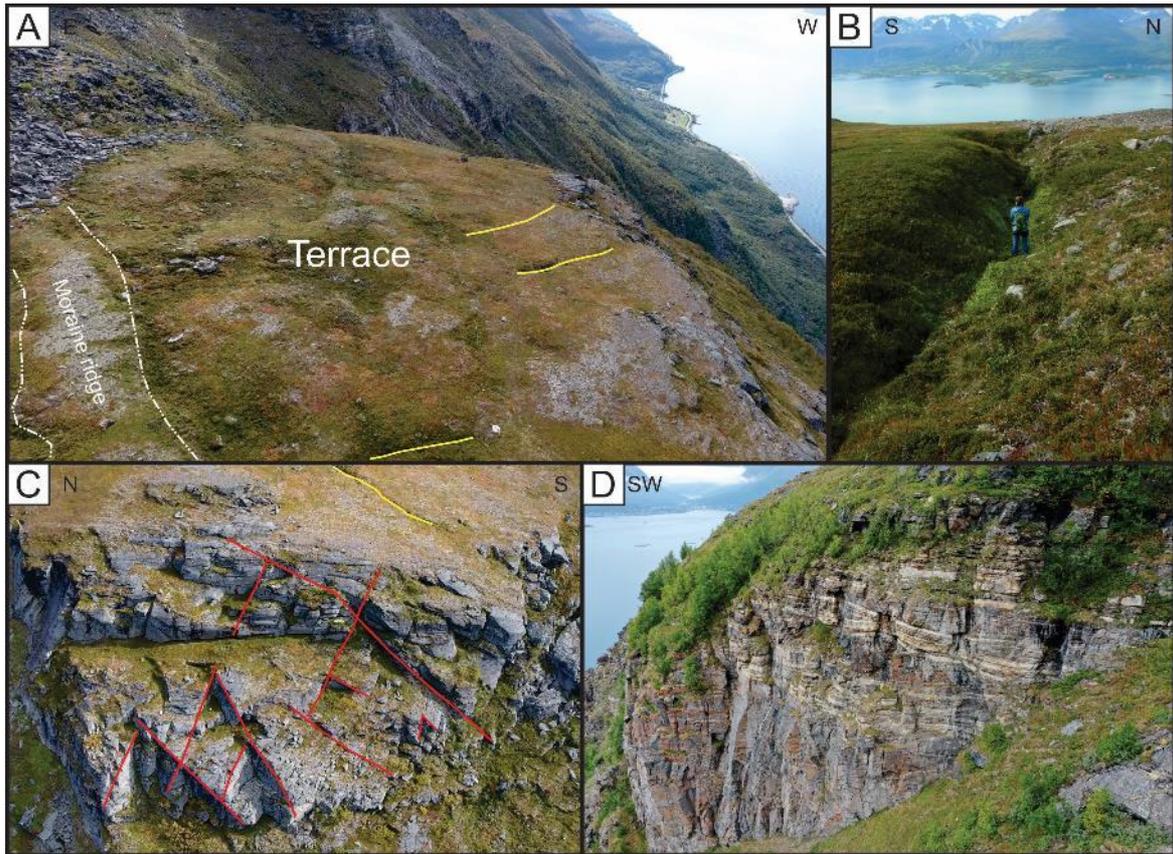
Figure 56: A) Drone photograph showing the upper large terrace, the moraine ridge and depressions. B) Field photograph illustrating one of the depressions found on the large terrace. C) Drone photograph of the uppermost minor scarp with zigzag pattern from orthogonal joint sets. D) Drone photograph of the large wall towards the south, marking the outer limit of the URS.

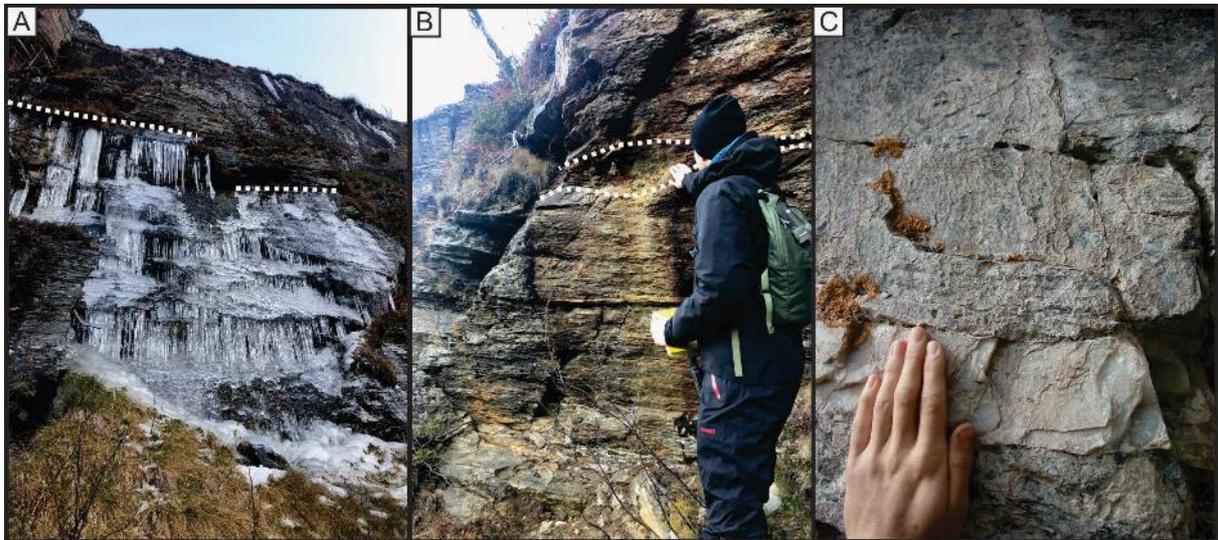
Figure 57: Seepage found in the upper eastern part of the wall and calcite coating found on joint surface. A) Seepage here seen as frozen, coming out of the weaker zone (white stippled lines). B) Perpendicular display of the weaker zone (white stippled lines), which was traced to the seepage point. C) Calcite marble coating on a joint surface in the lower portions of the wall.

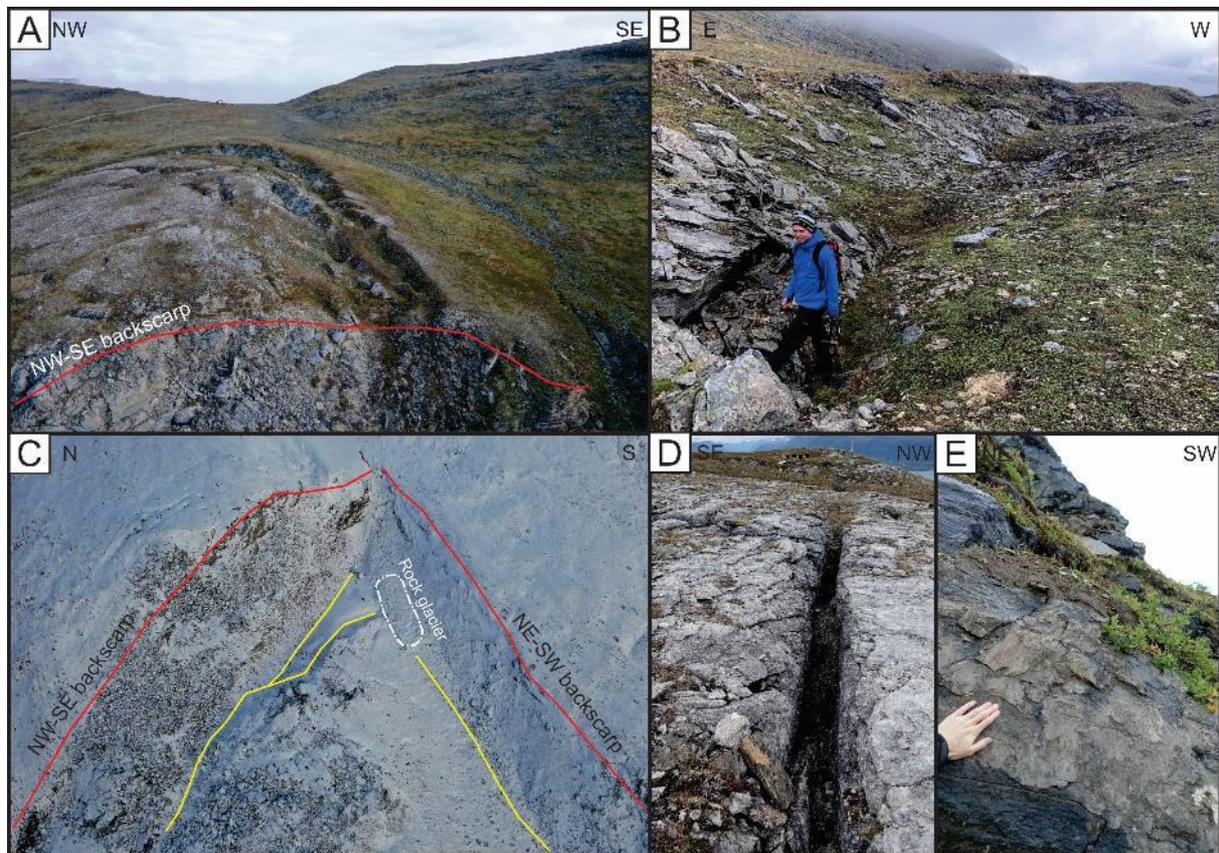
Figure 58: Domain 5. A) Drone photograph of the upper most area of the URS. Depressions and tension cracks. B) Field photograph illustrating the outer most depression. C) Drone photograph showing the meeting of the two backscarp making a V-shape. Depressions is marked as yellow lines, and the rock glacier is marked with white polygon. D) Field photograph of a tension crack in the middle upper part. E) Field photograph of slickensides on the fault plain.

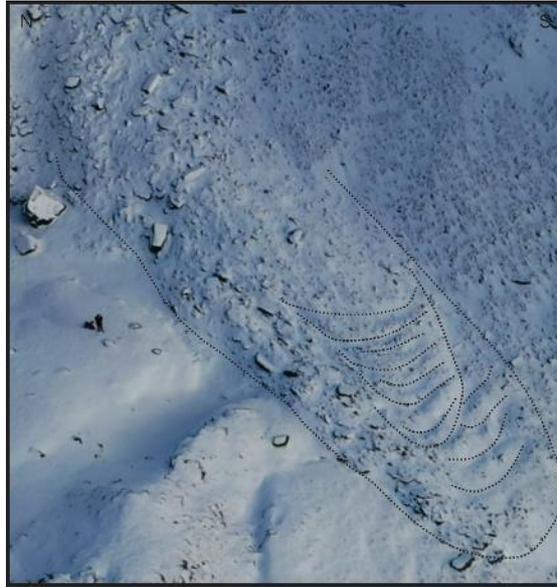
*Figure 59: Drone photograph of the rock glacier with dotted lines along the ridges.*

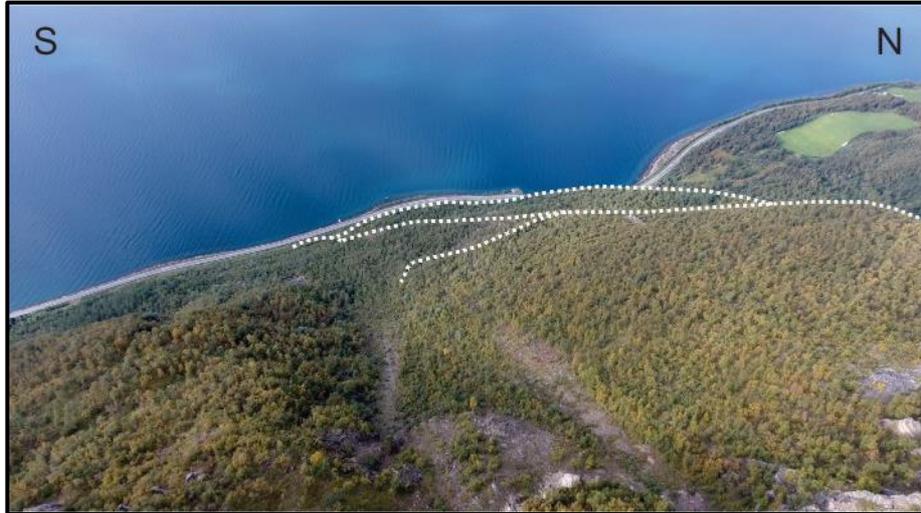
Figure 60: Domain 6. Drone photograph of talus and avalanche deposits (lobe marked with white dotted lines).

Domain 6 includes the lower northernmost parts of the URS, an area characterized by historic avalanche and rockfall deposits (figure 60). The domain stretches from between 400 - 450 m asl to toe level. There are no observable intact displaced blocks or scarps. From the hillshade map (figure 51), it is clear that the domain is dominated by deposits, supporting the theory that this is an old avalanche deposit. On top of the avalanche deposit several rock fall deposit paths could be traced downslope (figure 60). In the lower western parts of the domain, large scarps interpreted as frontal lobes of the old avalanche deposit are found. The height of the frontal lobes was observed to have been a maximum height of 45 m. The lobes expressed higher elevation drop in the north and a gradually lower drop towards south.

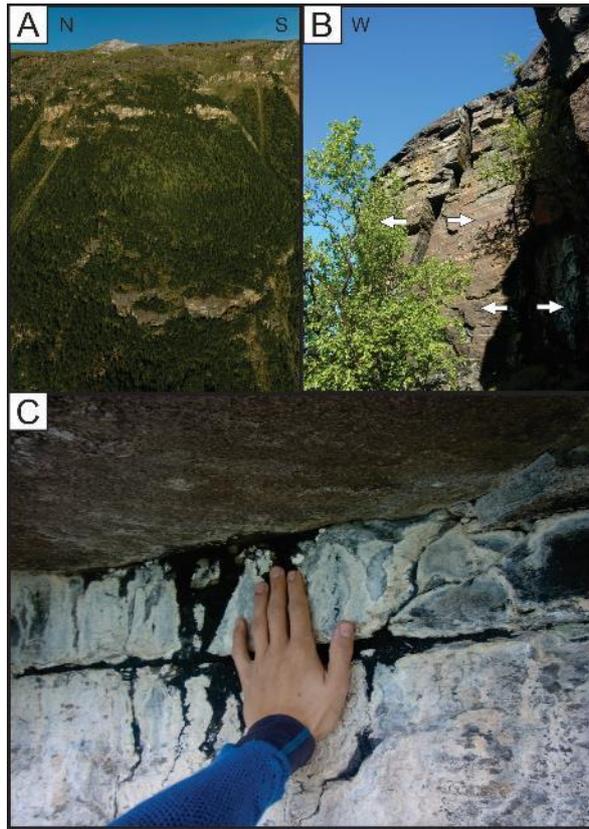
Figure 61: Domain 7. A) Uppermost terrace and the large scarp below. B) Field photograph of vertical tension cracks opening towards the fjord. C) Field photograph illustrating calcite coating on joint surface. (Reference picture A)
