## **Engineering geology of the Jettan rockslide, Kåfjorden**

GEO-3900 Master's thesis in Geology, May 2020

The unstable rock slope (URS) Jettan is located at Nordnesfjellet in Kåfjorden municipality in Troms and Finnmark County, 800 m above the fjord. The rockslide has an estimated volume of  $6 \text{ Mm}^3$ , and moving at a rate of up to  $50 \text{ mm a}^{-1}$ . Jettan is considered a “high risk object” within the Norwegian unstable mountain framework. This is due to the potential displacement wave impact to housings, infrastructure and industry. As such there has been a scientific interest in the site since 1999 generating several studies, reports, investigations and theses. Continuous monitoring began in 2007.

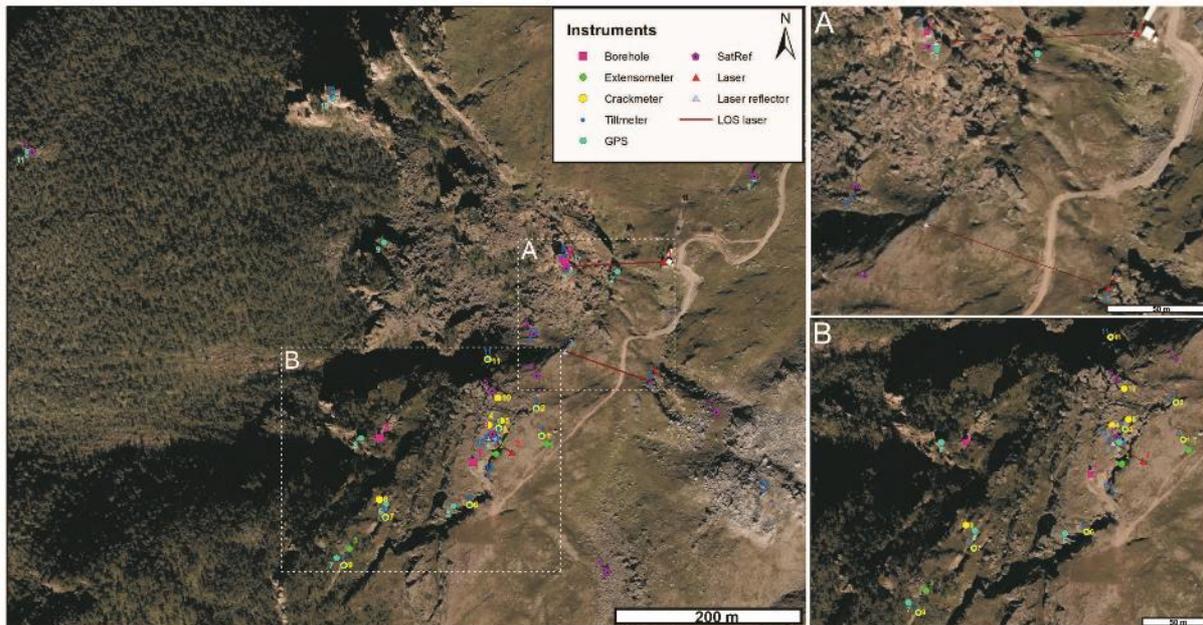
Figure 62: Position of the different continuous monitoring instruments at Jettan. Number indicates which instrument. Insets A and B are located in the left panel. LOS is referred to as line of sight for the lasers and SatRef is referred to as satellite reference (NVE, 2019).

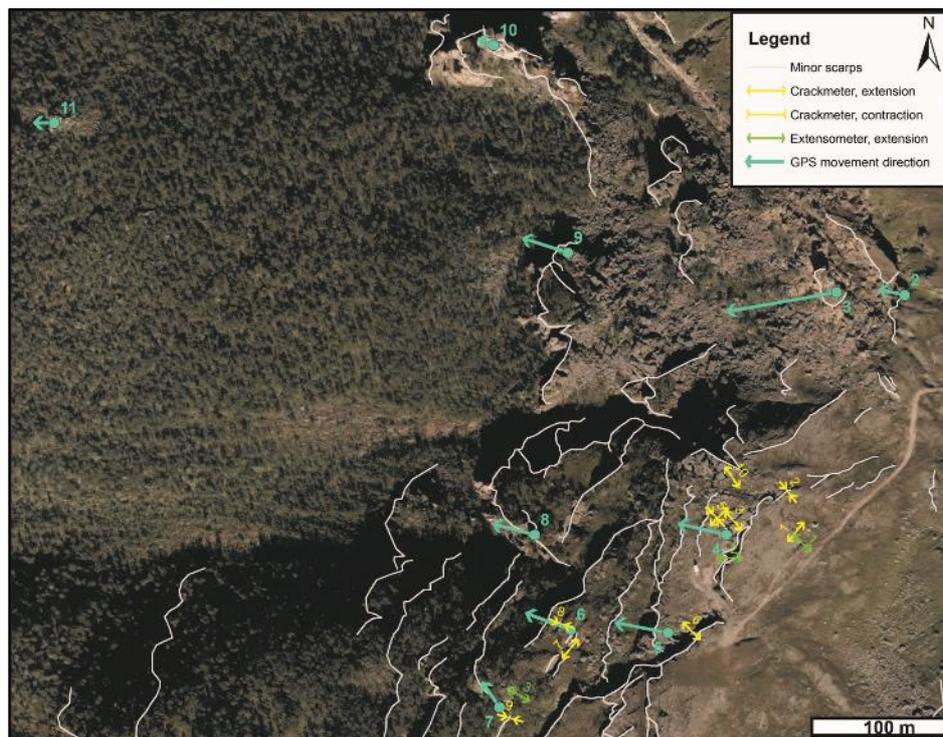
Figure 63: Overview of movement vectors for GPS's and orientation of extensometers and crackmeters showing contraction or extension. Movement vector express average mm/year.

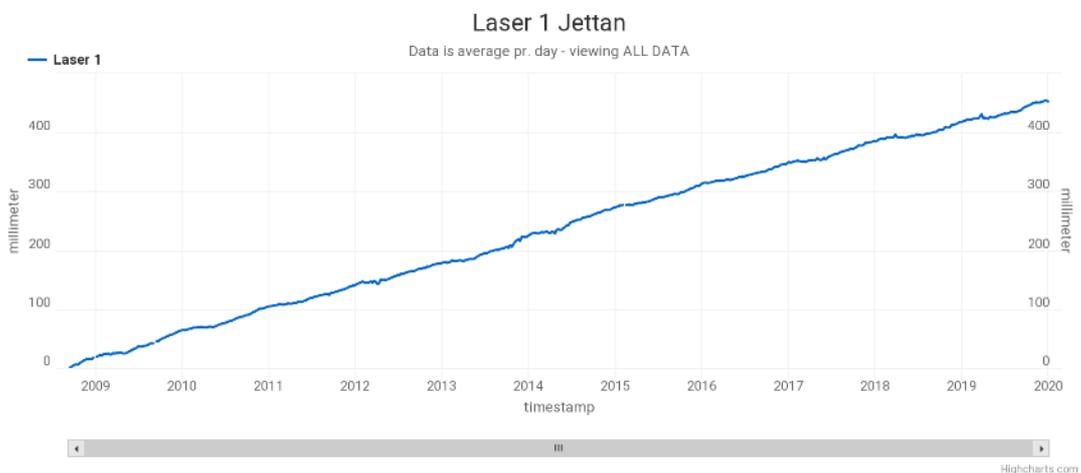
Figure 65: Registered movement for laser 1 (NVE, 2019).

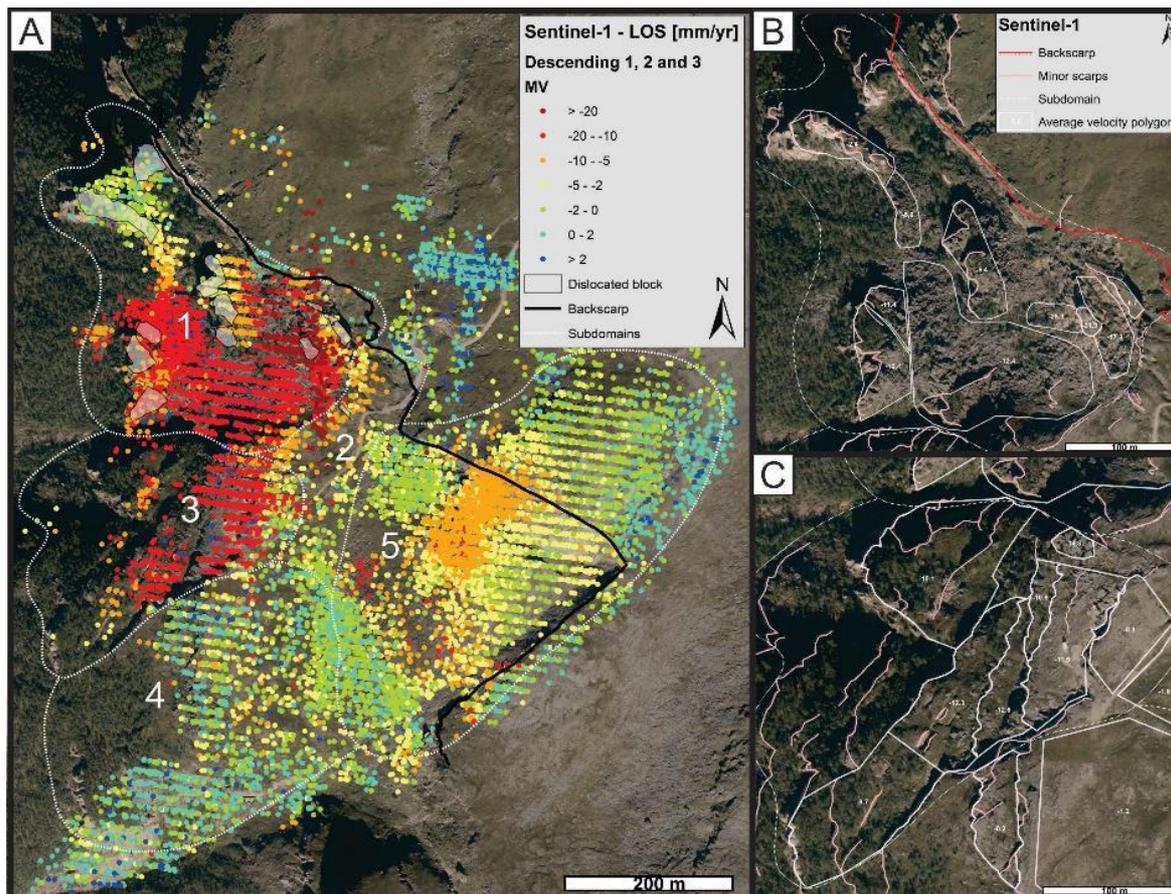
Figure 66: Displacement measured by the Sentinel-1 satellite. A) Showing the displacement for the whole area at Jettan with the different domains marked along with the backscarp and displaced blocks. B) Polygons in domain 1 showing average displacement per year. C) Polygons in domain 3 and 4 showing average displacement per year (NGU, 2020).

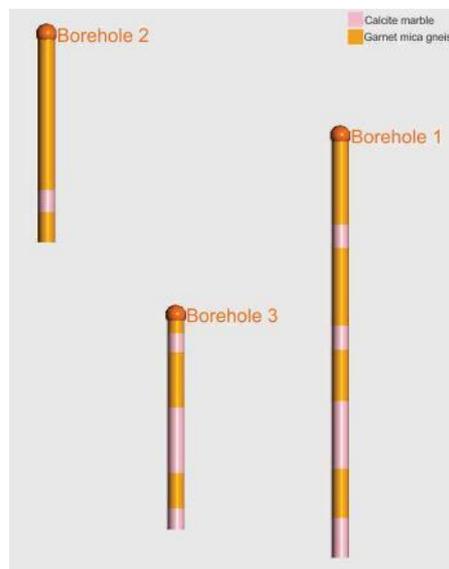
Figure 71: The different lithologies in the boreholes at Jettan.

The lithology model is shown in figure 67 and cross sections through the boreholes in figure 68, 69 and 70. The borehole lithologies could be seen in figure 71. The bedrock map suggests that the different lithological units are seen as bands through the whole area. This matches with the layers of boreholes 1 and 3, while domain 1, 6 and outside the unstable area show poor correlation compared to field investigations (see chapter 4.1.7). Cross-section DD' shows how the dolomite marble is expressed both in the dome (domain 5) and in Jettankallen (domain 1). Limitations of the model is a wrong offset of the lithologies when the fault was activated (figure 70), and that the model have garnet mica gneiss in the large fractures in the dolomite marble dome which was not observed in field (figure 69).

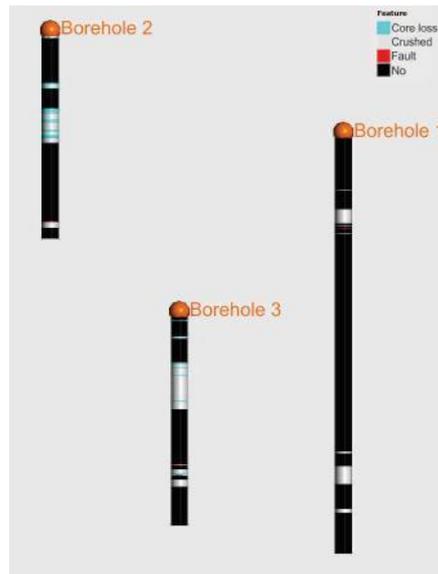
Figure 72: Borehole 1, 2 and 3 showing core loss (blue), crushed zones (grey), fault (red) and relatively intact rock (black).

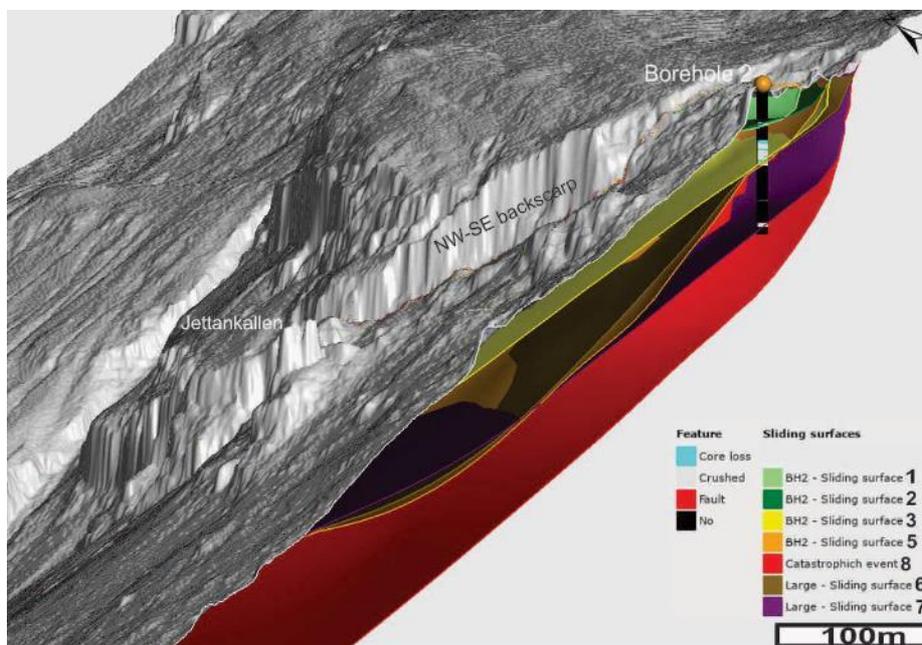
Figure 73: Sliding surfaces in domain 1 going through borehole 2.

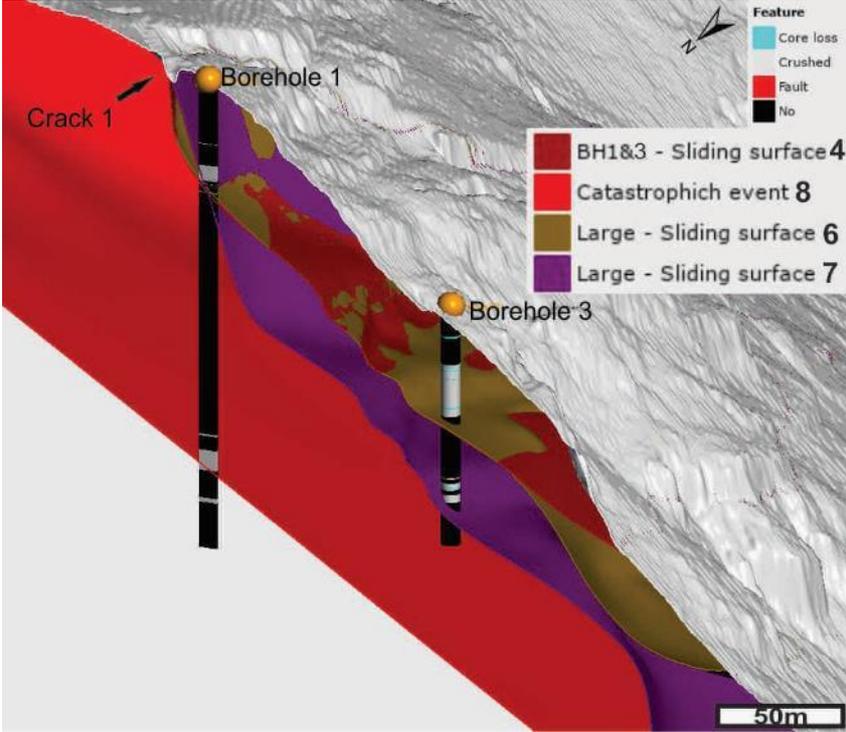
Figure 74: Sliding surfaces in domain 3 going through borehole 1 and borehole 3.

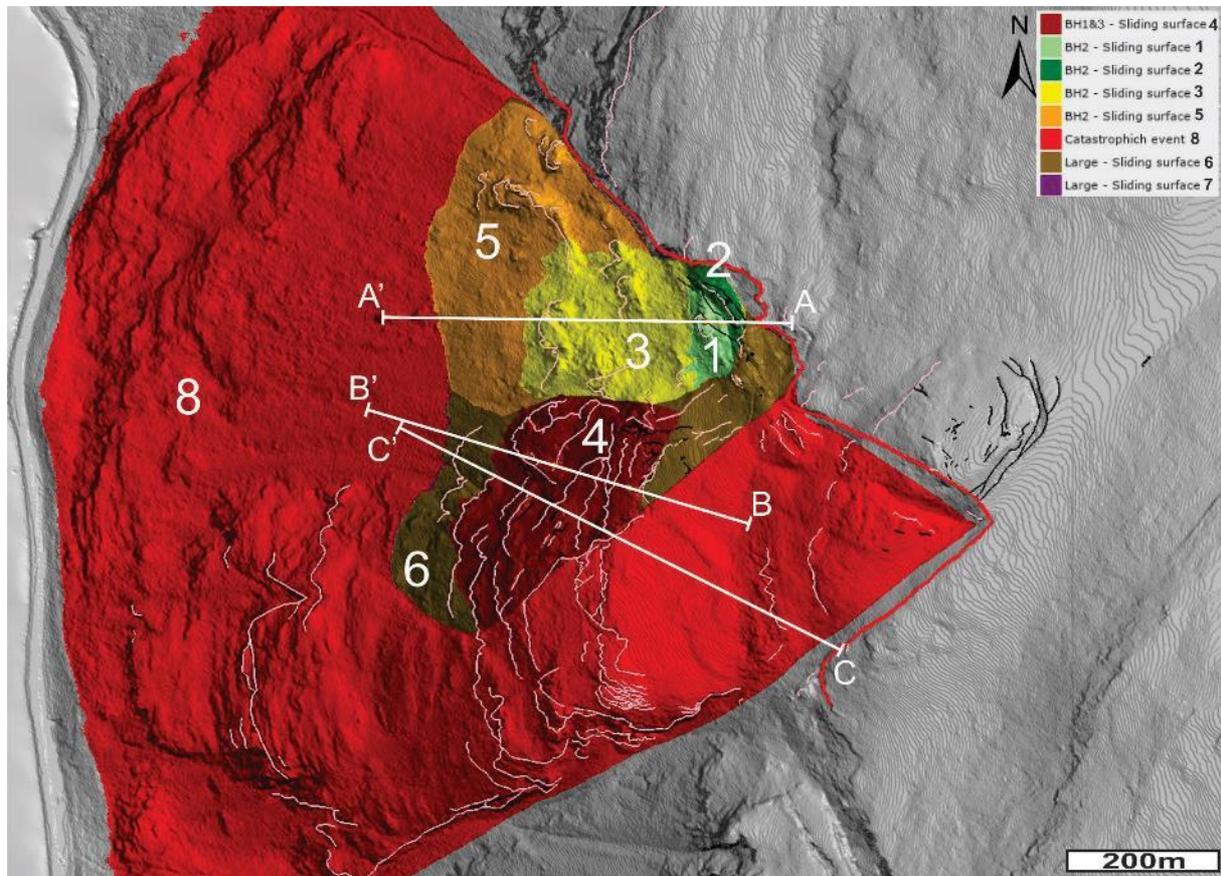
Figure 75: Possible failure scenarios (marked with numbers) and location for the different cross-section. Failure scenario 7 is not seen at the surface as it daylight in the slope matching scenario 6. Backscarp (red line), scarps (pink lines) and tension cracks (black lines) are marked.

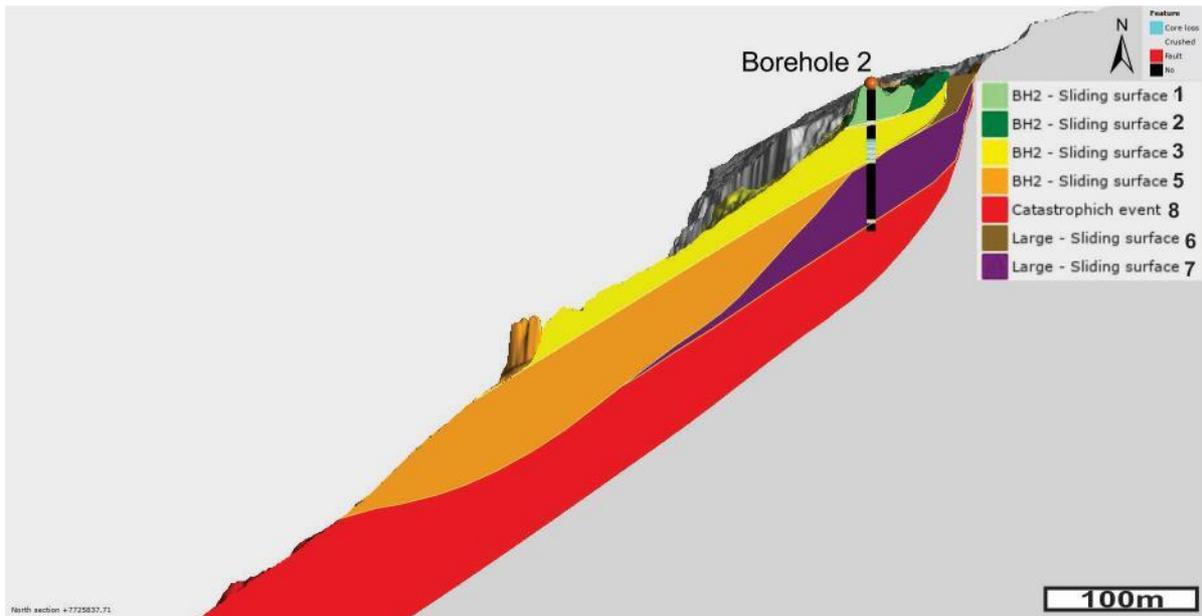
Figure 76: Cross-section AA' showing different failure scenarios. Borehole 2 displays core loss (blue), crushed rock (grey) and fault (red). Sliding surfaces are marked with yellow lines.

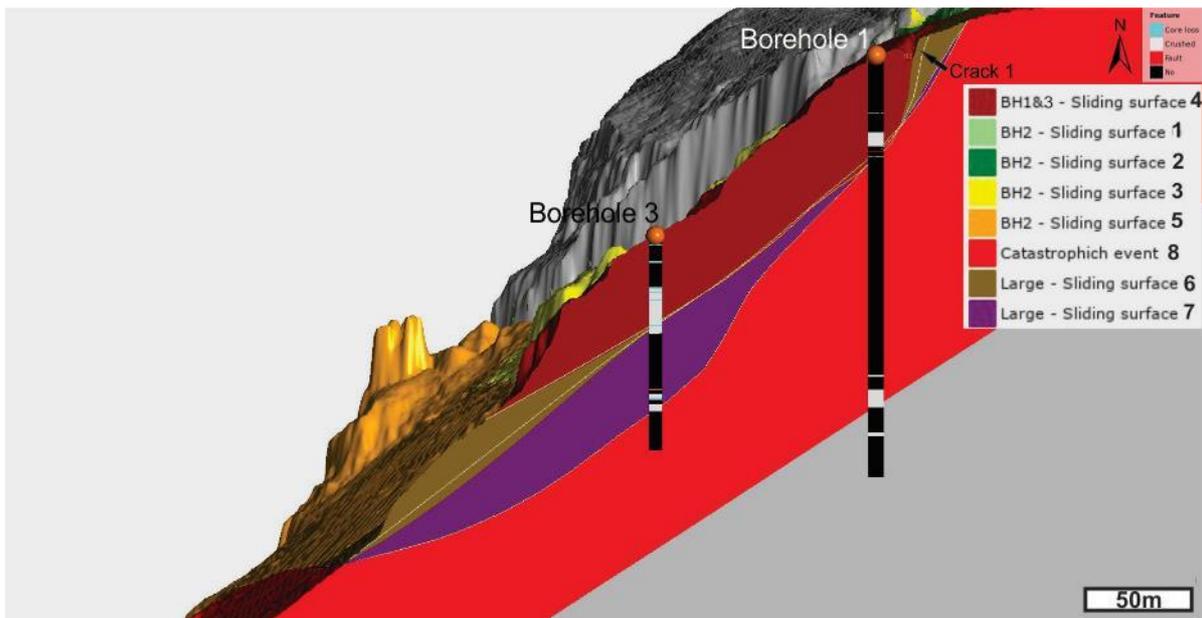
Figure 77: Cross-section BB' showing different failure scenarios. Borehole 1 and 3 displays core loss (blue), crushed rock (grey) and fault (red). Sliding surfaces are marked with yellow lines.

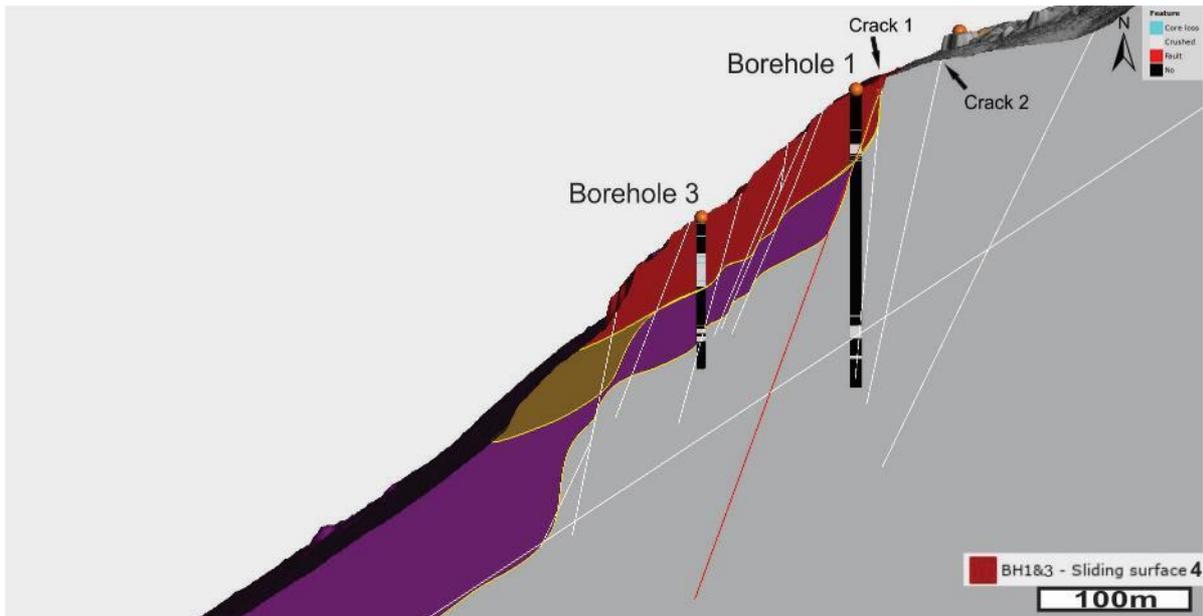
Figure 78: Cross-section BB' showing failure scenario 4.2 including suggestions of lower sliding planes. Borehole 1 and 3 displays core loss (blue), crushed rock (grey) and fault (red). Sliding surfaces (yellow lines), scarps and fractures projected at depth (white lines) and the fault logged in borehole 1 (red line) are included.

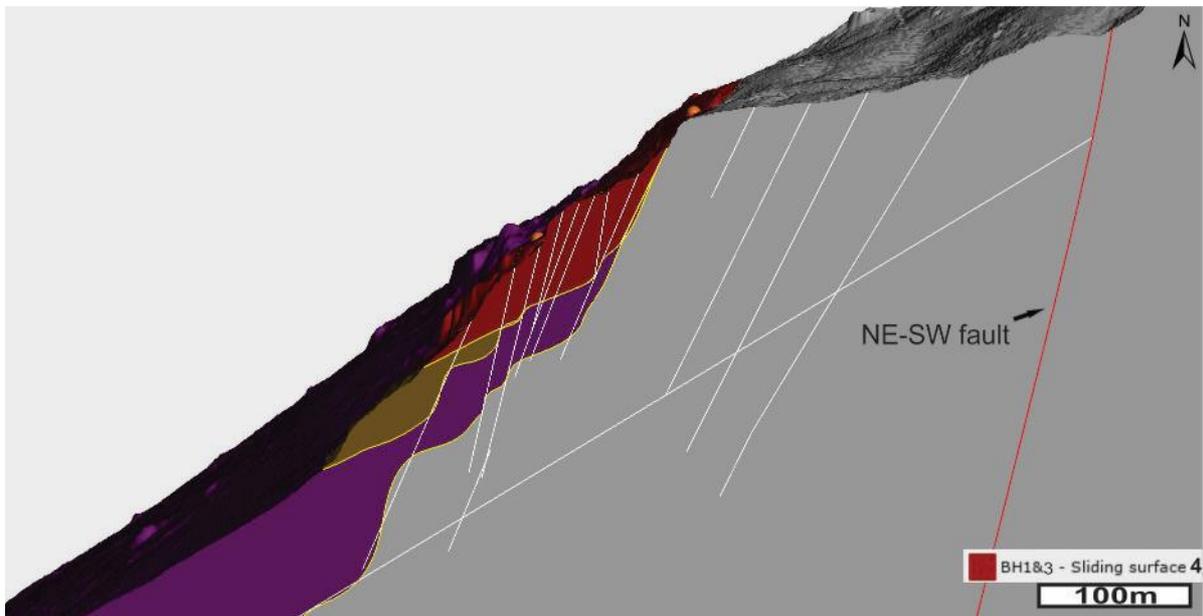
Figure 79: Cross-section CC' showing failure scenario 4.2 including suggestions of lower sliding planes. Sliding surfaces (yellow lines), scarps and fractures projected at depth (white lines) and the NE-SW striking fault (red line) are included.

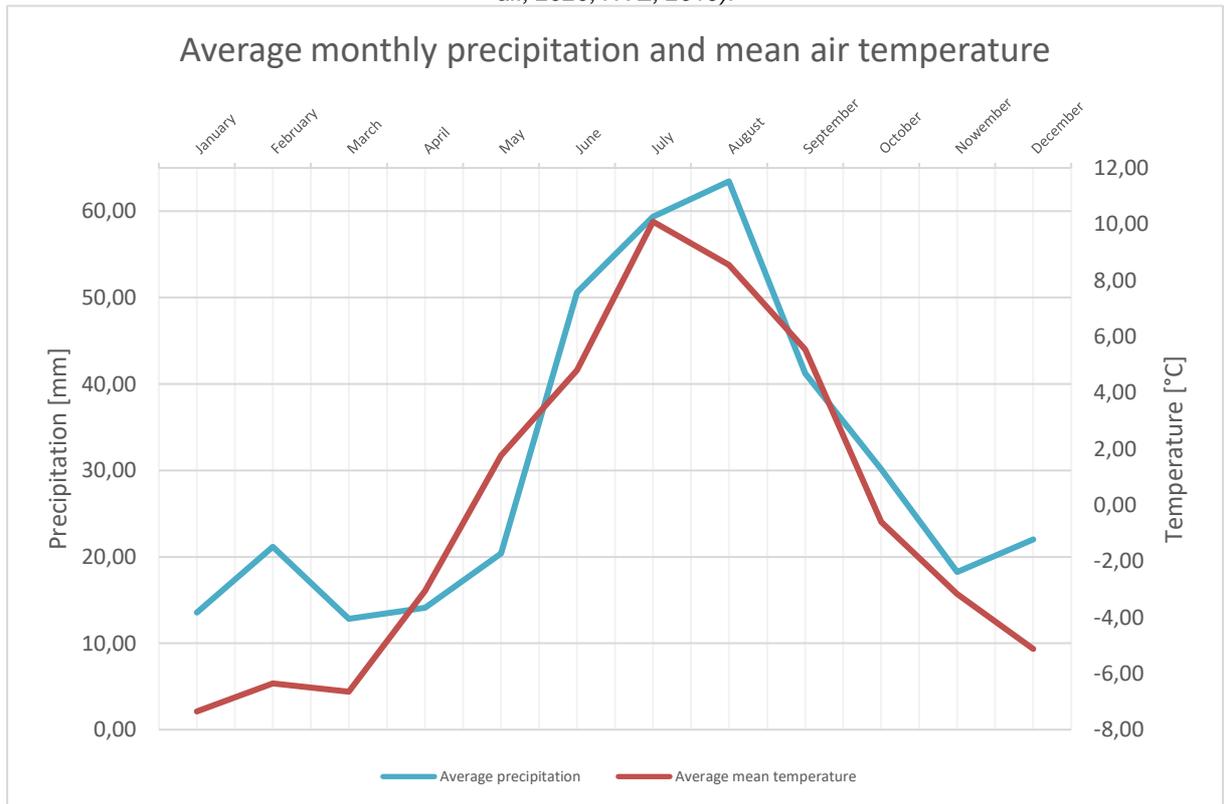
Figure 81: Average precipitation and average mean air temperature for each month at Jettan (Norsk\_Klimaservicesenter et al., 2020).

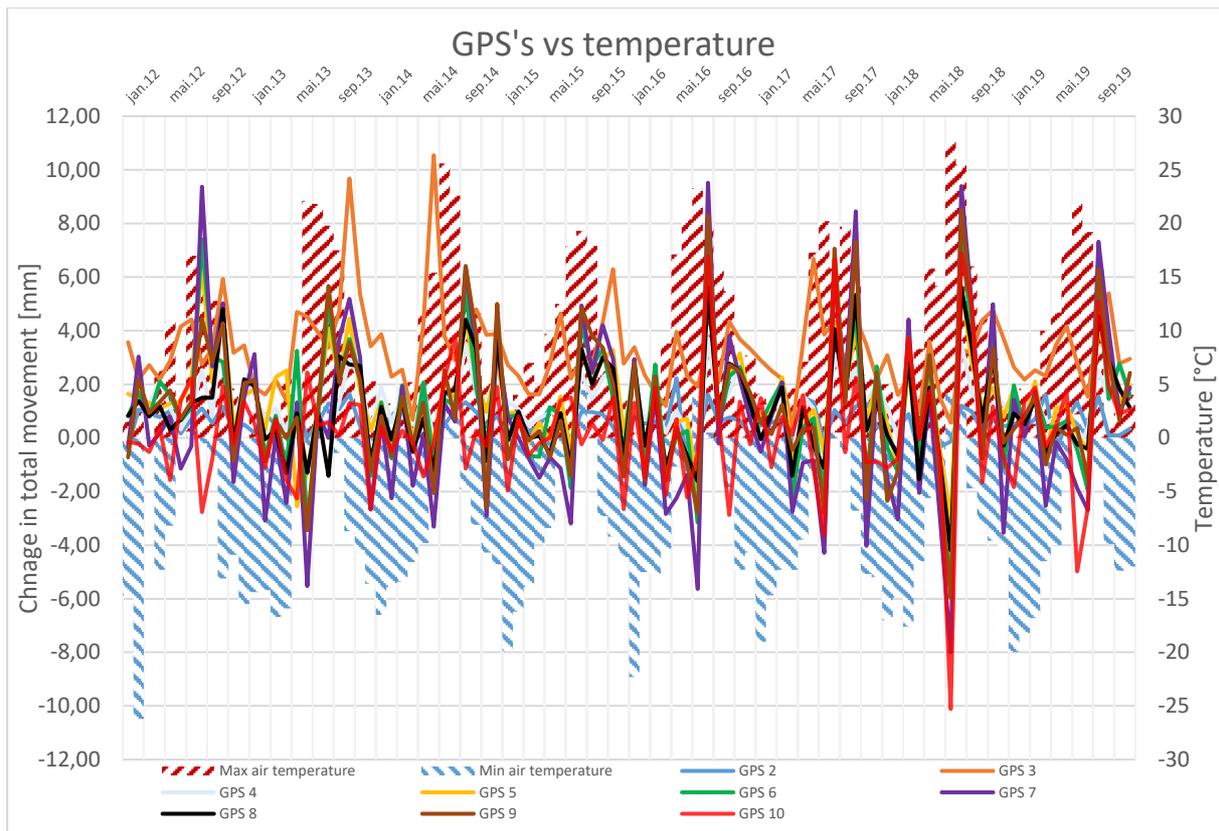
Figure 83: Change in total movement compared to maximum and minimum temperatures.
