Reconstruction of the Kråknes landslide event, Alta.

Stina Mari Pettersen

GEO-3900 *Master's thesis in Geology, May 2021.*

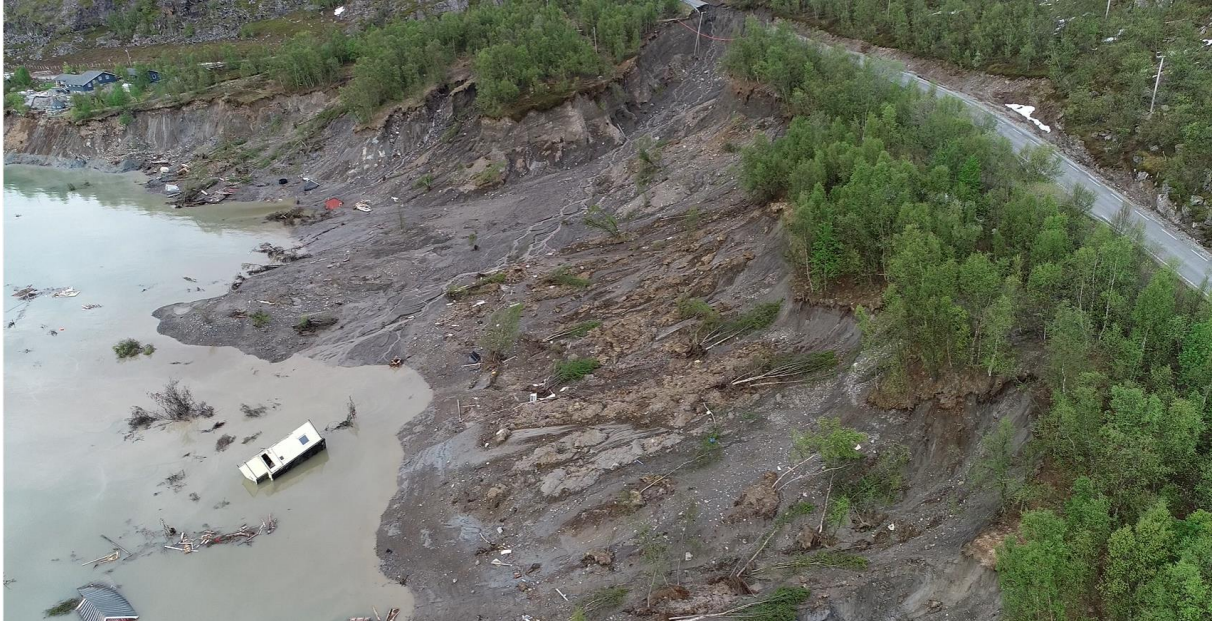
Figure 1 The Kråknes landslide area on June 7th, 2020 (Photo courtesy of Anders Bjoerdal, NVE).

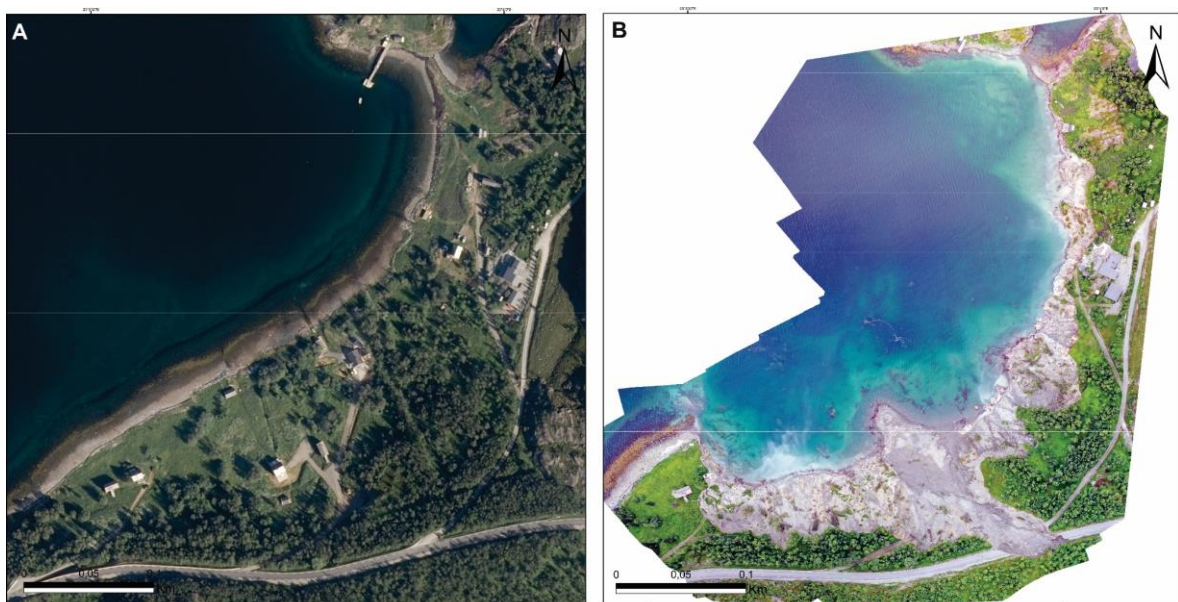
Figure 3 A) The study area before the landslide (Kartverket, 2018). B) The study area after the landslide.

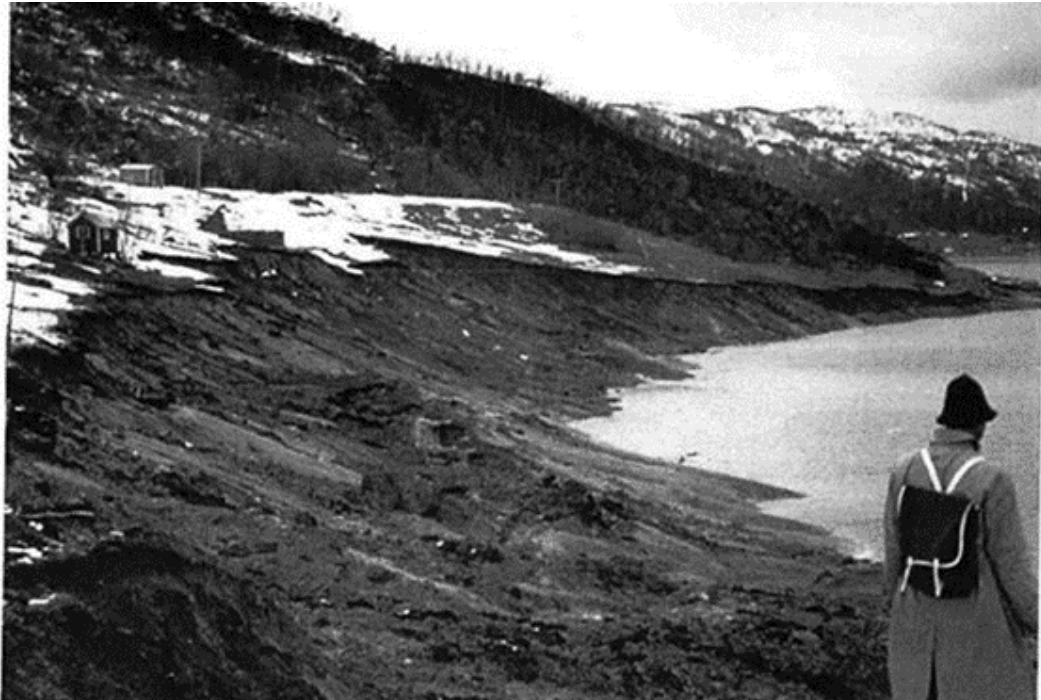
A quick clay landslide occurred in Indre Sökkelvik, Nordreisa municipality in 1959. During road construction six months prior to the landslide event, a 7.5 m high embankment fill was placed close to the shore, which caused the area to become unstable. The landslide event was later triggered due to high amounts of rainfall and meltwater in the area that increased the pore pressure in the ground. A total of 17 out of 29 inhabitants along the bay in Sökkelvik were taken by the landslide, and 9 of them perished (L'Heureux et al., 2017). Figure 5 shows the 12 m high and 600 m long landslide scarp after the event. The landslide also triggered a tsunami that caused waves up to 5 m high to hit Sørkjosen, 5 km away from Indre Sökkelvik (Furseth, 2013). A similar landslide event happened again 60 years later in Sørkjosen, three km south of Indre Sökkelvik. This landslide event started when a newly built pier disappeared into the fjord after intense rainfall (Austefjord, 2016). A road was destroyed in the event, but there were no casualties (Aspaker, 2019).

Figure 5 Picture of the landslide scar in the northernmost part of Sokkelvik captured in 1959 (L'Heureux et al., 2017).

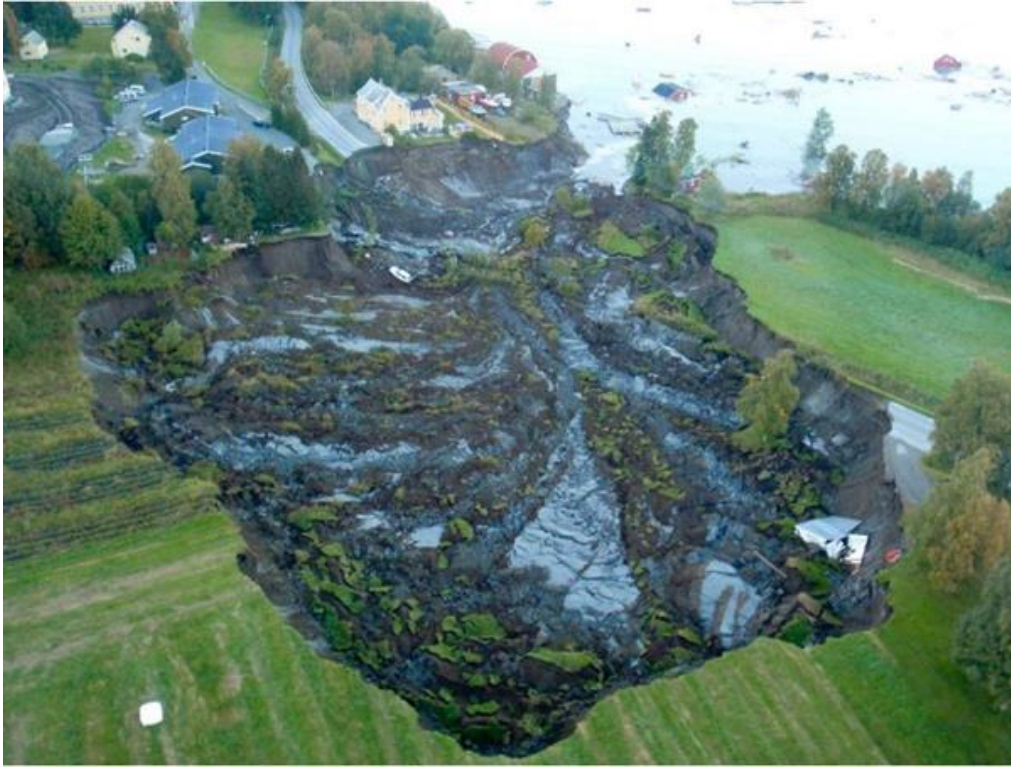
Another recent landslide event happened at Lyngseidet in Lyngen municipality in 2010. The landslide event started in the tidal zone and retrogressed backward over several days. It was found to be triggered by unsanctioned filling during construction. The landslide evolved over time, where several buildings, construction vehicles, cars, and parts of the highway slid out into the ocean. Up to 1000 m³ of landslide masses slid out and left a bowl-shaped scarp (Figure 6). One resident was taken in his house, but later rescued from his attic by helicopter. A new highway was later established through the slide area, and security measures were made for the inhabitants in the area (Hoseth et al., 2014).

Figure 6 Quick clay landslide at Lyngseidet in 2010 (Hoseth et al., 2014)

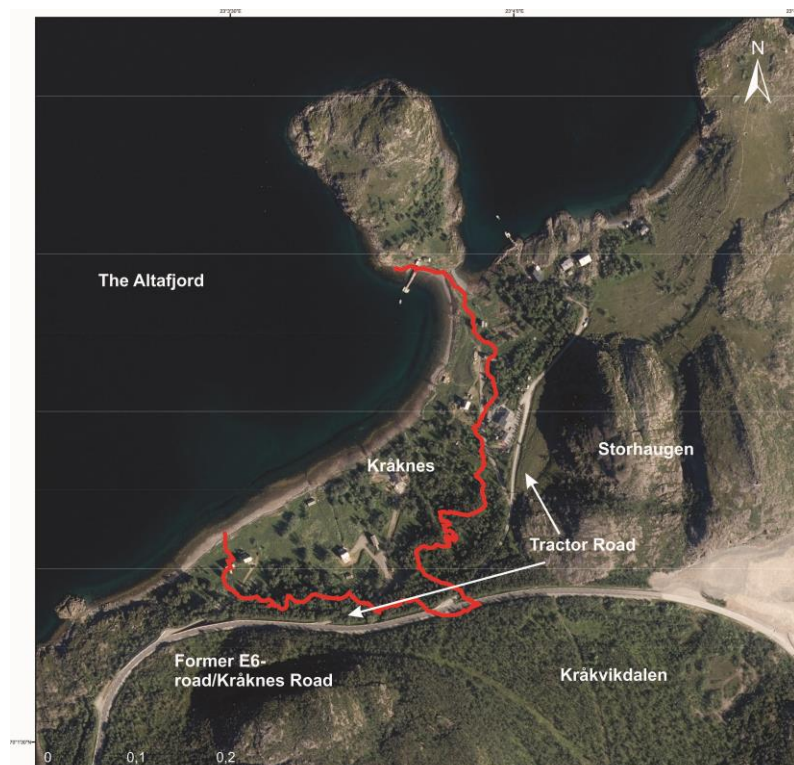
Figure 37 The study area described in this section. The red line is the back scarp.

The landslide area occupies most of the beach at Kråknes. The landslide area is around 600 m wide from the southwest to the northeast. At the west is the water of Altafjord, and at the east rock of the Tålvik peninsula. A dome of rock, Storhaugen, frames the landslide on the northeastern side and reaches 80 m asl. Framing the landslide immediately at the east is the former E6-road (Now Kråknes Road). The geomorphology of the landslide area is shown in Figure 38. Within the landslide area is a well-exposed (up to 10 m high) back scarp facing west-northwest with a dip of 40-60°. From the foot of the back scarp to the waterline is a flat (slope angle) beach area which slopes gradually into the fjord. Within the landslide area (i.e. between the back scarp and waterline) are deposits of landslide debris, vegetation and remains of the houses that were caught in the landslide. Rotated blocks of soil that are intact can be seen within the debris and along the shore are two smaller scarps. Thin streams of water and sediments can be seen seeping from the back scarp, draining through the landslide area and into the sea. Some of the seepages come from soil pipes that can be seen in the back scarp.

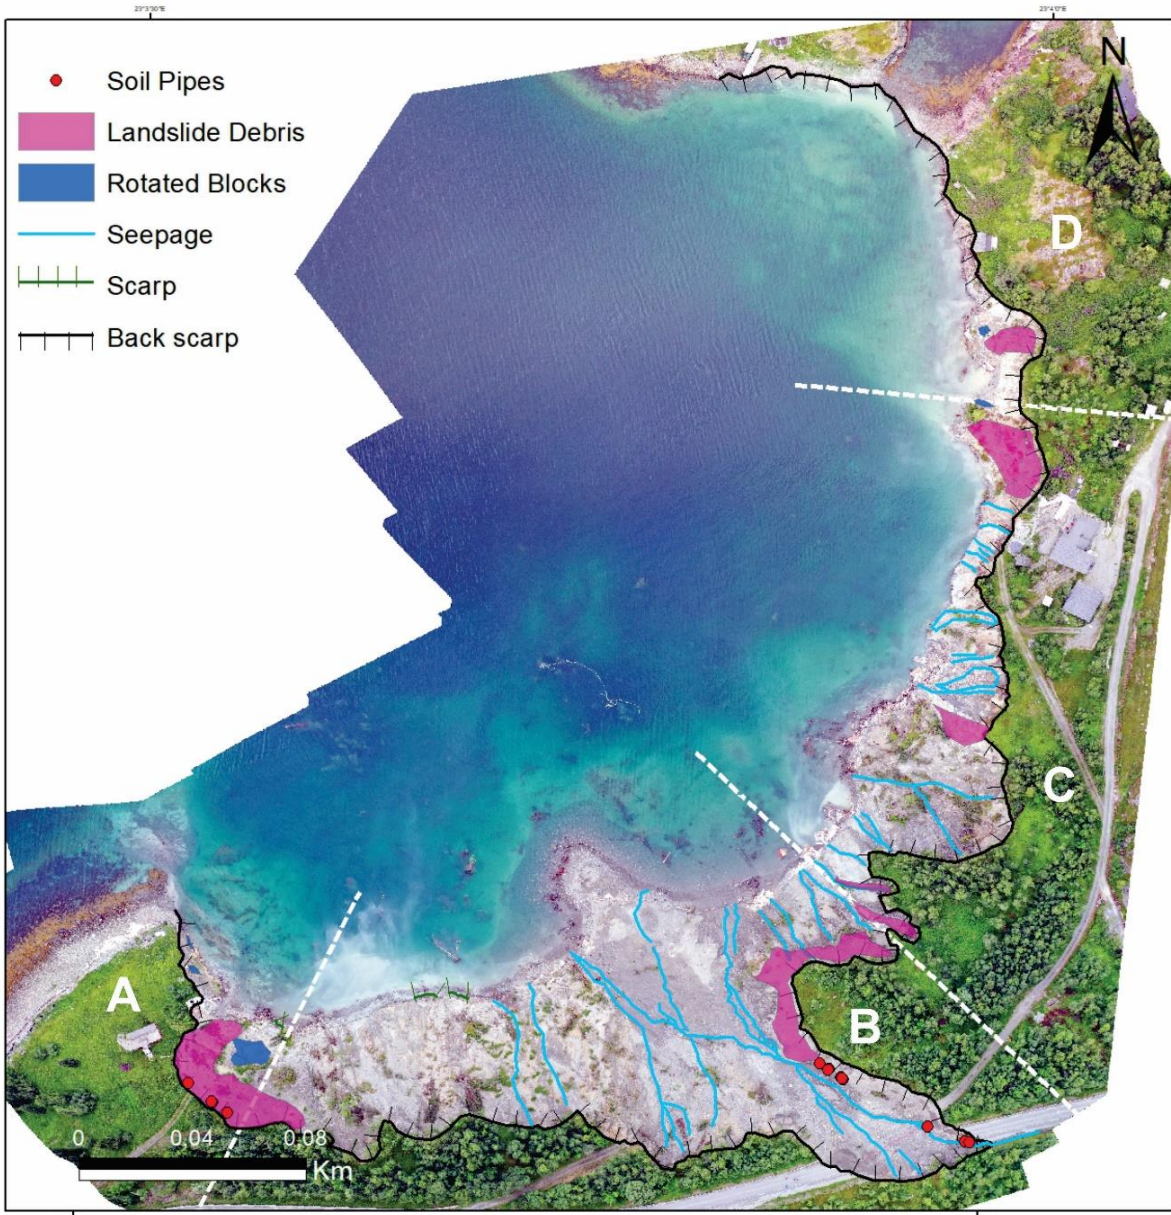
The landslide area has been divided into sections A, B, C and D (Figure 38) to provide a higher resolution description of the study area in subsequent sections.

Figure 38 Perspective overview of the landslide area, showing sections divided by the stippled lines and geomorphological features. The UAV mosaic was taken on July 28th, 2020, 54 days after the event. Landslide debris can be seen floating in the water.

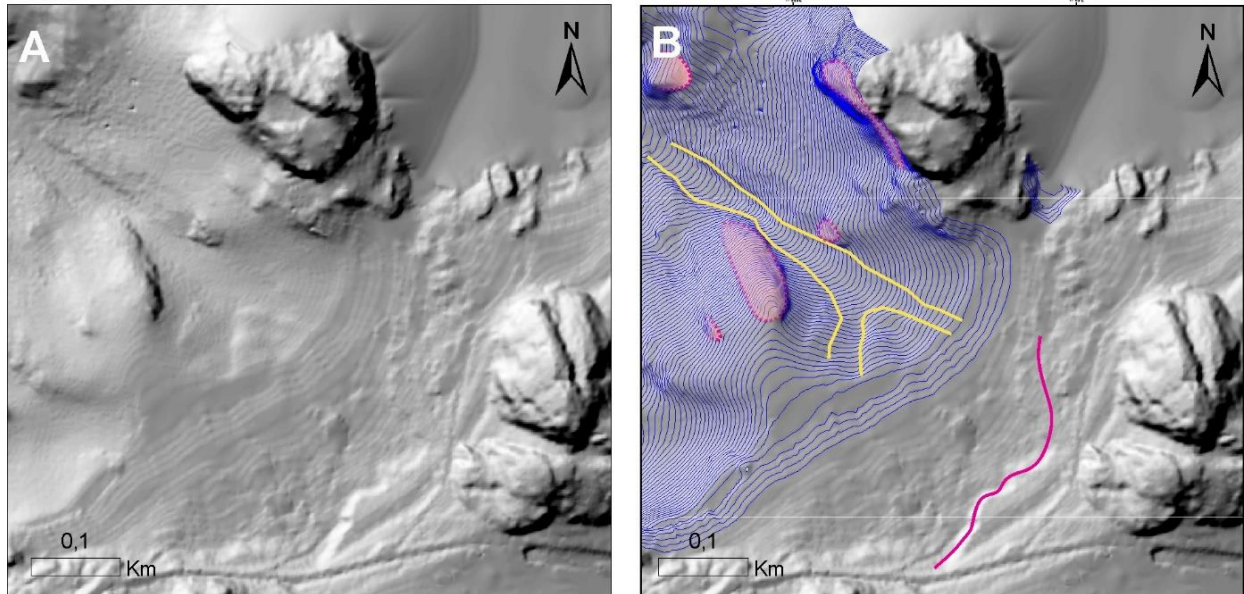
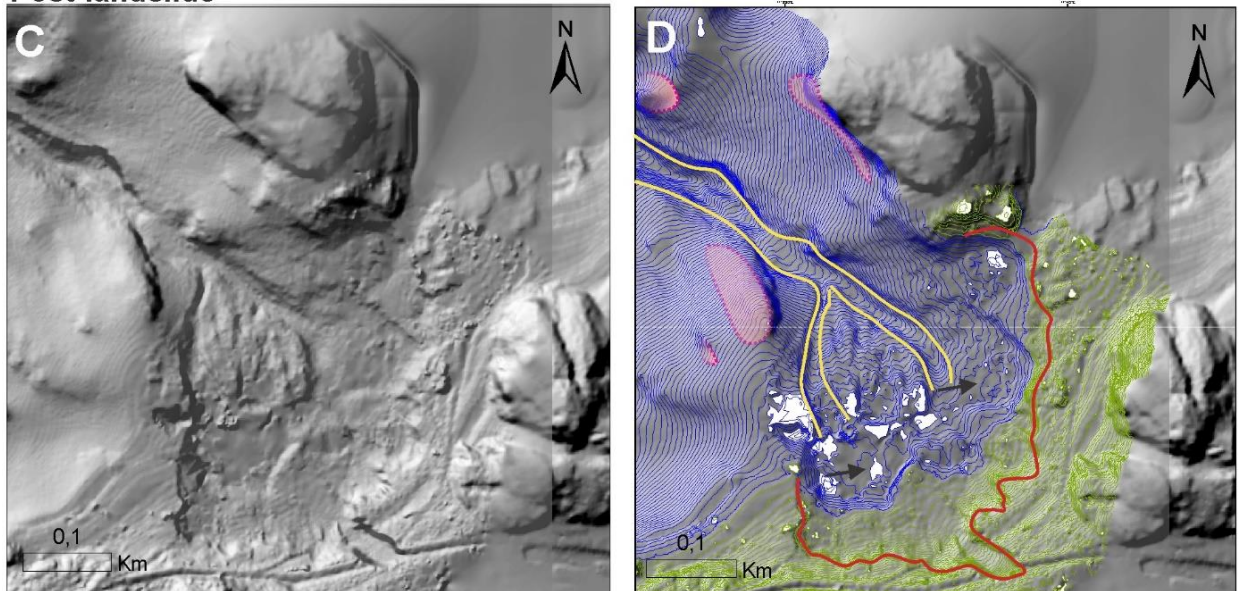
The difference in topography from before and after the landslide event in 2020 can be seen in Prior to the 2020 landslide event, the area on land affected by the landslide had water channels that fed into the sea and down into a 50 m wide and 5-6 meter deep subsea channel further into the fjord. These channels are shaped by the surrounding bedrock, which protrudes several places on the seafloor on either side of the channel. Traces of a back scarp from the historic landslide event can be seen on land in the before topography (Pink line in Figure 39B).

In the post-landslide topography, a steep slope is formed in the back of the landslide area and below is an uneven terrain with landslide deposits on the beach, which gradually slopes into the sea (Figure 39C & D). The shoreline (0 m elevation marker from the ETRS 1989 datum) has become more irregular and has progressed relatively higher into the landslide area in the northwest. Large masses from the seafloor below the landslide back scarp are gone and two channels from the landslide area merge into the subsea channel seen in the pre-topography. This subsea channel has now become longer and 5-10 m deeper. In the south part of the landslide area, a steep back wall is followed by a weakly dipping surface at about eight m.b.s.l. A similar surface at the same depth can be seen further east (Arrows in Figure 39D).

Figure 39 A) Hillshaded DEM-files of the study area before the landslide. B) Hillshade with Bathymetry contour (from 0 m asl and below). C) Hillshaded DEM-files of the study area after the landslide. D) Hillshade with Bathymetry contour (from 0 m asl and below) and terrain contour of the study area after the landslide. The arrows point at potential sliding surfaces at 8 m bsl.

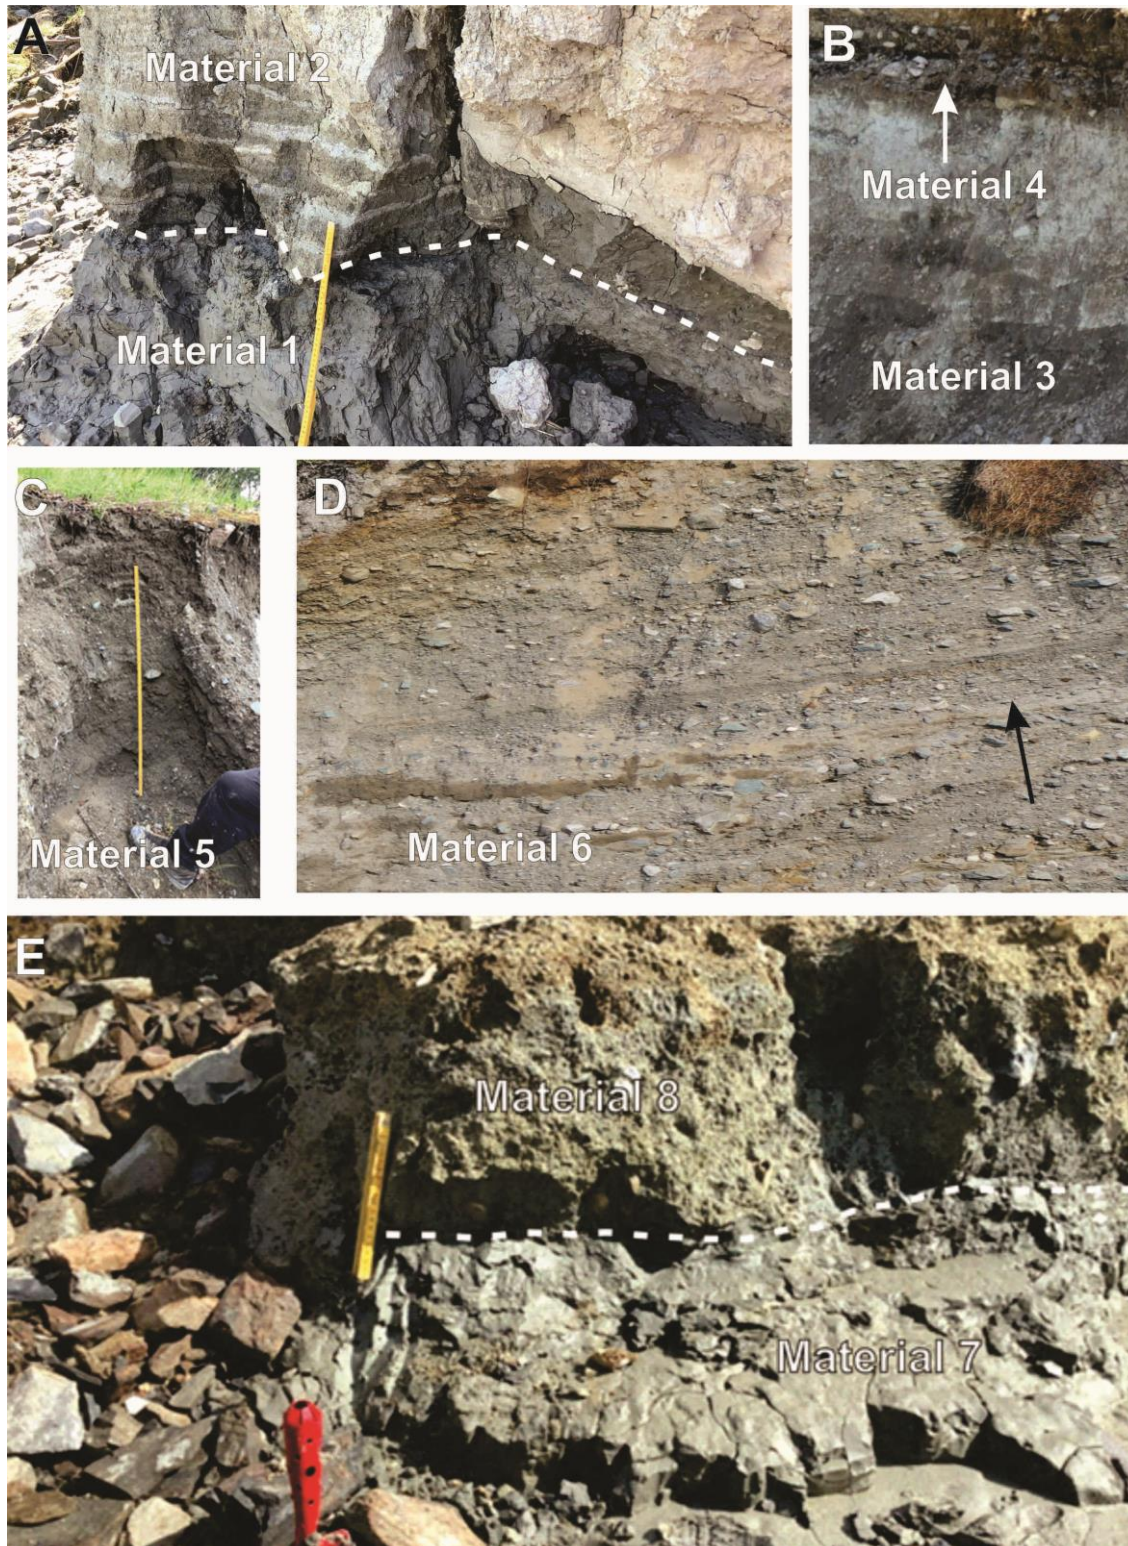
Material 1: Silty CLAY; grey. Soft, very wet, high plasticity, extra sensitive/quick (Figure 40A). Interpreted as marine deposits.

Material 2: Silty CLAY with minor sand; light grey/beige; bedded. Wet, soft, high plasticity, extra sensitive (Figure 40A). Interpreted as marine deposits.

Material 3: Sandy silty GRAVEL, dark grey. Tightly packed; moist; well-graded; subrounded to subangular (Figure 40B). Interpreted as glaciofluvial deposits.

Material 4: Sandy fine to coarse GRAVEL; grey. Loosely packed; dry; well graded; subangular to subrounded, fine to coarse sand (Figure 40B). Interpreted as glaciofluvial deposits.

Material 5: Gravely SAND; Greyish brown; bedded loosely packed; moist (Figure 40C). Interpreted as glaciofluvial deposits.

Material 6: Sandy fine to coarse GRAVEL with minor pebbles; brownish/beige; bedded; loosely packed, dry to moist; well graded; thick; rounded to subrounded; sand, fine to coarse (Figure 40D). Interpreted as glaciofluvial deposits.

Material 7: CLAY; bluish-grey; bedded. Very soft, moist, high plasticity, moderately sensitive (Figure 40E). Interpreted as marine deposits.

Material 8: Gravely fine SAND with silt; yellowish brown; massive, medium dense; dry to moist; low plasticity; contains shell fragments (Figure 40E). Interpreted as beach deposits.

Figure 40 The different materials in the landslide area. A) Material 1, silty CLAY and 2, silty CLAY with sand B) Material 3, sandy silty GRAVEL and 4, sandy fine to coarse GRAVEL C) Material 5, gravelly SAND D) Material 6, sandy fine to coarse GRAVEL E) Material 7, CLAY and 8, gravelly fine SAND with silt.

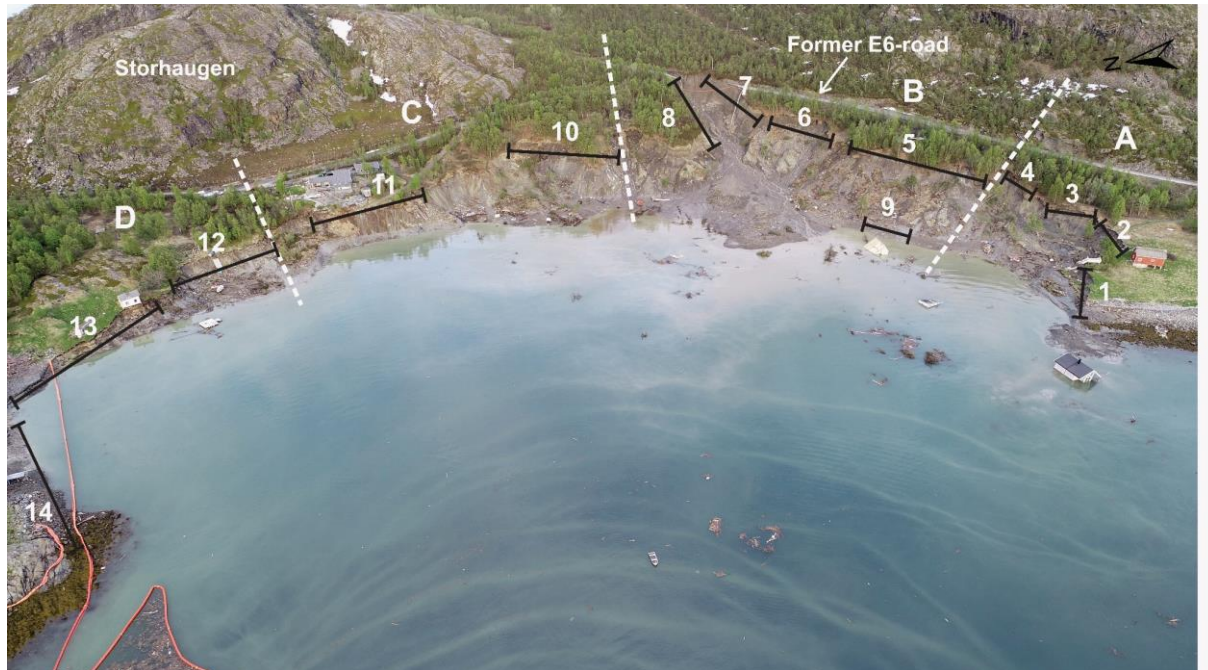
Here the different sections in the landslide area will be described closely. Fourteen different outcrops along the back scarp and floor of the landslide will be described based on fieldwork observations. Figure 41 shows the study area in front of the former E6-road and Storhaugen, with the divided sections and locations of the different outcrops.

Figure 41 Overview of the study area from June 7th, 2020 with sections A,B,C and D and locations of outcrops 1-14 (Photo courtesy of Anders Bjordal, NVE).

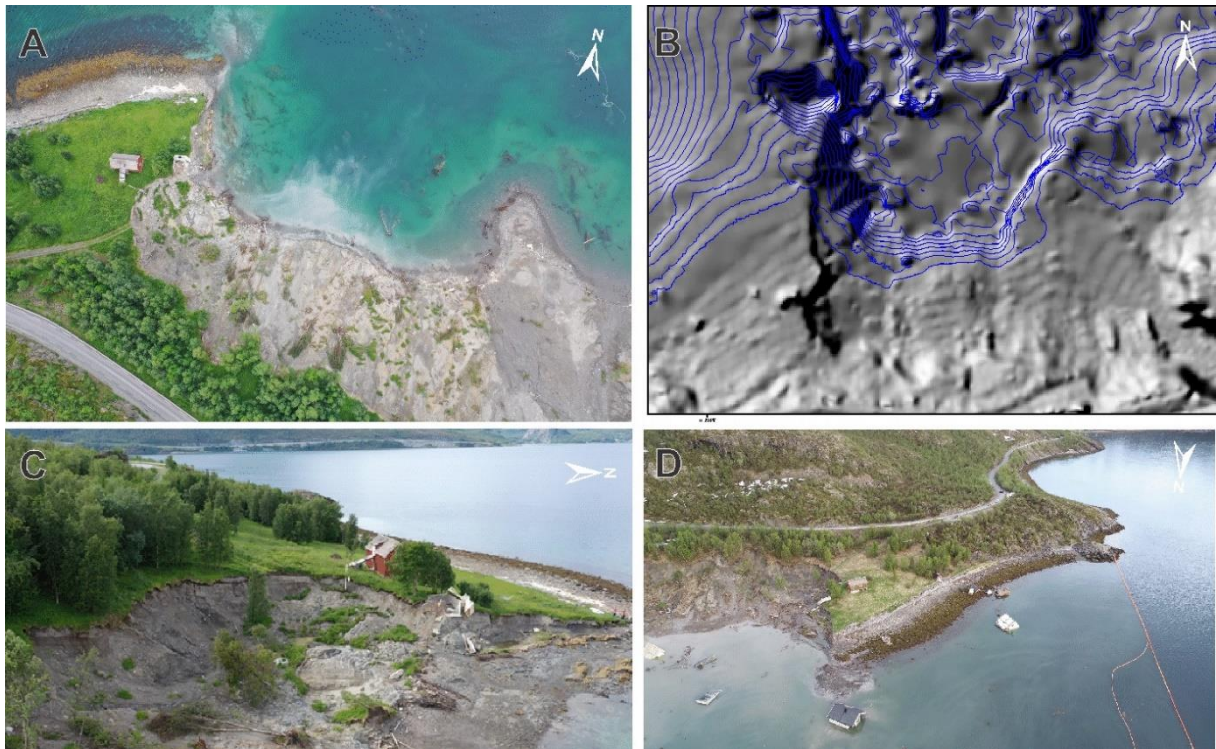
Section A lies in the southwestern part of the landslide area and extends from the westernmost edge of the landslide scarp to the boundary of section B. This section is around 100 m wide from the west towards the east. The back scarp height is up to 11 m asl and has a 40° slope towards the northeast. The beach area consists of blocks of landslide debris up to 10 m long and 7 m wide. Among the landslide debris is vegetation and trees and remains of the house at 470 Kråknes Road that was transported by the landslide (Figure 42). The beach area has a gradual slope of around 10° into the sea. During low tides, a fine-grained, smooth

surface is well exposed at sea level. This section of the landslide area slid out towards the northeast on June 3rd, 2020 .

Figure 42 A) Orthographic overview of the section B) Hillshade based on 1 m DEM (top right) with 1 m contours from bathymetry, a.s.l. C) Drone images from June 7th, 2020 of section A (Photo courtesy of Anders Bjordal, NVE).

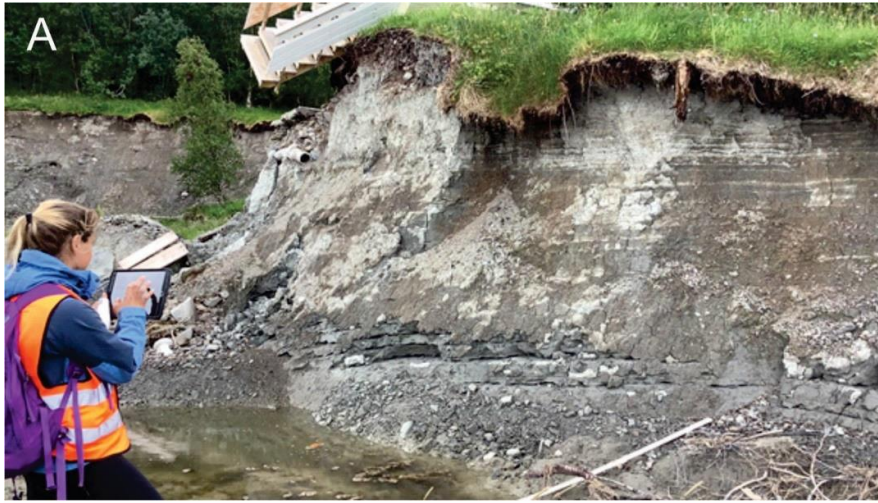
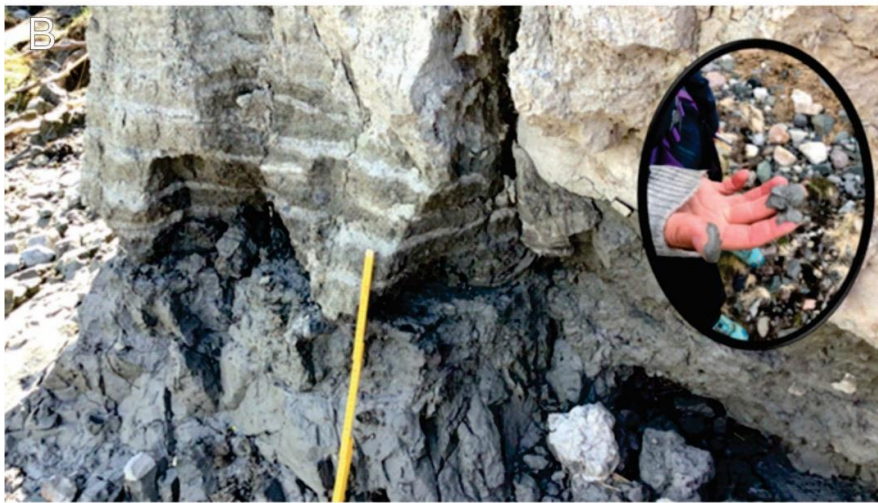
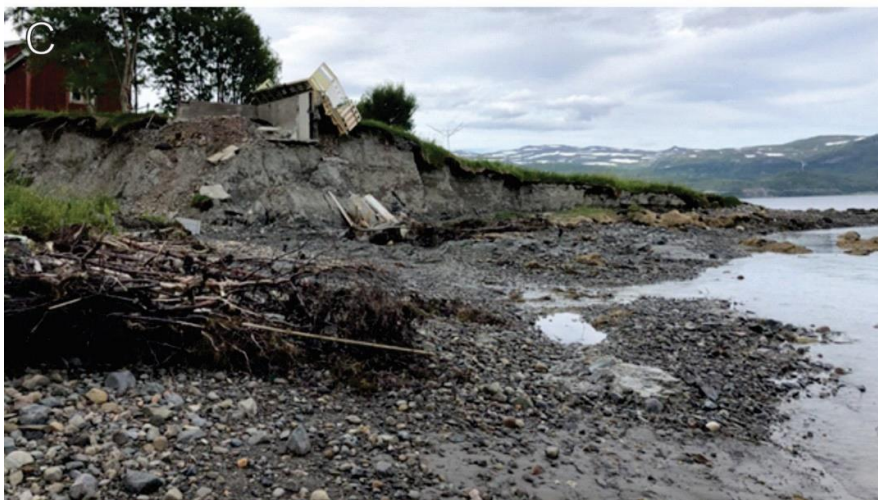
In the eastern part of section A, materials 1 and 2 are exposed in the back scarp (Figure 42A & B). From sea level a 20-40 cm thick layer of material 1 is exposed, with a 50-100 cm thick bedding of material 2 above. Topsoil and vegetation mantle the scarp. Nearby the remains of the house at 470 Kråknes Road can be seen above the scarp (Figure 43

A). Some vegetation, landslide debris and rounded cobbles (likely glaciogenic) are deposited below the scarp. During low tides, bedding surfaces of clay (Material 1) are exposed along the shoreline due to landslide debris being washed away by waves. The surface has a gentle dip towards the north into the sea (Figure 43C).

Figure 43 A) Outcrop 1 in section A with bedding of Material 2 and 1. B) Bedding of Material 2. Inset: Material 1 when remolded between fingers. C) Material 1 surface exposed during low tides.

More of material 1 and 2 beddings are exposed in the back scarp further east in the outcrop and the height of the back scarp increases up to 5-6 m asl. The beds in this outcrop has a dip from 8-16° in the southeast direction dips in the southeast-. Rounded to sub-angular glacio-genic cobbles, boulders, trees, vegetation, and house remains are scattered across the beach in the release area. Some almost intact blocks of clay (Material 1 and/or 2) can be seen within the debris (Figure 43C).

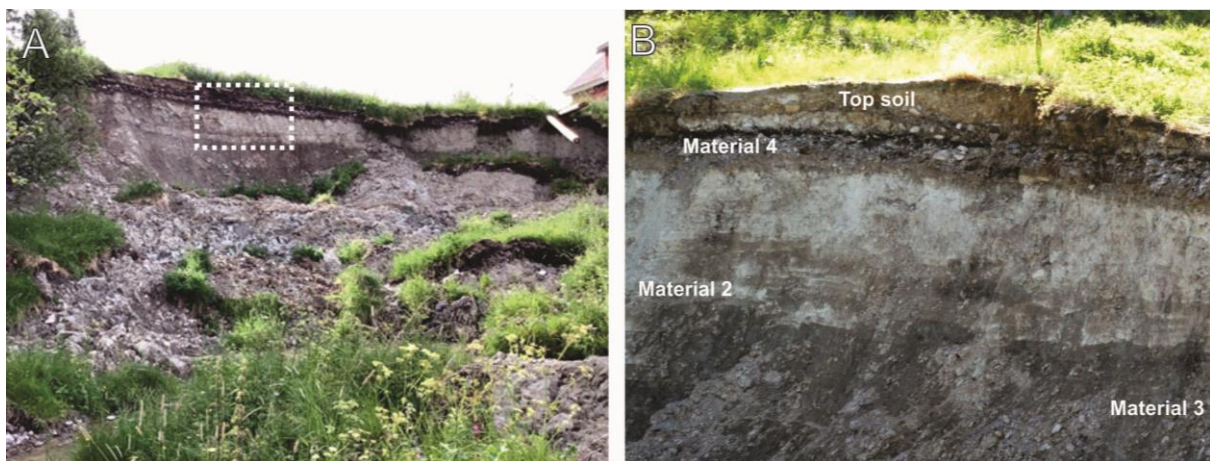
Outcrop 2 is located east of outcrop 1 (Figure 44A). Here the back scarp and materials are interpreted from a distance and through pictures. At the bottom of the scarp is 2-3 m of a dark colored layer of material 3. Above material 3 is a series of 0.5 to 1 m thick layers of clay, silt, and sand, interpreted to be the same as or similar to material 2. This layer is dry compared to the moister and darker colored material below. At the very top of the back scarp is a 20-30 cm thick layer of material 4 and topsoil (Figure 44B).

Figure 44 A) Gravel, Material 2 and 3 in the back-scarp of Outcrop 2. B) Close-up of the dashed square in A.

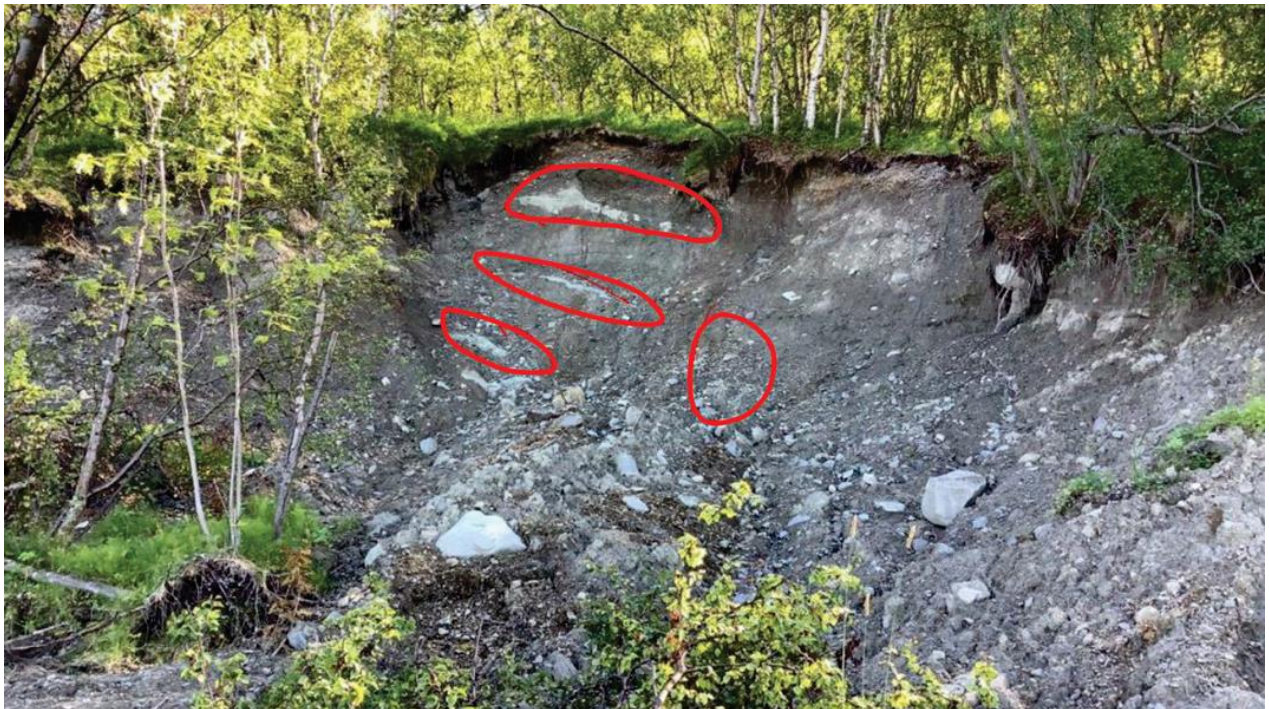
Outcrop 4 is located on the border to section B. Landslide deposits of gravel, angular boulders and vegetation are deposited beneath the well-exposed back scarp. The back scarp mainly consists of bedrock covered with thin layers of fine-grained sediments (Figure 46). The bedrock surface has an average dip of 24° with a W-NNW dip-direction. Similar bedrock measurements can be found in foliation east of this outcrop, in the bedrock exposed above the landslide area and the Kråknes road.

Figure 46 Outcrop 4 with areas of exposed bedrock marked within the red circles.

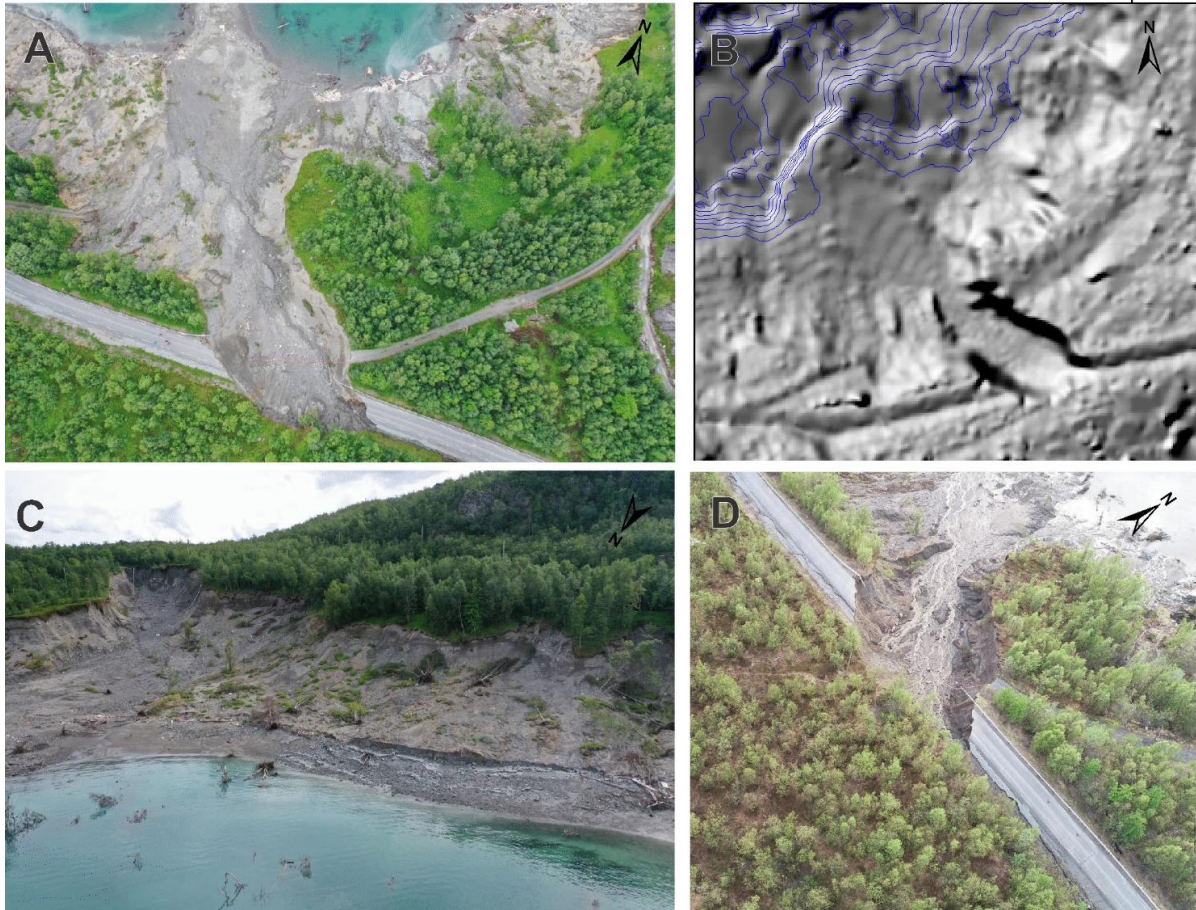
Section B (Figure 47) is north of section A with a back scarp that stretches 230 m from the southwest towards the boundary of section C in the northeast. The landslide area in this section stretches from the shoreline and all the way up to the former E6-road at 38 m asl. The majority of this section slid out on June 4th when the landslide event started, but the upper part of the section, which took parts of the former E6-road, slid out on June 5th and June 6th, 2020.

Figure 47 A) Orthographic overview B) Hillshade based on 1 m DEM with 1 m blue bathymetry contours, C) Drone photos from July 27th, 2020 D) Drone photo from June 7th, 2020 (Photo courtesy of Anders Bjørndal, NVE).

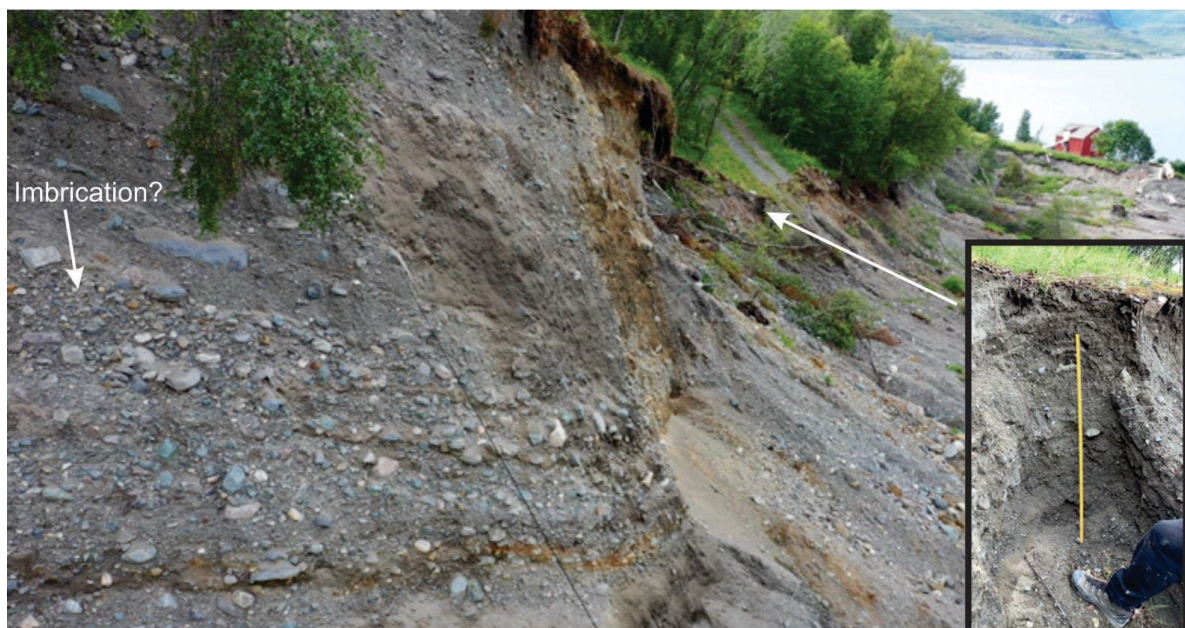
Outcrop 6 is a small outcrop seen through a close-up of the scarp from drone photos (Figure 49). Here the scarp mainly consists of a thick deposit of material 6 with beds dipping northwest. Within material 6 there are small cobble-sized rocks oriented with their oblong side in the dipping direction and seem to overlap each other in a consistent fashion. This orientation may resemble imbrication from a fluvial environment. By the tractor road in Figure 46, a soil sample was collected and classified as material 5. Based on these observations with the finer-grained material below coarser-grained bedding and the presence of imbrication, the deposits are likely to have been deposited in a glaciofluvial delta. The orientations of the beds also fit well the direction of the ice during YD (Figure 10).

Figure 49 Outcrop 6 with thick deposits of material 6 and imbrication. Close-up of material 5 by the tractor road.

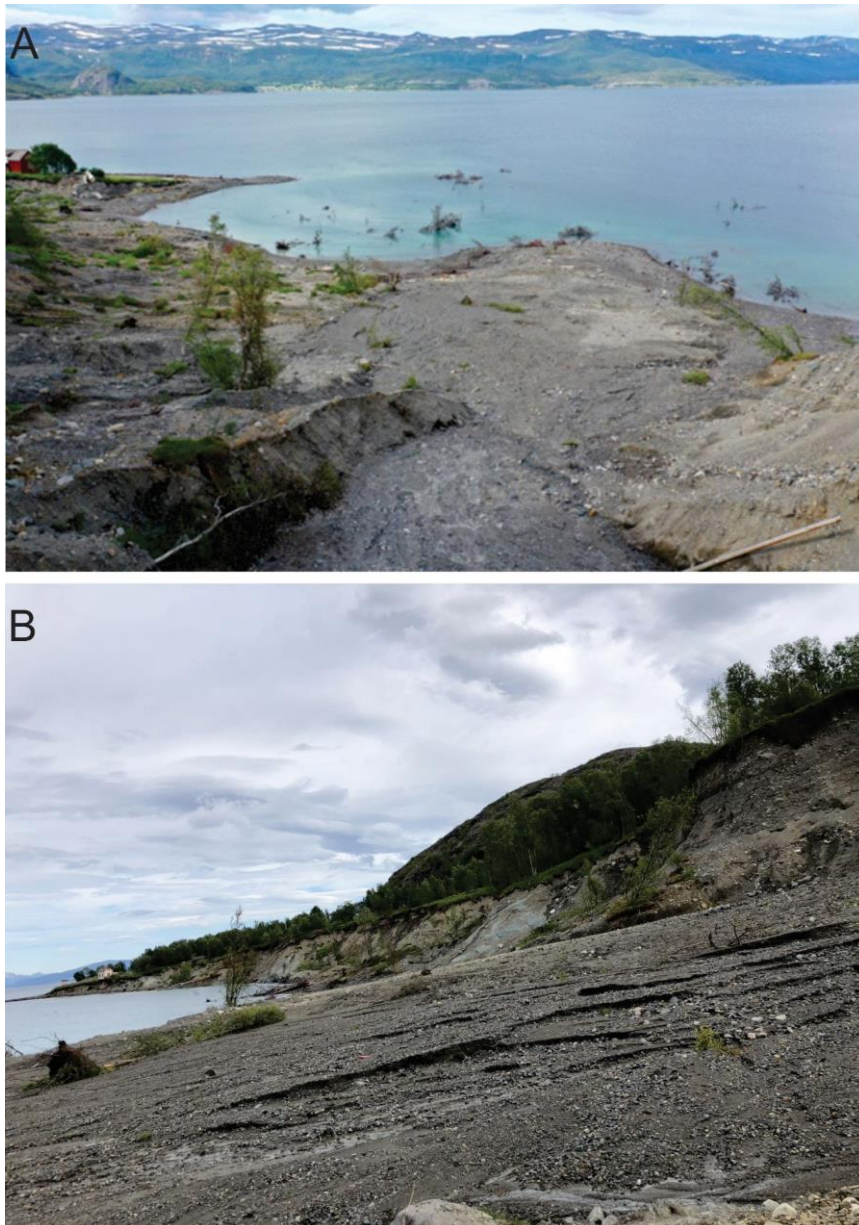
Between outcrop 7 and 8 is a fine-grained surface from about 30 m asl towards the sea in the northwest with a gradual slope of 10-15° (Figure 53A). On this surface are small braided channels of water streams from the back of the landslide area into the fjord. Some dry stream channels can also be seen (Figure 53B). Talus, landslide debris and vegetation have been deposited on the beach between the back scarp and the sea, and vegetation can be seen floating around in the fjord (Figure 53A).

Figure 53 A) View of landslide area towards the west. B) Stream channels in clay covered by thin layers of silt and sand.

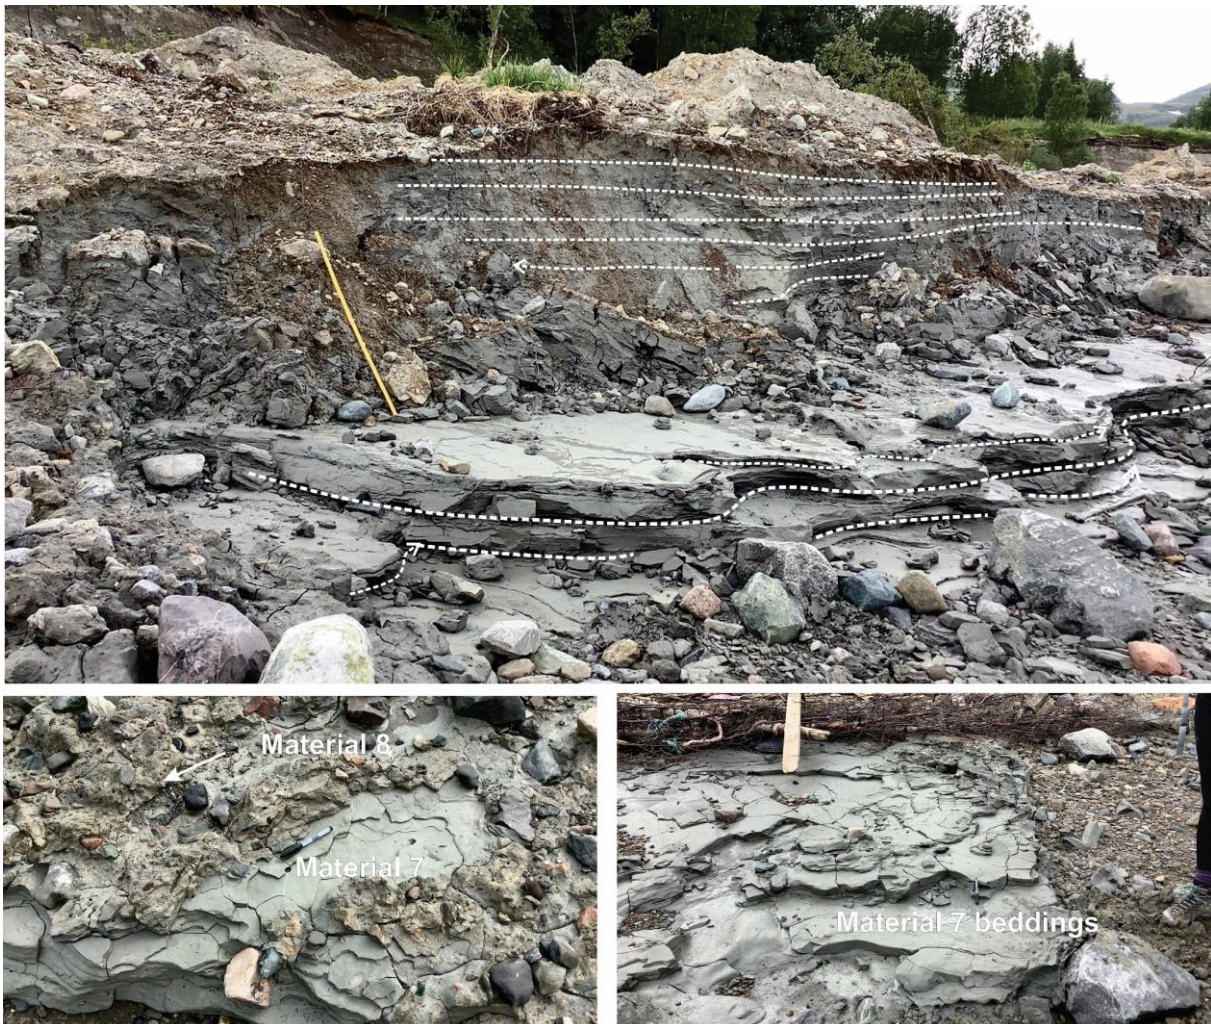
Outcrop 9 is exposed during low tides towards the northwest. It stretches 5-7m from the east towards the west and consists of a 1-1.5 m high in-situ scarp (Figure 54). The scarp consists of material 7 with beach deposits (likely material 8) on top and has stair-like morphology. The bedding has a dip from 6-9° in NW-NNW dip-direction and has cracks from being exposed to the sun.

Figure 54 Outcrop 9 of the scarp with clay/silt beddings covered with beach deposits that are exposed during low tides.

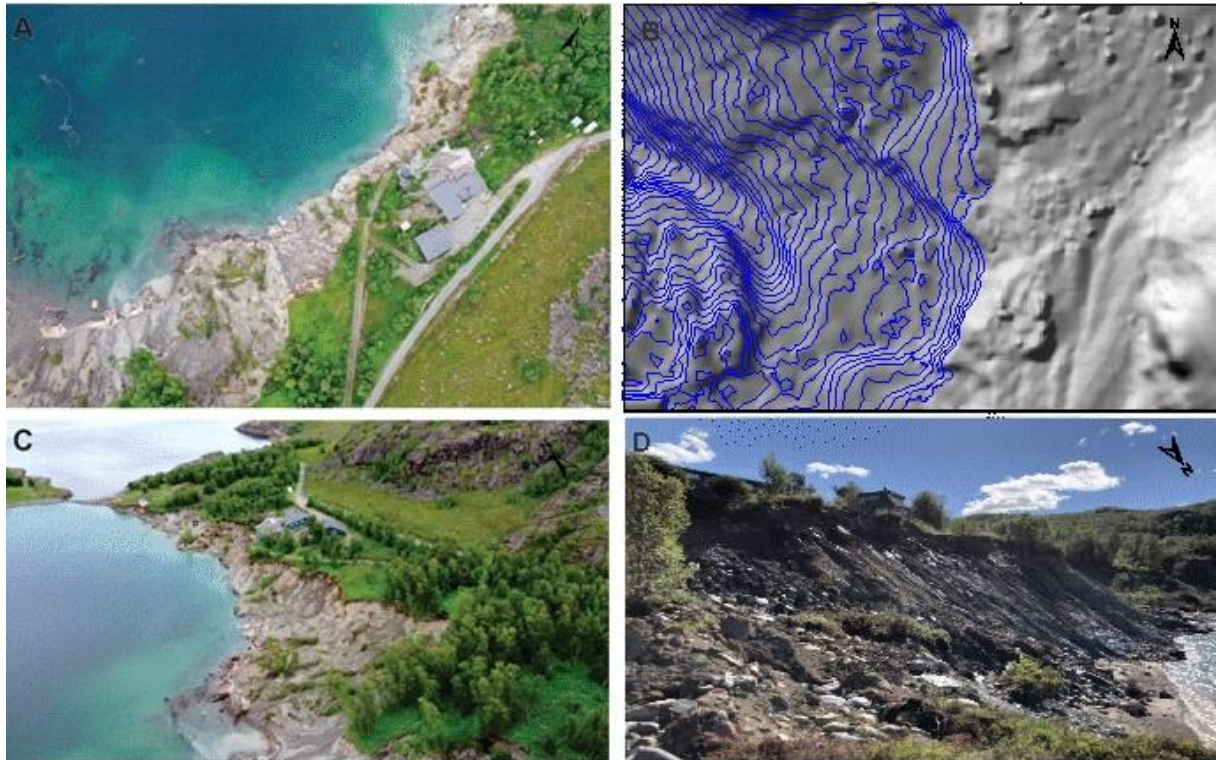
Section C is located north of section B and stretches around 200 m from north to south. This is the section in which the landslide started on June 3rd, 2020. The back-scarp in this section has a height up to 8 m from sea level and has a slope ranging from 30-50° (Figure

55). Storhaugen, east of the section, consists of very fractured bedrock that also can be seen within the landslide back scarp. Right above the back scarp is a blue house located safely on top of bedrock, where a resident watched the landslide as it occurred.

Figure 55 Section C. A) Perspective overview of sections C from July 27th, 2020. B) Hillsahde from 1 m DEM-files with blue contours of bathymetry. C) Drone photo from July 27th, 2020. D) Picture from fieldwork on July 27th, 2020.
