Reconstruction of the Kråknes landslide event, Alta.

Stina Mari Pettersen

GEO-3900 *Master's thesis in Geology, May 2021.*

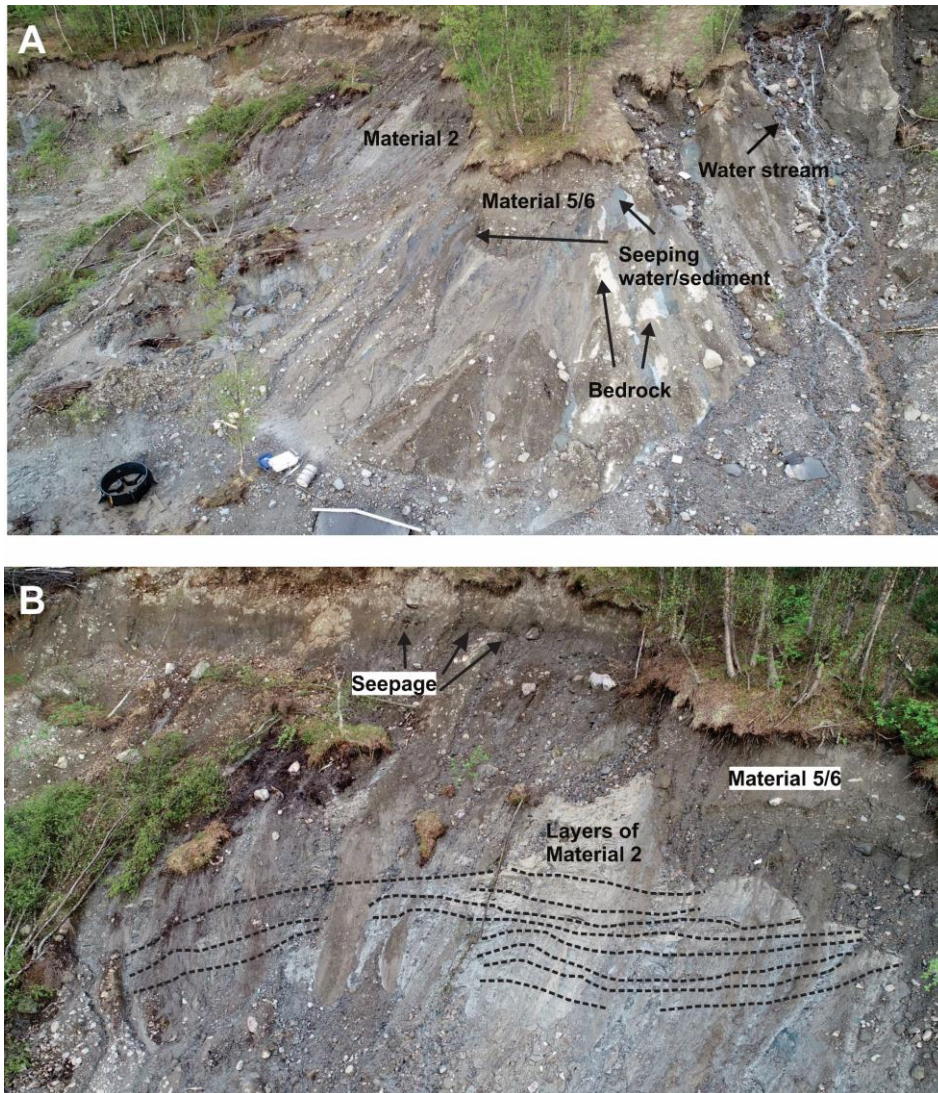
Outcrop 10 is located in the south part of section C at the border of section B. It includes about 40 m of the back scarp with a dip of about 40° towards the northwest into the sea. The back scarp mainly consists of bedrock covered with thin layers of fine-grained sediments and debris at the bottom. Above the bedrock is a 30-50 cm thick layer of or similar to material 2 with 50-60 cm thick layers of sand and gravel (possibly material 5 or 6) on top. In some parts of the back scarp are thin layers of clay/silt that seem to cover the bedrock (Figure 56B). Several places in the scarp there are moist areas within the gravel or in the boundary between the fine-grained and coarser-grained soils. In several places there is seepage of water and sediments between the bedrock and soil layers (Figure 56A). A stream of water running down the back scarp is also present in this area (Figure 56A).

Figure 56 A) Outcrop with sand/gravel, layered clay/silt and rock. B) Close-up of the soils in A with layers of material 2. The arrows are pointing out areas where there is/have been seeping of water and sediment (Picture courtesy of Anders Bjordal, NVE).

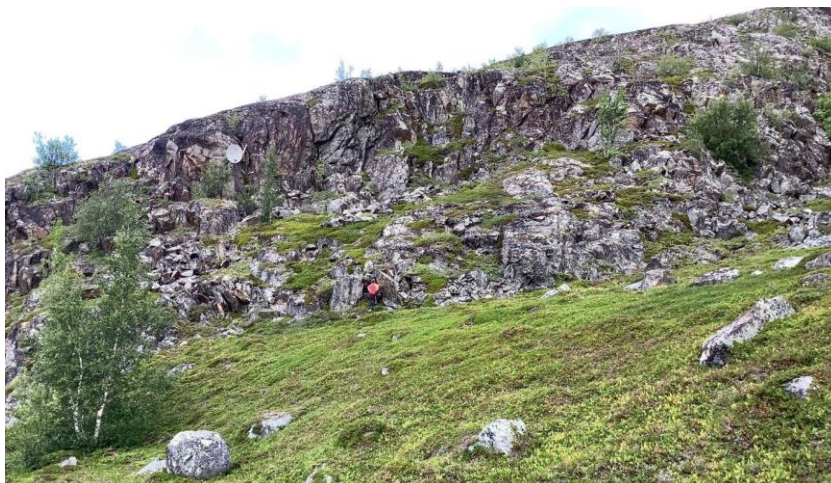
Behind outcrop 11 and the blue house, there is a fractured bedrock with an average foliation striking NNW-SSE with a 15° dip (Figure 58). This foliation is cut by E-W striking faults (See chapter 4.2).

Figure 58 Fractured bedrock at Storhaugen, east of section C.

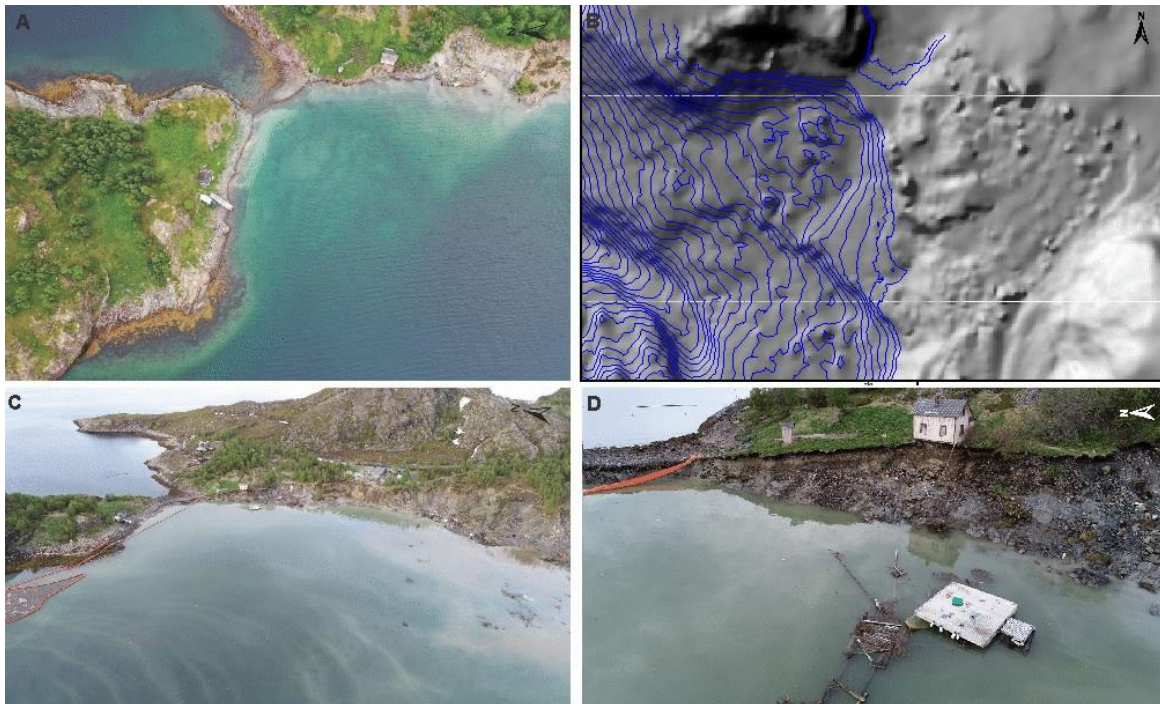
Section D is the northern part of the study area and follows the scarp for 170 m from the border of section C in the southeast towards the northwest. The scarp height in this area varies from 1 to 10 m asl and faces the south and the southwest (Figure 59). Parts of the landslide in this area occurred underwater, and therefore, the back scarp is not well exposed in most outcrops. This section of the study area slid out after section C on June 3rd, 2020 and destroyed parts of the dock located in the section.

Figure 59 Section D A) Orthographic overview of the section. B) Hillshades based on 1 m DEM with 1 m blue contour of bathymetry. C) Drone image from June 7th, 2020 (Photo courtesy of Anders Bjordal, NVE). D) Close up of scarp below shed in the section from June 7th, 2020 (Photo courtesy of Anders Bjordal, NVE).

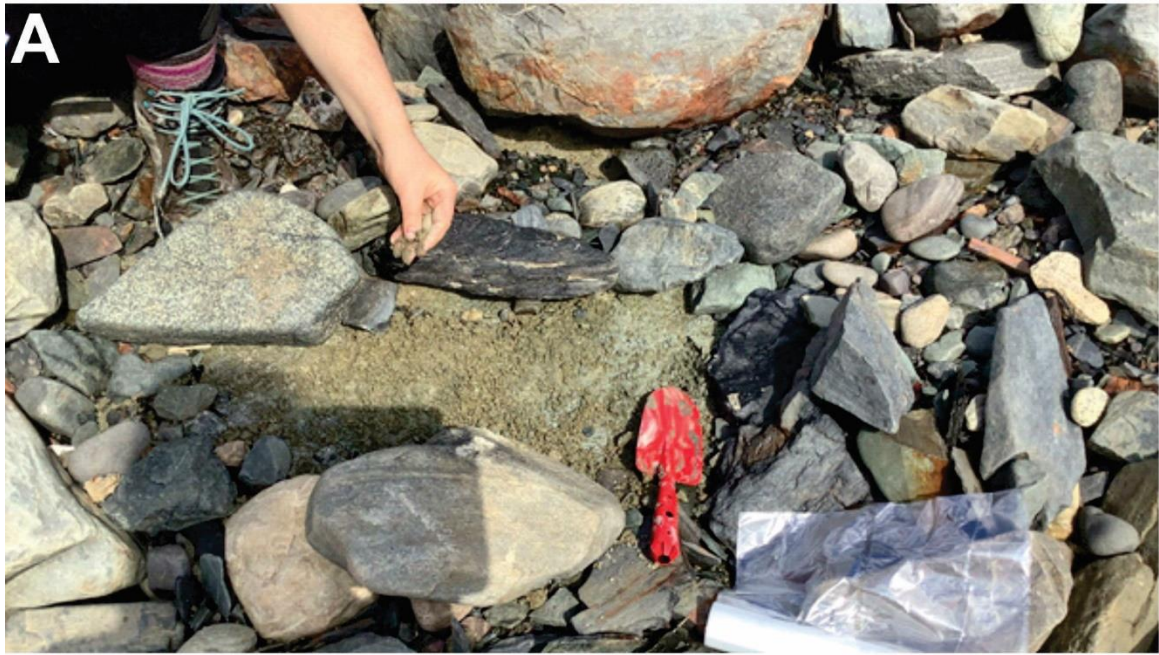
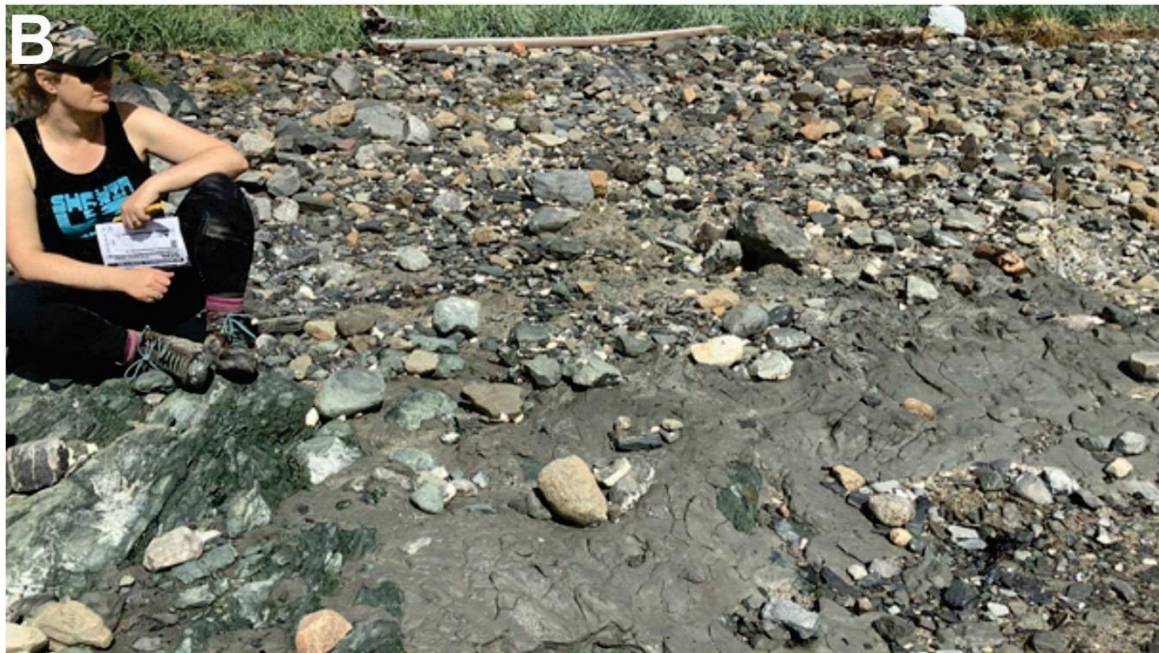
Figure 64 Outcrop 14 A) Material 7 and 9 between cobbles and boulders. B) Material 7 covering bedrock.

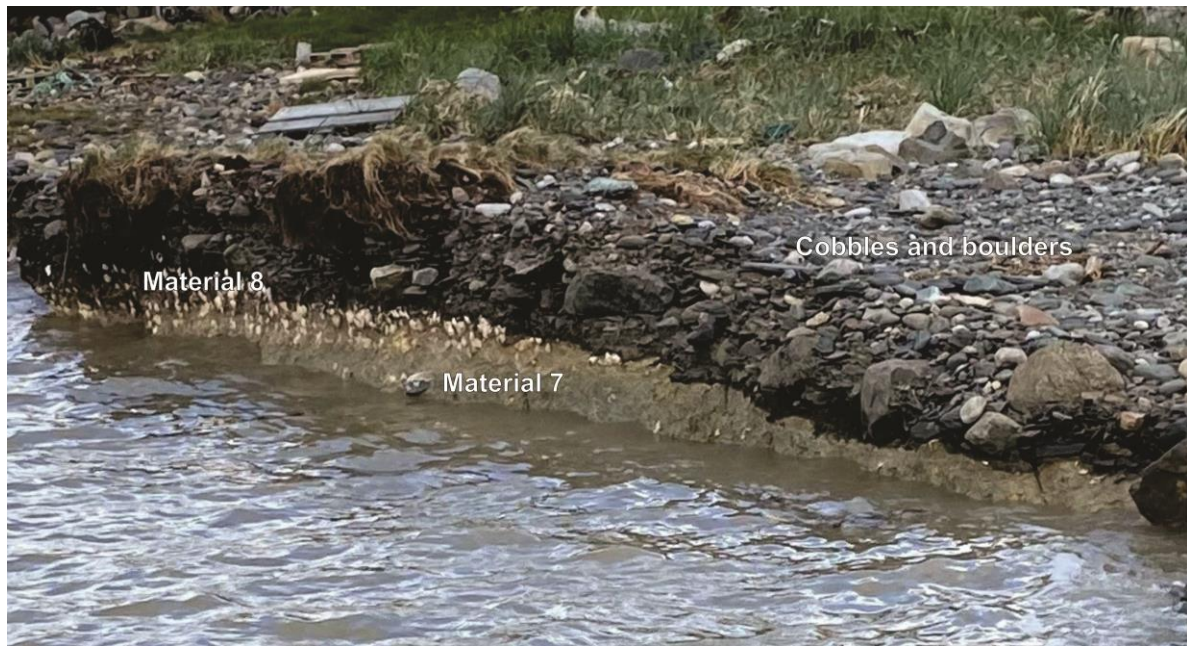
Outcrop 14 is in the most northern part of the study area on a little peninsula and stretches 30-40 m from southeast to northwest. The scarp in this outcrop is facing south and is barely exposed even during low tide. This part of the landslide slid out mainly underwater and destroyed parts of the dock (Figure 63). The outcrop mainly consists of bedrock, which is covered by vegetation and subangular to subrounded cobbles and boulders. Underneath and in between the cobbles and boulders are deposits of silt or a material similar to material 8 (Figure 64A). A thin layer of material 7 with drought cracks covers the bedrock located close to the dock (Figure 64B). The top of the barely exposed back scarp consists of materials 7 and 8 with cobbles and boulders on top (Figure 65).

Figure 65 Top of the back scarp in outcrop 14 that can barely be seen above water during low tides.

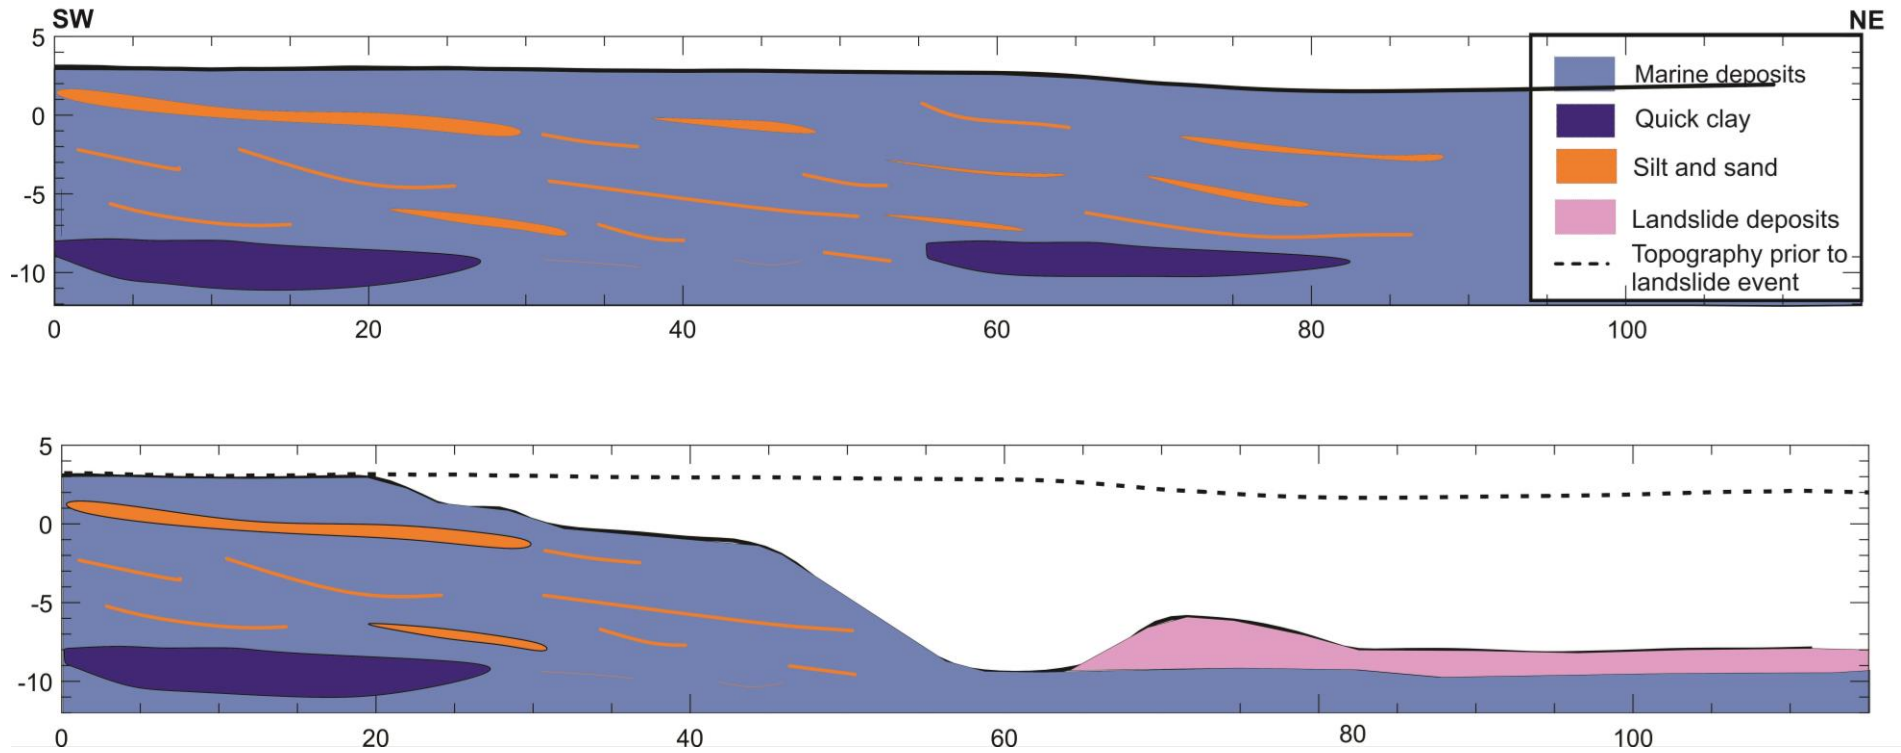
Cross-section A-A'

Figure 69 Cross-sections A-A' from before (upper) and after (lower) the landslide..

In the bathymetry, there is a sliding surface at 8 m bsl, which can also be seen in cross-section A-A'. Here the landslide deposits from block 11 are deposited on top of the sliding surface, supporting that the slide below sea was triggered before block 11 and supported by the stair-like morphology in cross-section A-A'. During the next two days after initiation, block 12 and 13 fail at the top of section B as explained in the first scenario.

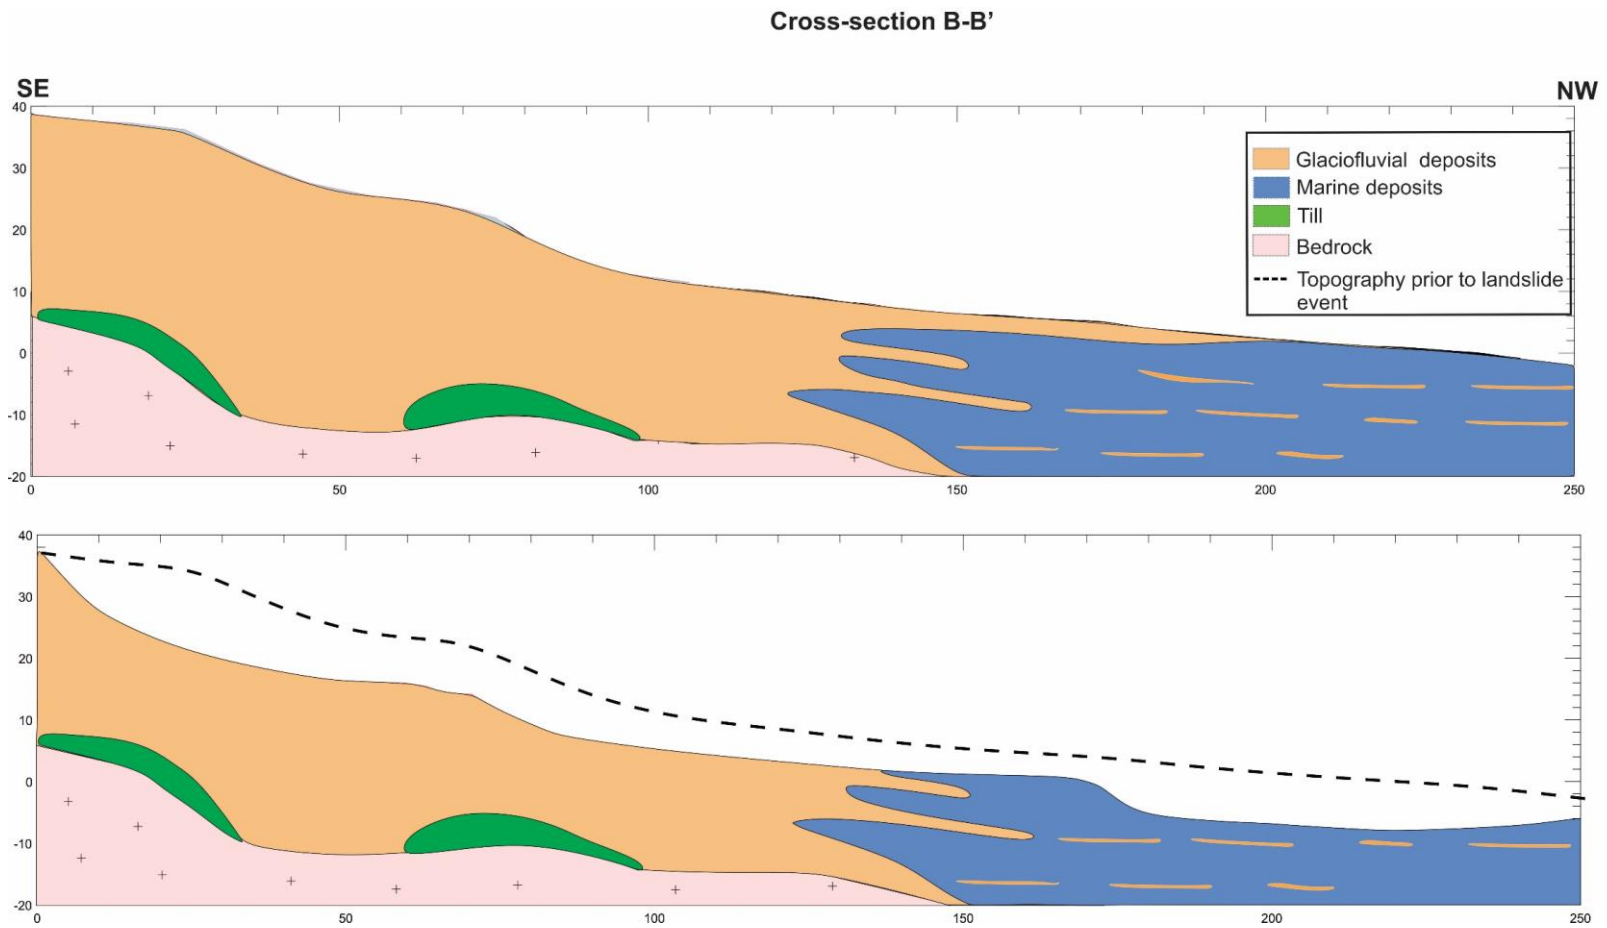
Figure 70 Cross-sections B-B' before (upper) and after (lower) the landslide occurred.

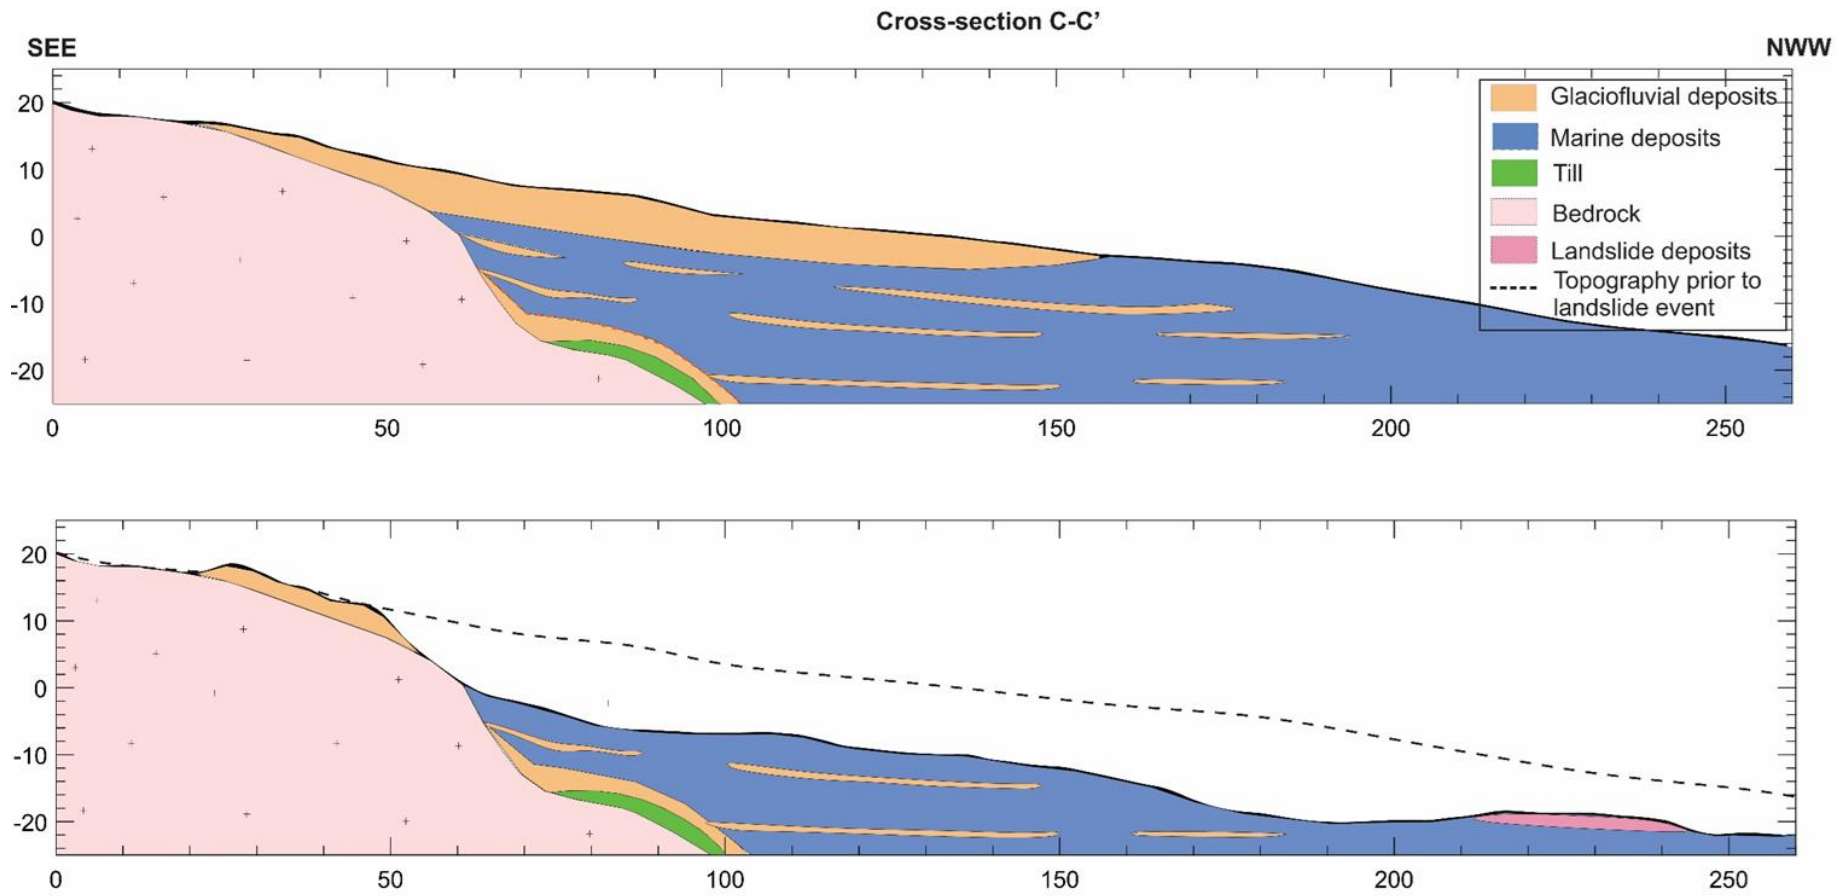
Cross-section C-C' from section C (Figure 71) has similar deposits as seen in cross-section B-B' with bedrock covered with till, marine deposits and glaciofluvial deposits. The cross-section stretches 250 m from the southeast towards the northwest. The illustrated layers are based on the closest located core sample (12) and the observations in the back scarp from a distance during fieldwork and drone photos (See chapter 4.1.3). Bedrock is well exposed in the southeast, providing a foundation for a house at the top of the scarp. The bedrock has a steep slope towards the northwest as it is exposed in the back scarp around sea level after the landslide event. The presence of till has not been observed but is interpreted to be deposited on top of the bedrock based on the up to 4 m thick layers with high probing resistance above the bedrock during geotechnical investigations. Clay/silt (Possibly material 2 or 7) that covers the bedrock in the back scarp is interpreted as marine deposits with smaller layers of sand and gravel grains in between. The marine deposits are covered with coarser-grained layers, which can be seen traced through section C to section B, and are interpreted to be the same glaciofluvial deposits seen in section B (Material 6).

The morphology in cross-section C-C' from before the landslide event has a weakly dipping slope around 10° towards the northwest. After the landslide occurred, a “stair-like” morphology was created. The morphology between the 70-170 meter marks in the post landslide section could be deposited from landslide masses further upslope, or it could be a potential sliding surface or a combination of both.

Figure 71 Cross-section C-C' before (upper) and after (lower) the landslide.

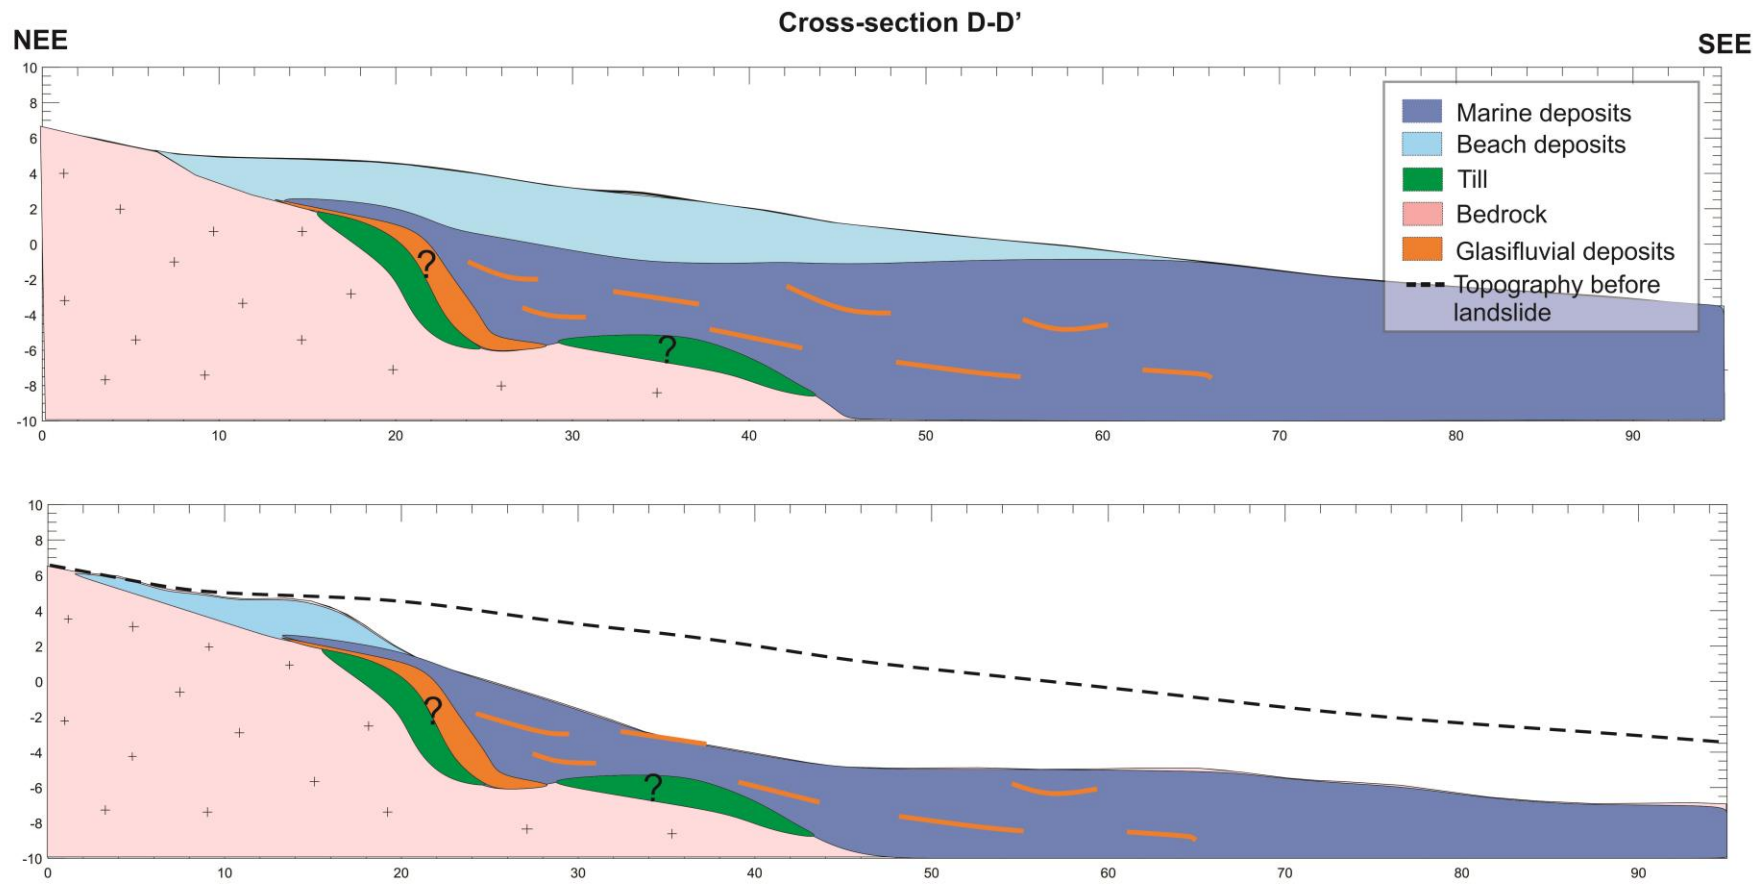
Cross-section D-D' is from the northern part of the study area in section D (Figure 72). The cross-section stretches about 100 m from the northeast east towards the southwest west and mainly consists of bedrock, marine deposits, beach deposits and possibly glaciofluvial deposits and till. Before the landslide occurred, there was a weakly dipping slope throughout the cross-section. After the landslide, the morphology is steeper but still gradual towards the sea with a surface at 8 m bsl that seems similar to possible sliding surfaces seen in the post-landslide topography in sections A and C (Figure 39D). The bedrock is considered to be uneven and steep. Even though the bedrock is not exposed in the back scarp in this cross-section, it can be seen in several places within the back scarp further south in section D (Outcrop 12). Based on field observations the gravel and sand deposits are classified as beach deposits because it is unsorted and consists of shells and shell fragments (see chapter 4.1.4). The beach deposits are deposited on top of clay and silt interpreted as marine deposits.

Figure 72 Cross-section D-D' before (upper) and after (lower) the landslide.

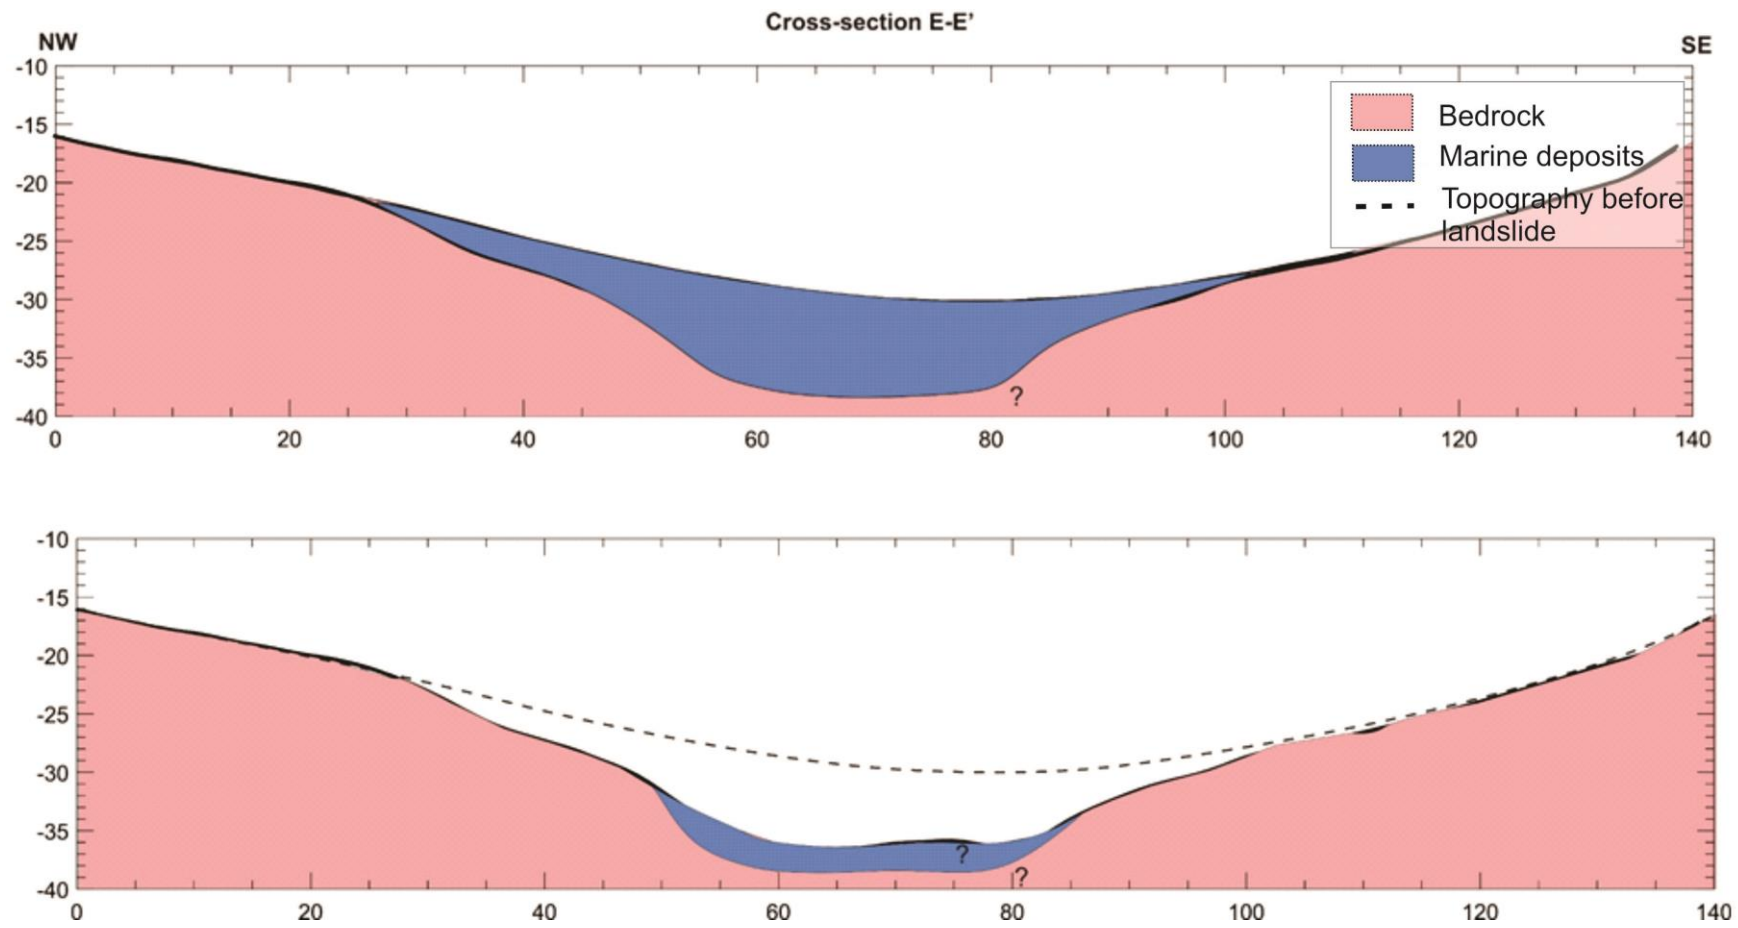
Cross-section E is of the seafloor right outside of Kråknes (Figure 73) and stretches 140 m from the northeast to the southwest. Because this cross-section is located underwater and there are no seismic data accessible for this study, the cross-section is mainly based on the provided DEM-files and surrounding deposits. The cross-section crosses the subsea channel seen in the topography map (Figure 39B & D) and based on the protruding bedrock on each side of the channel, it is interpreted as the section mainly consists of bedrock which shapes the morphology. The bottom of the channel is interpreted to be filled with fine-grained deposits (Material 7). Before the landslide, the bottom of the channel was at about 30 m bsl and due to the erosion from the landslide mass, the depth increased by 5-6 m.

Figure 73 Cross-section E-E' before (upper) and after (lower) the landslide.

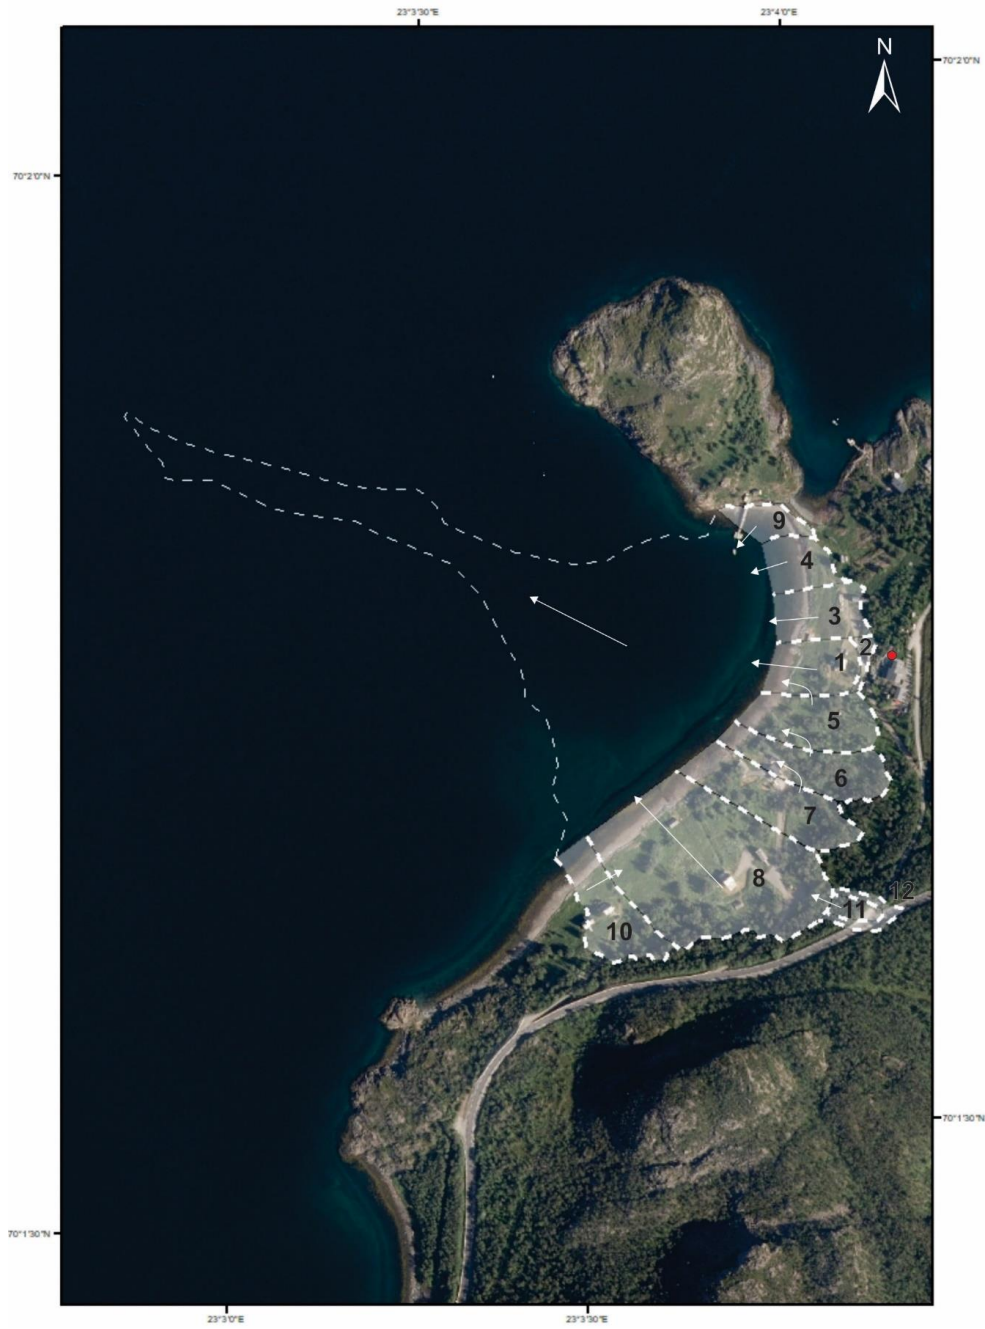
An eyewitness has described the landslide's sequence of events based on what he saw on the day the major landslide event started. Figure 74 illustrates the sequence of events based on the eyewitness who witnessed it all from his house, safely located on bedrock (The red circle in Figure 74). The landslide area is divided into 12 different blocks, which are numbered in the order the masses slid out. The eyewitness was working outside of his house when the electricity disappeared as power cords are pulled out of the house towards the sea. He then witnessed his childhood home (block 1) sink into the sea and his dog and the doghouse (block 2) followed 10-15 seconds after (Gylland et al., 2021). Blocks 1-7 slid out consecutively from around 3.15 pm on June 3th 2020, while blocks 8 and 9 followed shortly after. At 4.20 pm the same day, block 10 slid out. A few days later on June 5th, parts of the former E6-road were destroyed as block 11 slid out, according to NVE. On June 6th, block 12 is the last slide to be initiated.

It is not certain that block 1 in Figure 74 is in fact the initiating landslide, as it is possible the landslide event was initiated below sea level or other places which the eyewitness would not be able to see. However, the eyewitness did not observe any bubbles or strange activity in the sea prior to the landslide.

After blocks 1-9 (Figure 74) had failed, the coast guard came to Kråknes by boat to inspect the area on June 3rd. As a small boat came up close to the landslide area, the crew explained that the water below them suddenly started to disappear and that the boat “fell” down. Shortly after, the sea level started to rise again and the crew later witnessed the failure of block 10. This episode could have been caused by an underwater landslide, where the seafloor failed and caused a sudden drop in sea level.

Figure 74 Map of the sequence of the landslide event. The numbers indicate in what order the area slid out. The red circle is the location of the eyewitness on who this reconstruction map is based on. Arrows show sliding direction (Based on the information provided by Anders Bjordal from NVE during fieldwork).

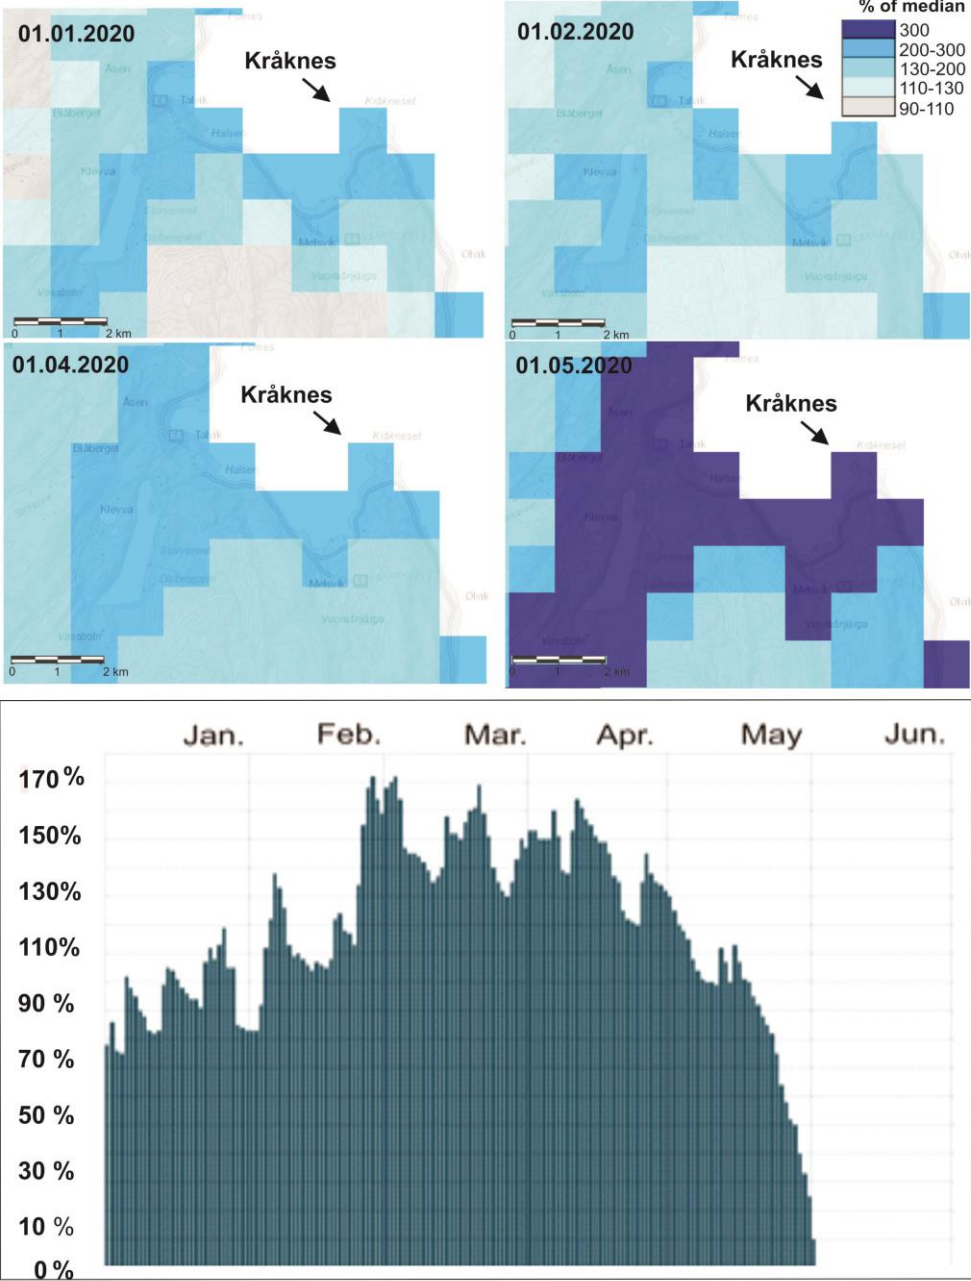
In the winter season in 2020, the percentage of snow or water equivalent in the surrounding area of Kråknes was 90-300% of the normal value (Geodata AS, 2020). The normal value is the median value in the time period from 1991 – 2020. In Figure 79, the amount of snow from January to June 2020 is illustrated based on the median value. On May 1st the data shows that the amount of snow at Kråknes was up to 300% of the median value. However, data from the metrological institute shows that the maximum snow depth was around 170 cm in February and March 2020, before the snow depth started to decrease in April and May (Metrologisk Institutt, 2020). From May 1st to June 1st the snow depth dropped from a total of 130 cm to only 10 cm, implying a large and rapid snowmelt event (Figure 79). Similar

amounts of snow have not been recorded in the month of May in this area since 1996 (Geodata AS, 2020).

Figure 79 Illustration of the percentage of snow surrounding the study area January-May 2020 (Geodata AS, 2020). Graph of the snow depth in cm (Metroligisk Institutt, 2020).

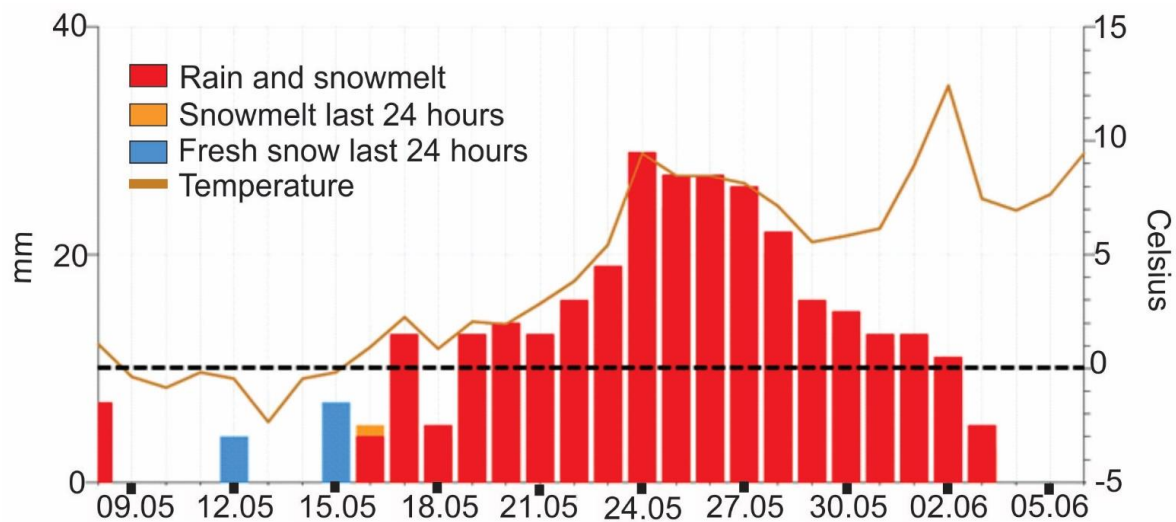
In the days prior to the landslide event, hydrometric data from Geodata AS (2020) show that there was an increase in snowmelt in the area surrounding Kråknes. On May 24th the temperature increased, and 28 mm of rain and meltwater was recorded in the area. The day the landslide event started on June 3rd, only 5 mm of rain and meltwater were recorded (Figure 80). In this time period, there were insignificant amounts of rainfall in the area; therefore, the supplied water is considered to be meltwater.

Figure 80 Graph showing the temperature and the amounts of rain and snowmelt from May 9th- June 5th, 2020 (Geodata AS, 2020).

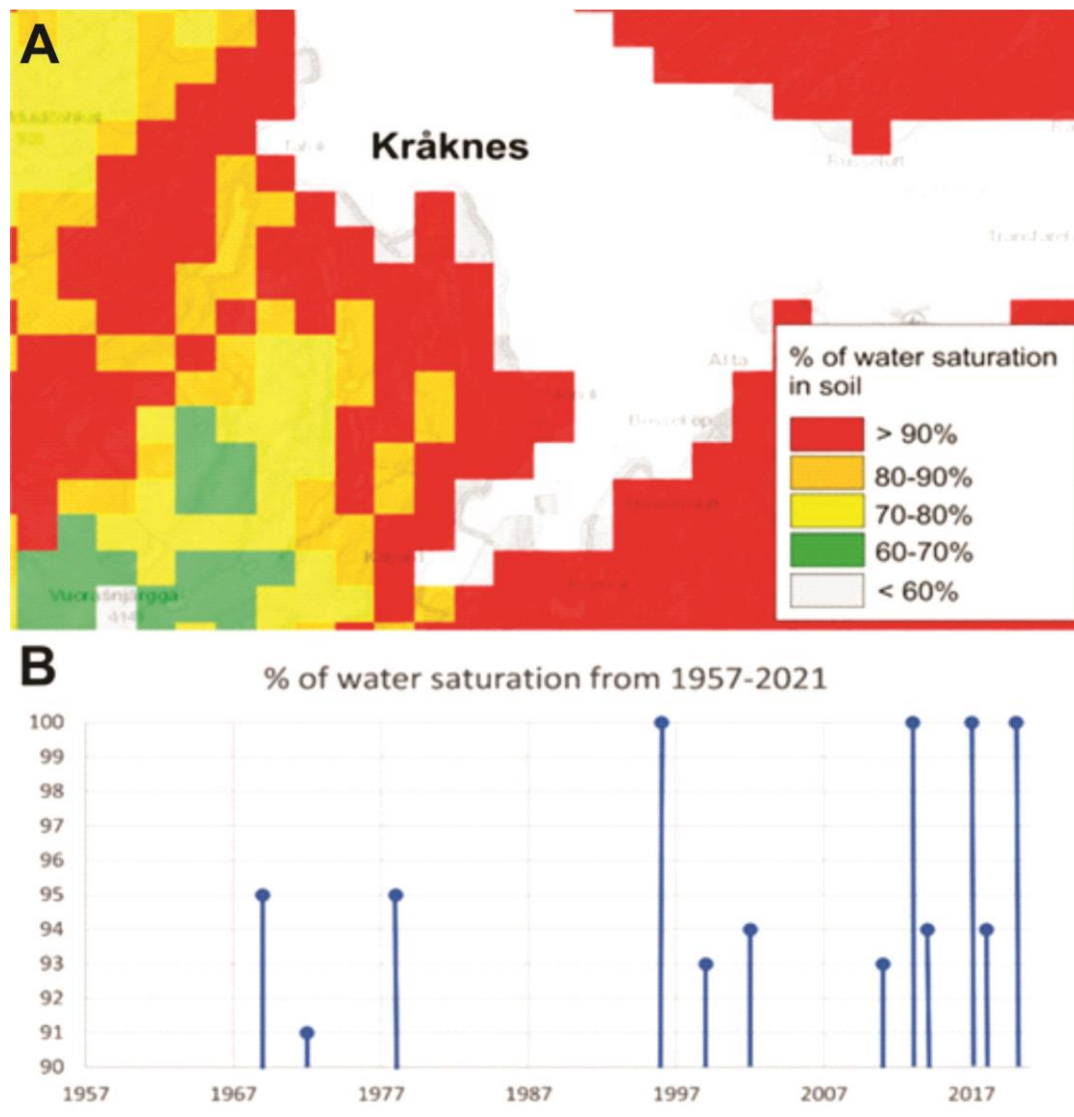
Simulated data of the percentage of water saturation in the soil from senorge.no show that the soil in the Alta area was 100% saturated on the day the landslide event started (Figure 81A). Historical data from 1957 until 2020 show that the water saturation has only been this high on four occasions during this time period (Figure 81B). In 1996, 2013, 2014 and 2017 the water saturation was close to 100% or more compared to reference years between 1981-2010. These values were all related to snowmelt during springtime (Gylland et al., 2021).

Figure 81 A) The percentage of water saturation in the soil at 8 am, June 3rd, 2020 (Geodata AS, 2020) and historical years with more than 90% water saturation (Geodata AS, 2020; Gylland et al., 2021).

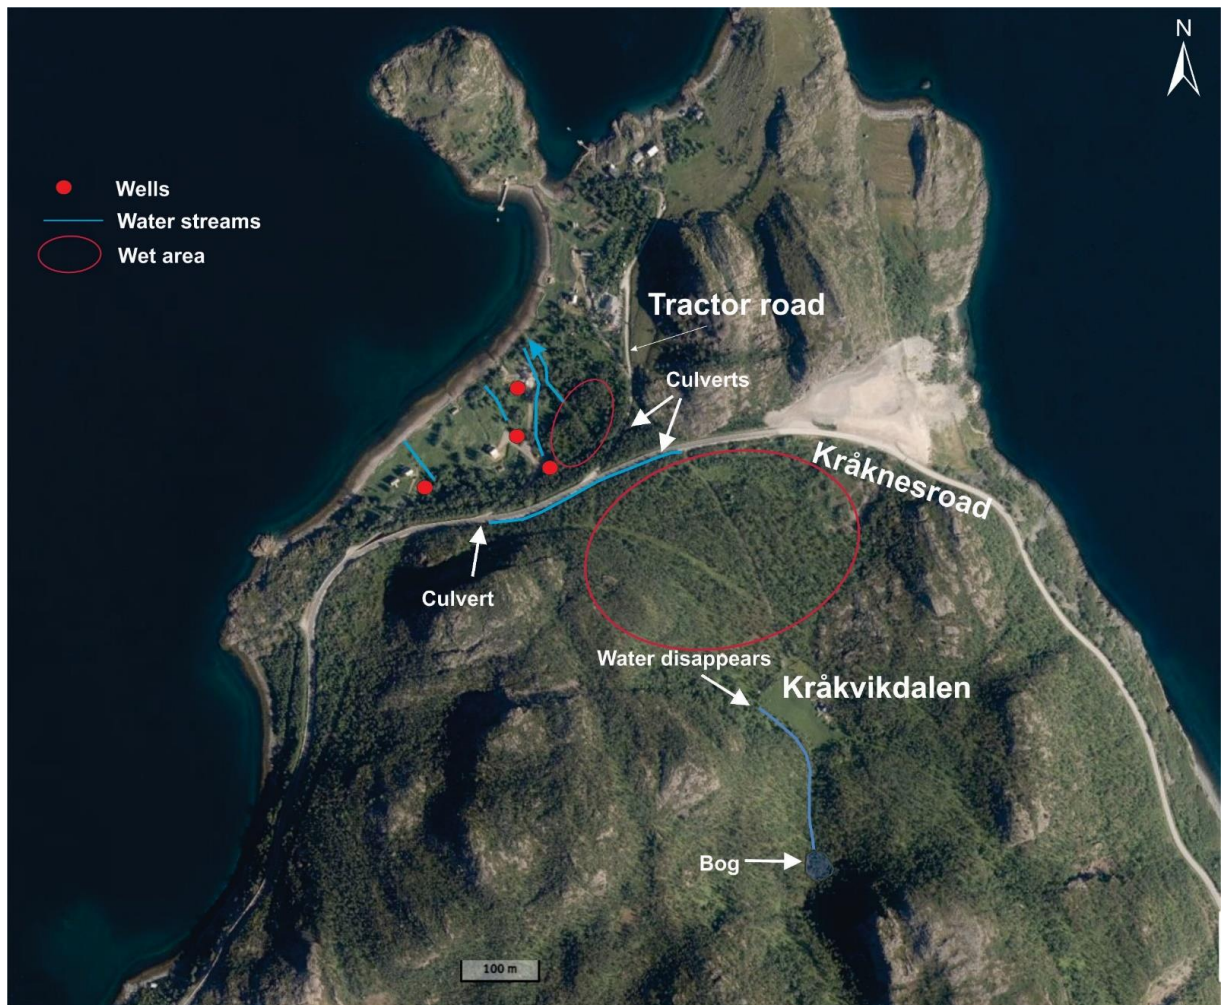
Figure 82 Map of water presence at and around Kråknes showing water streams, wells and significantly wet areas in the days prior to the landslide. The bog and disappearing water streams were observed during field work. Orthophoto from 2018.

Before the landslide, Kråknes was characterized by streams and manholes that collected water from the slope above the Kråknesroad. Wells were put on several of the manholes and the inhabitants explained that the wells would fill up shortly after they were emptied (Figure 82).

In the days prior to the landslide event, there were large amounts of water observed in the area around Kråknes. Kråkvikdalen (Figure 82) was described as “floating in water” and the ground was vibrating in the days prior to the landslide. Locals that normally hiked in the area explained that it was not possible to access the area due to the large amounts of water on

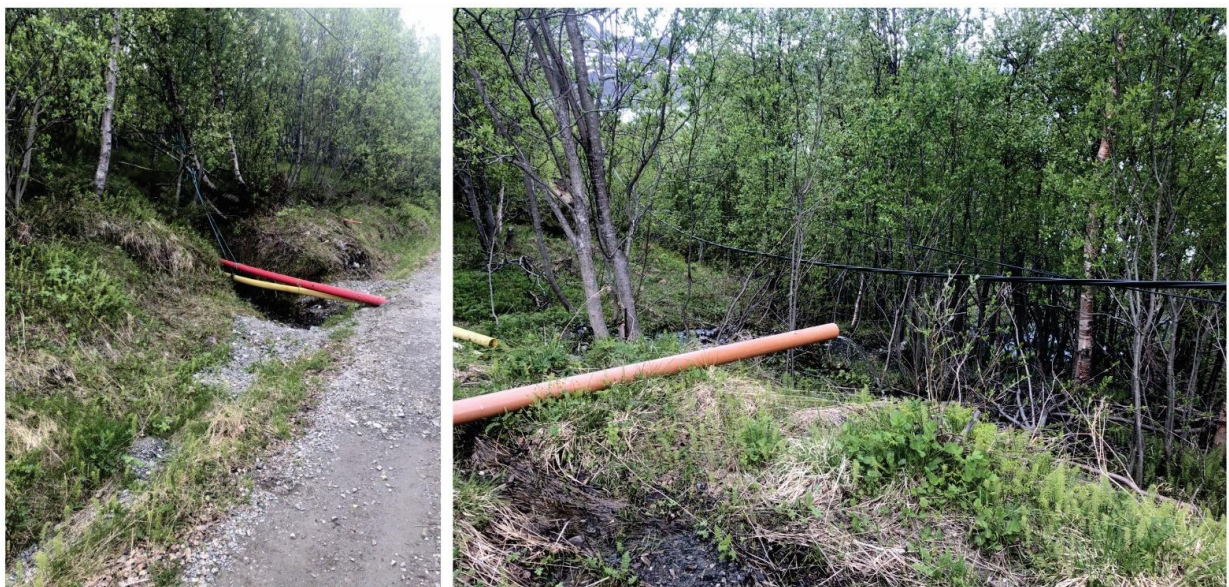
the ground (red circle in Figure 82). The high amount of water from Kråkvikdalen flooded the area between the tractor road and the cabin properties (red circle). New culverts were put in above the tractor road a few days before the landslide event to prevent the water from flooding the area (Figure 83). Significant amounts of water built up in the ditch system parallel to the main road, eroding tunnel gullies in the ditch floor, and undercutting the shoulder of the road (Figure 84C). After the landslide even there were still small streams of water running from the ditch north of section B into the landslide area (Figure 85A). South of section B, the eroded channels were completely dry (Figure 85B & C).

Figure 83 Culverts added to increase drainage to the beach through the tractor road.
