Reconstruction of the Kråknes landslide event, Alta.

Stina Mari Pettersen

GEO-3900 *Master's thesis in Geology, May 2021.*

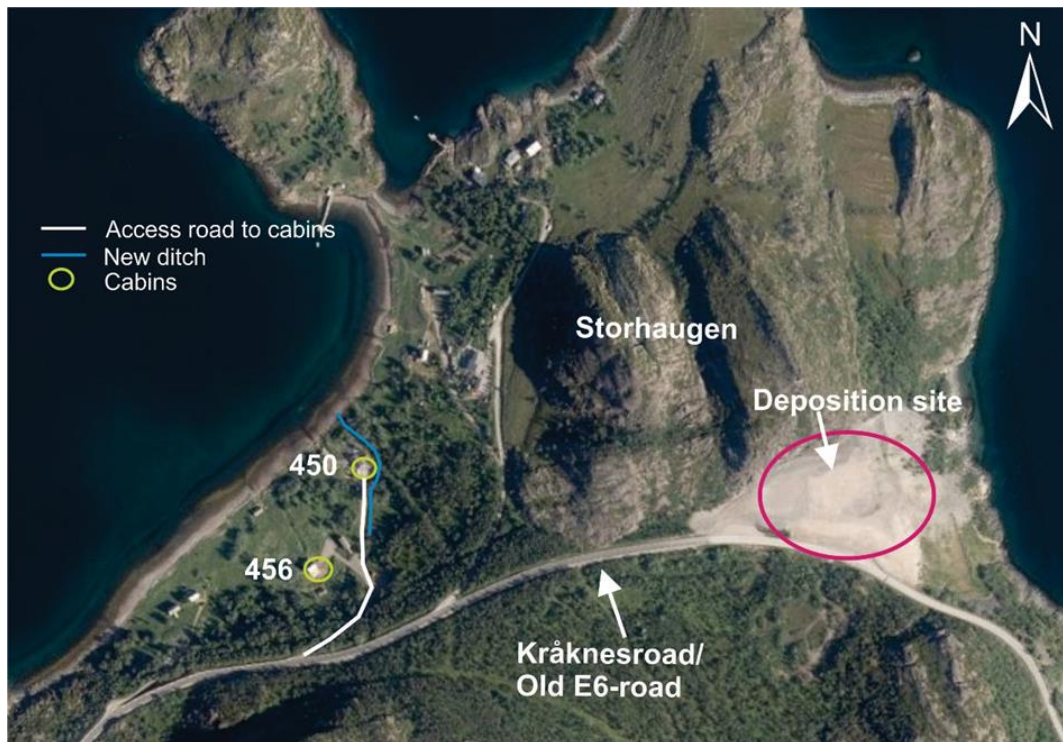
Before the E6-road was reconstructed between 2013-2016, the E6-road passed through Kråknes (Now called Kråknes Road) and was the main access road in and out of Alta City and northern Norway. During construction of the new E6-road, a deposal site for cut material was made in 2015 at Storhaugen east of Kråknes (Figure 86). According to SVV (Norwegian Public Roads Administration), the disposal material was deposited on bedrock and consisted of sand and silt. After the new E6-road was constructed, SVV made improvements on the former E6-road with new asphalt and railing. The ditch above the road was cleaned, but no new culverts were put in.

Figure 86 Locations of different human activities before the landslide event in 2020

In 2015 an older cabin in Kråknes Road 450 was torn down and a new cabin was put up (Figure 86). Because of the soft ground, a new filling had to be put in as a foundation. Excavated material from the cabin plot were placed as an embankment towards the sea with a septic tank installed within (Gylland et al., 2021). According to the owner of the cabin, 80 truckloads of fill material that came from the disposal site at Storhaugen were used to raise the level of the cabin plot. In a news article that came out in March 2021, Alta municipality claims that the cabin owner never applied to load the ground at the plot and that it would never have been approved due to the ground conditions at Kråknes (Cissè, 2021). The road leading to the cabin at Kråknes Road 450 was also improved using excavated material from the property at Kråknes Road 456 and a new ditch for water drainage around Kråknes Road 450 was made. At Kråknes Road 450 the cabin footprint of slightly more than 1000 m² was raised by 2 m, while 400 m² was removed from the terrain at Kråknes Road 456 (Gylland et al., 2021). Slope stability calculations at Kråknes have been done to compare the stability before and after the cabin in Kråknes Road 450 was upgraded. The stability analyses show that

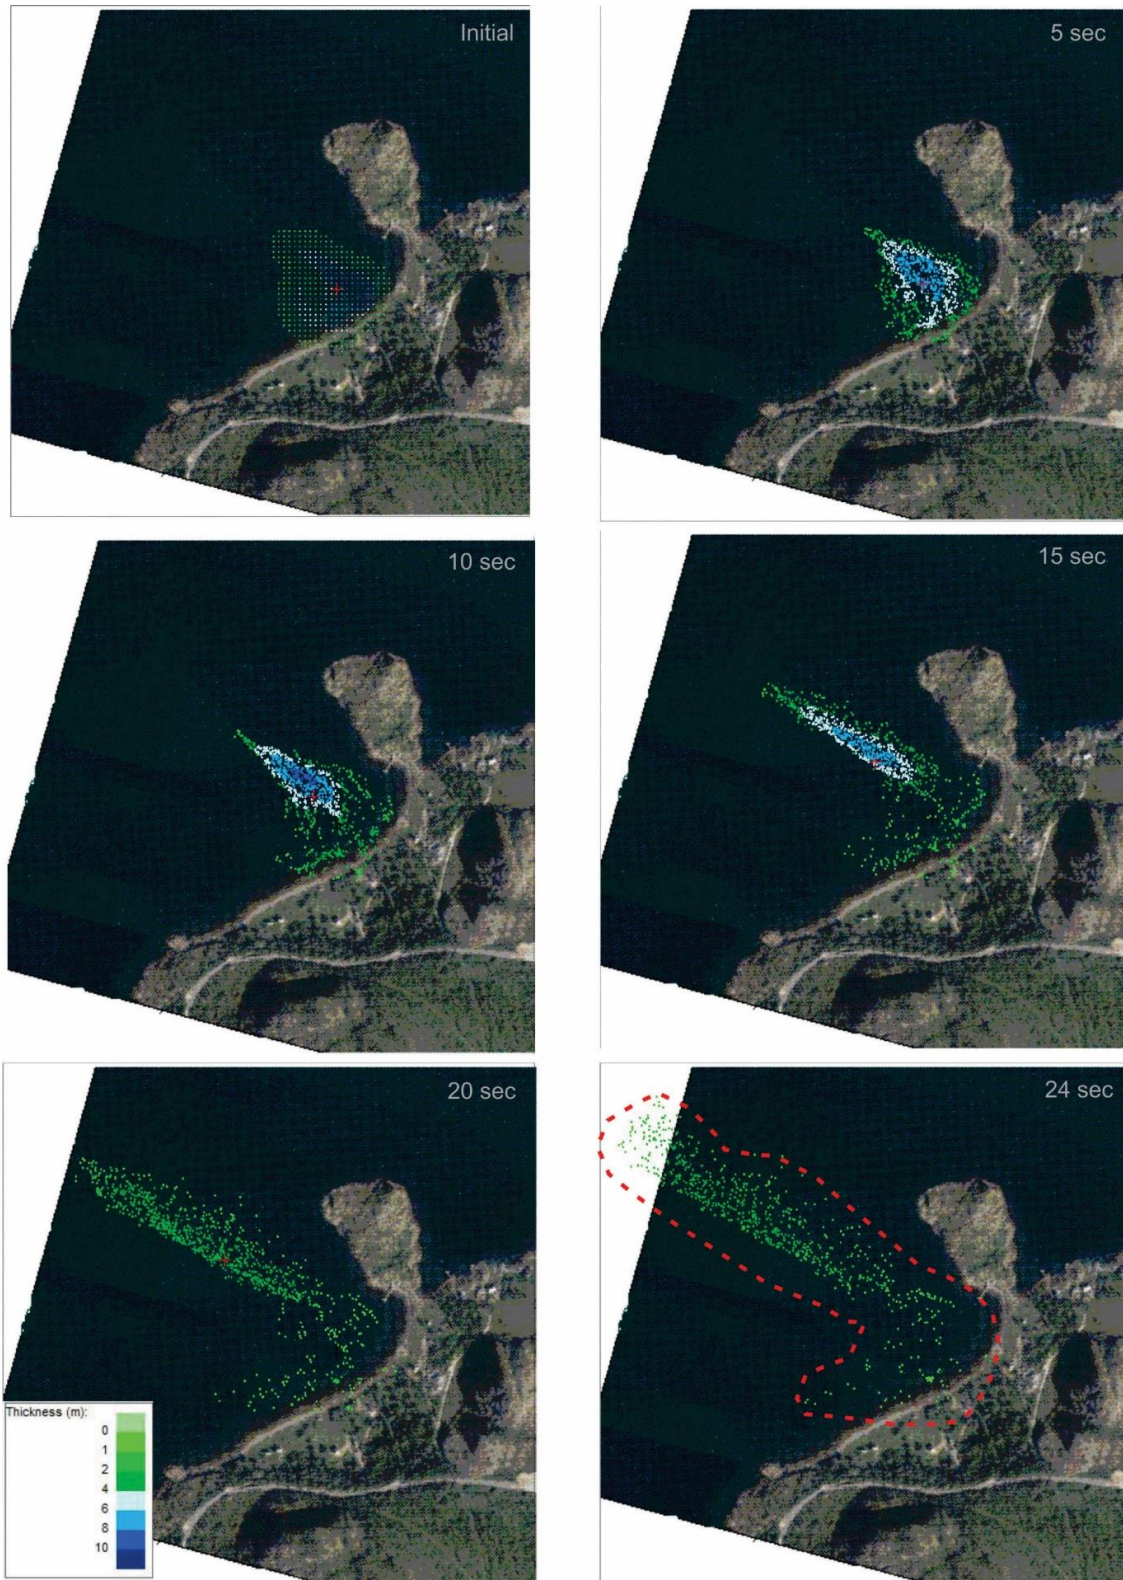
Run 1 has its initiating landslide mass below sea level, outside of section C. The total initial volume is calculated to be $344\,841\text{m}^3$ and by the end of the landslide event, the total volume is $671\,687\text{m}^3$. However, the total volume of the landslide mass is probably bigger than what can be calculated, as an unknown volume of the landslide mass may have been transported several km into the fjord. The run-out distance and thickness of the simulation for this scenario are seen in Figure 87 and show that the landslide mass came to a complete stop 24.8 seconds. The total simulated run-out distance is 411.4m and the average thickness of the landslide was initially 5.6 m and decreased to 1.09 m by the end of the landslide.

Out of the two different simulations, the run-out in run 1 looks to be more realistic based on the shape of the landslide mass compared to the morphology in the post-landslide topography. The landslide mass does not spread out wide but stays narrow and follows the subsea channel. The total run-out distance in this simulation is 411.4 m, which is shorter than the empirical estimations for retrogressive landslides in channelized terrain suggests. The empirical calculation is three times the length of the release area (chapter 2.2.5), which is $3 \times 160 \text{ m} = 480 \text{ m}$ for the release area in run 1. For run 2, the total simulated run-out distance is 275 m. The empirical calculations with a 140m long release area give a run-out distance of 420 m in channelized terrain. However, the run-out in run 2 seems to spread out wide compared to the more channelized run-out in run 1. By using the calculation method for run-out in open terrain, the run-out distance is $140 \text{ m} \times 1.5 = 210 \text{ m}$.

Figure 87 Run 1. Simulation if landslide was initiated below sea level. The red dotted line shows the impact area

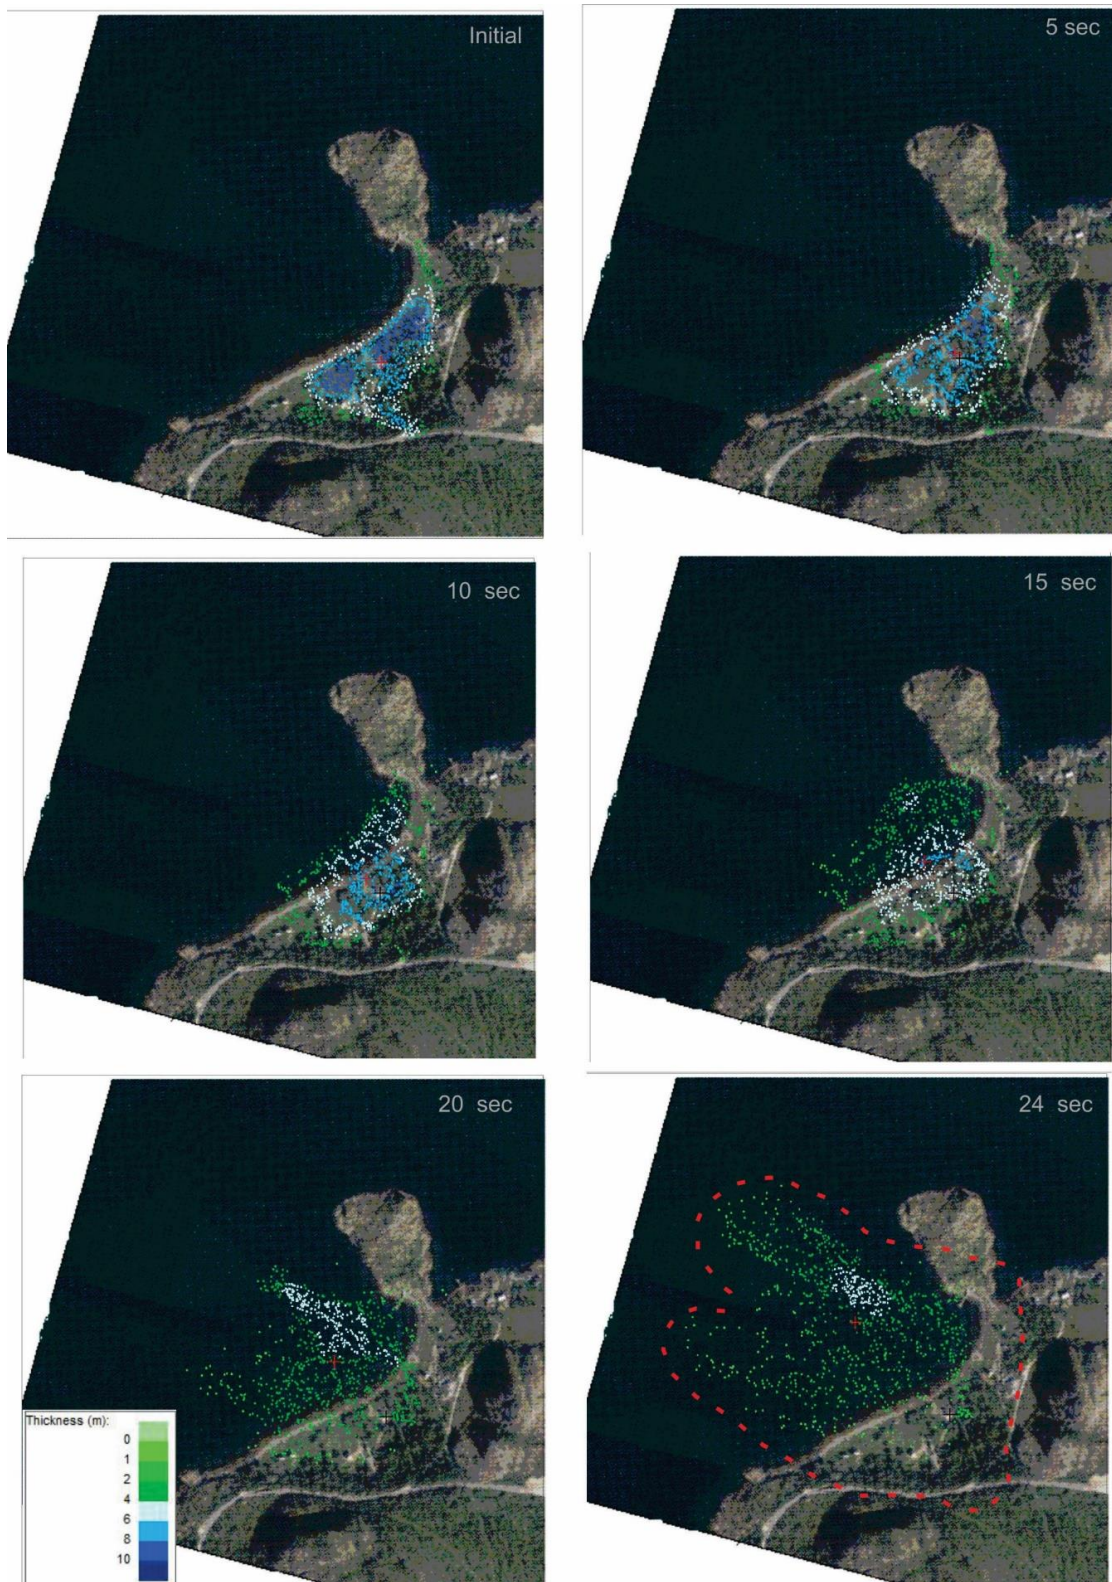
Figure 88 Run 2. Simulation of the landslide thickness and movement from DAN3D. The red dotted line shows the whole impact area.

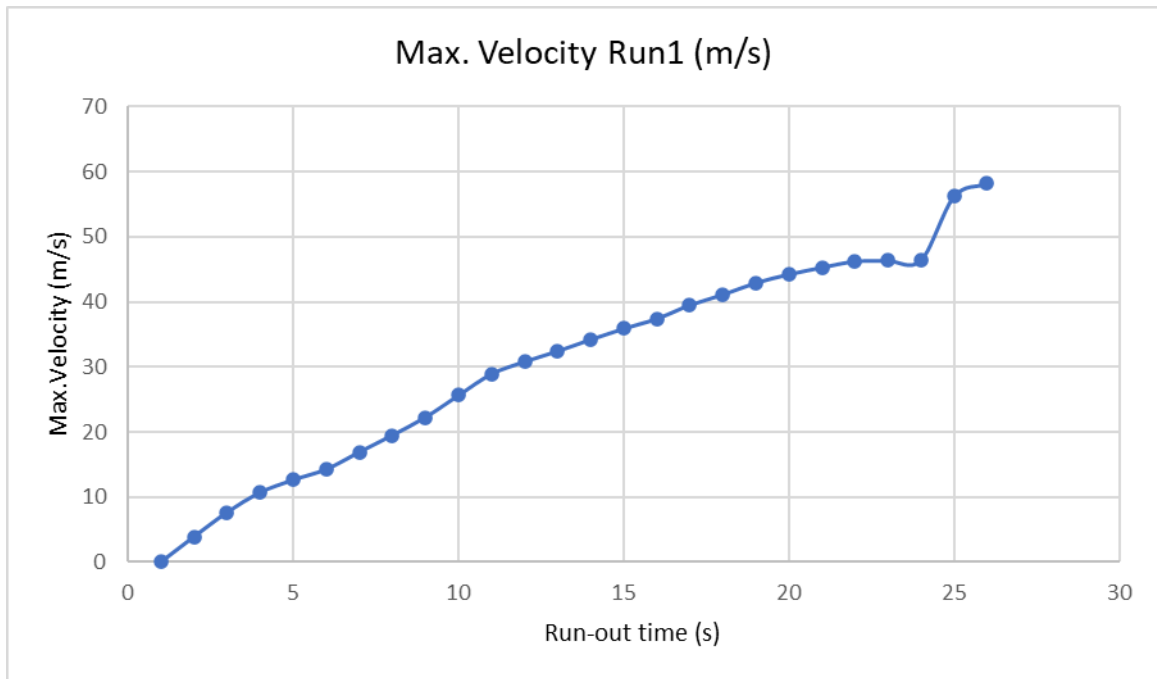
The maximum velocity of the simulation in run 1 can be seen in Figure 89. The velocity gradually increases between 0 and 23 seconds from 0 to 46.3 m/s before reaching its peak of 58.2 m/s at 24.2. The maximum velocity for run 2 can be seen in Figure 90. The graph show a gradual increase in velocity between 0 and 15 s from 0 to 25 m/s, before it has an exponential increase between 15 to 24 s from 25 to 128 m/s.

Figure 89 The maximum velocity of the landslide throughout the simulation time in run 1.

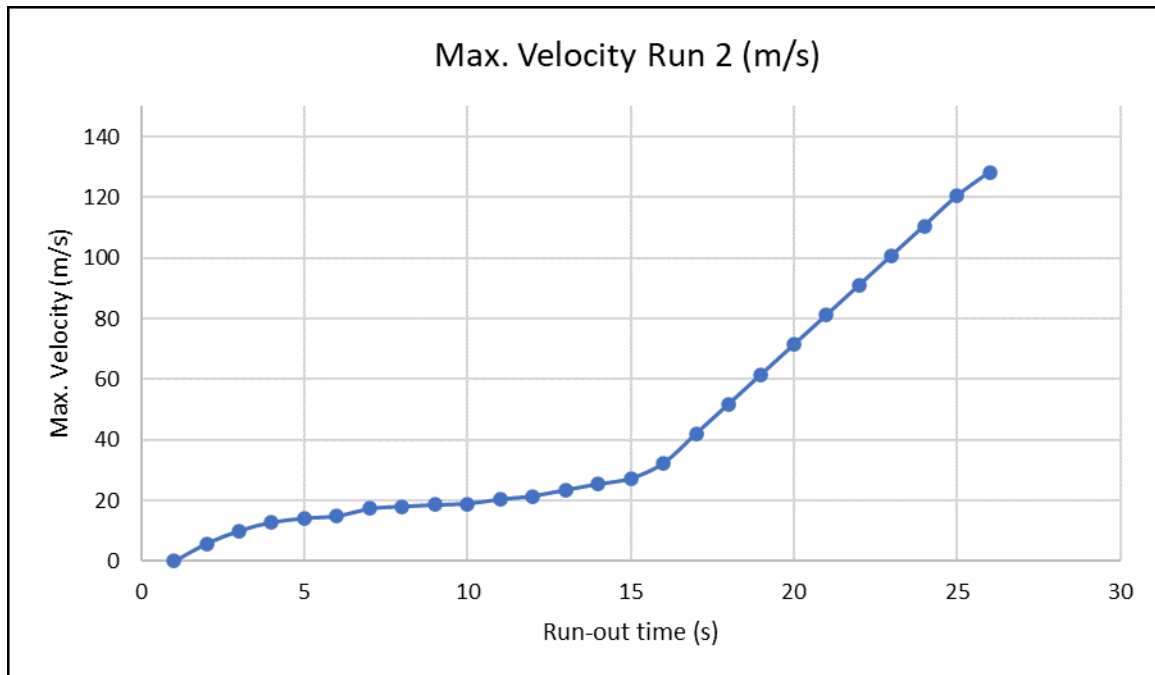
Figure 90 The maximum velocity of the landslide throughout the simulation time in run 2.

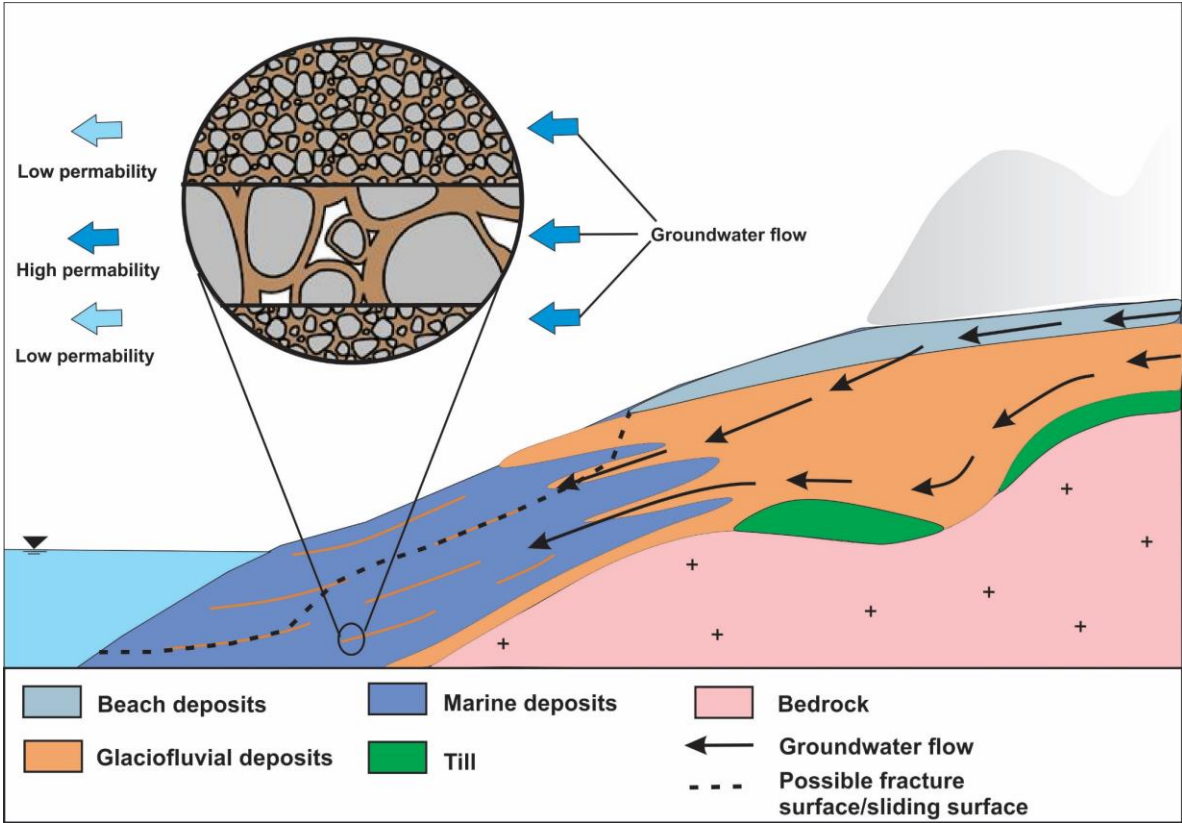
In Kråvikdalen the surface water drains towards Kråknes through permeable glaciofluvial deposits (material 6), and possibly fractured bedrock in the ground, and comes seeping out in the landslide back scarp between layers of glaciofluvial deposits and marine deposits, and between soil-layers and bedrock. Collected core samples show that there are layers of sand and silt within the marine deposits, and these layers are interpreted to stretch out into the fjord. Figure 91 illustrates the general stratigraphy in the study area and how the groundwater flow travels through the glaciofluvial layers from Kårkvikdalen towards Kråknes.

Figure 91 Illustration of the general stratigraphy at Kråknes with groundwater flow from Kråkvikdalen, through the glaciofluvial deposits at Kråknes and into the Altafjord. Inset is an illustration of the grain size of the marine and glaciofluvial deposits and their permeability.

The interpreted stratigraphy in the area (Figure 91) with glaciofluvial deposits from Kråkvikdalen continuing into the landslide area and into the fjord within the marine deposits could give a geological scenario where the groundwater levels have increased in the higher-lying areas and caused an increase in pore pressure in the sediments deeper down and below sea level. This scenario may create weak layers and possibly hydraulic fracture (soil piping) between layers of different textures and hydraulic properties. Several soil pipe structures are seen in the landslide area in the contact zones between coarser and finer-grained layers. These soil pipes can rapidly transmit water and speed drainage from hillslopes, but if the soil pipes are blocked or are dead-end pipes, they can be filled with water when there

are high amounts of rain or meltwater. This can produce excess pore pressure in the surrounding sediments. If a slope is already close to failure because of other predetermined factors, it is possible the pore pressure from the soil pipes may cause slope failure (Pierson, 1983). Figure 91 illustrates a likely scenario at Kråknes, where a layer of the permeable glaciofluvial soil is trapped between two layers of less permeable marine deposits. The groundwater flows through the glaciofluvial deposits but is impeded in the marine deposits, which can cause excess pore pressure followed by a decrease in the sediments' shear strength and eventually create a weak layer that decreases the slope stability. A weak layer could also have been formed in stratified beds from turbidity currents/flows from the prehistoric landslide in the area. Rapid deposition of landslide mass in the catchment area of the fjord after the prehistoric landslide may have produced biogenic gas due to the burial of benthic ecosystems, which increases the compressibility and reduces the shear strength of the sediments (L'Heureux et al., 2012). Such weak layers can, under critical conditions, form the sliding surface of the failure. The initial topography at Kråknes with a moderate dipping fjord where beds are able to accumulate in the slope, in addition to a prehistoric landslide event, creates good conditions for such weak layers to be formed. However, to confirm the existence of such a layer at Kråknes, seismic data would be necessary in a combination with bathymetry and terrain data. Unfortunately, there are no seismic data available for this study.

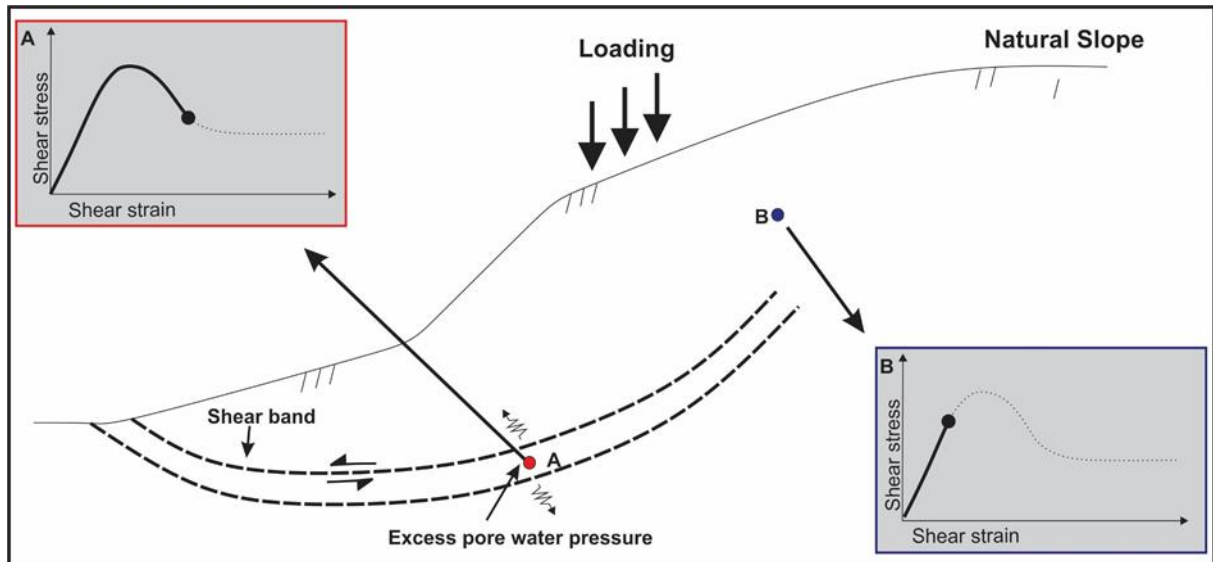
Another human activity has been shown to have made critical changes to the slope stability in the area. The 80 truckloads of fill material (1000-1200m³) that were added at Kråknes Road 450 in 2015 decreased the already unstable stability at Kråknes. The loading of the fill material causes an increase in the pore water pressure and shear stress in the sensitive clay because the loading happens more rapidly than the water can flow out of the soil. The concentrated shear deformation is therefore increased, and the peak strength of the soil is exceeded. If this does not cause an immediate failure, the shear strength of the material is permanently reduced, even though the pore water pressure decrease over time (Strain-softening) (Thakur et al., 2018). The reduction in shear strength spreads through the soil layer and can eventually create a shear band and potential sliding plane. Figure 92 illustrates a shear band that has been subjected to strain softening and the surrounding soil, which has not yet reached its peak shear stress. This process is considered a predetermined factor, and an initial trigger mechanism such as high amounts of meltwater can have caused the initial failure by increasing the pore water pressure and total stress within the shear band.

Figure 92 Loading of material on a natural slope where local excess pore water develop and a soil layer is subject to strain-softening (A) which creates a shear band and possible sliding surface within the sensitive clay. The surrounding soil (B) has not yet reached it's peak shear stress and has a higher shear strength than the soil within the shear band (Inspired by Thakur et al., 2018) .

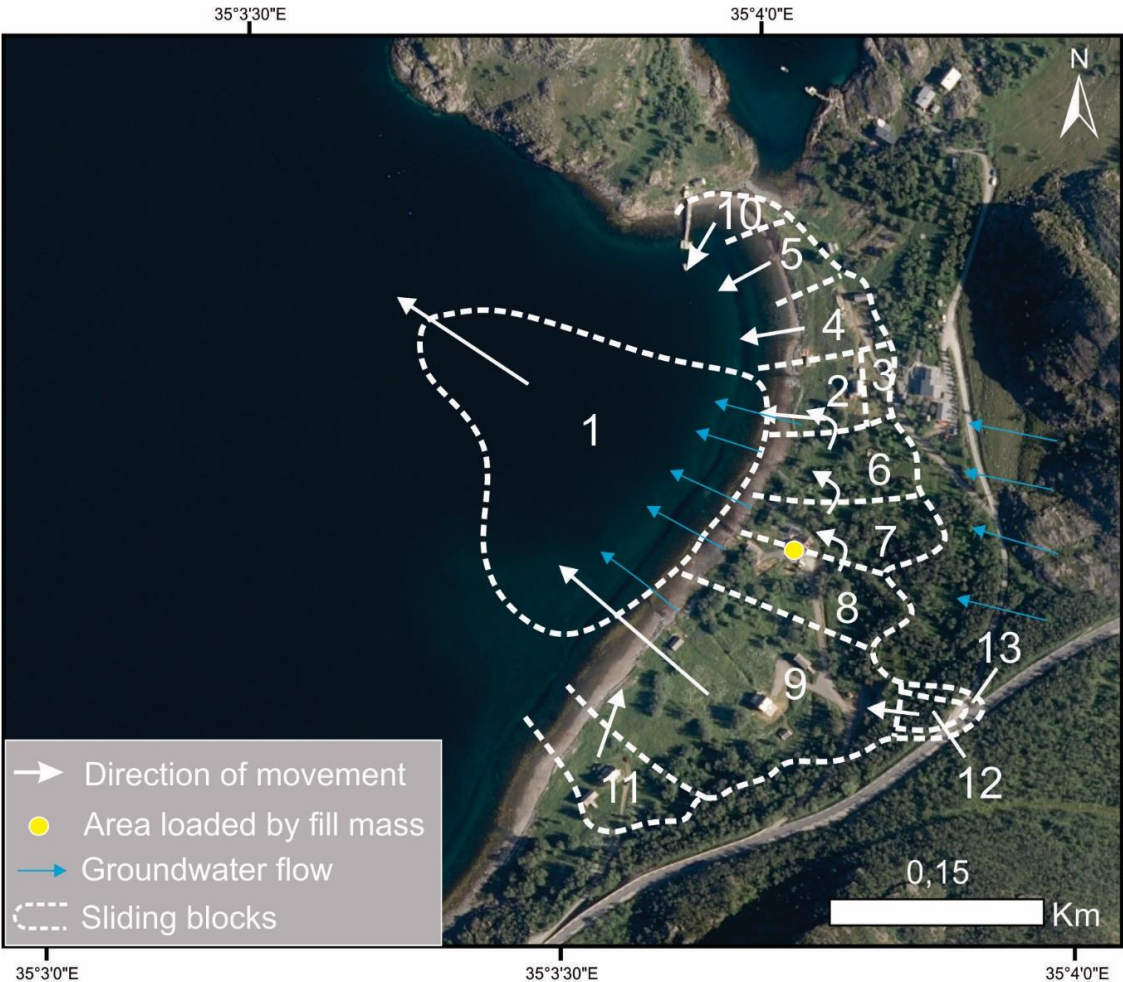
A possible scenario is that the landslide was initiated below sea due to the discussed failure mechanism of excess pore pressure and predetermined instability in the slope (weak layers) below water. This would be the same as if run 1 (Figure 87) was the initial landslide, followed by run 2 (Figure 88) shortly after.

The failure below sea level led to the failure on land in section C because of the loss of support from the failed mass below (Figure 93). Based on the sequence of events by the eyewitness (Figure 74), the landslide then continued to fail retrogressively sideways because of the sensitivity of the clay and the loss of support. In sections C and D, the landslide retrogression stopped when the back wall reached the bedrock and no further backward retrogression was possible. In section B, the cross-section B-B' shows a stair-like morphology, with a sub-scarp right below mean sea level, which could suggest that the failure in this section started below sea level and retrogressed backward on land. As block 8 failed on June 3rd, the back scarp in section B was established in the glaciofluvial deposits (material 6) at about 20 m asl. Water continued to seep into this section within the glaciofluvial deposits

and soil pipes in the back scarp and from surface streams along the E6-road, which eventually led to the failure of block 12 and 13 in the upper part of section B.

In the northern part of section D, the back scarp is mainly below sea level and the top of the back scarp can barely be seen during low tides. According to the eyewitness, block 10 (Figure 93) in this section slid out after block 8 on June 3rd, 2020. Cross-sections A-A' also has morphological suggesting retrogressive behavior. This is also the only area in which the geotechnical data show that there is the presence of quick clay layers in addition to several layers of sensitive clay ($S_t= 20-50$). The post-landslide cross-section suggests that this section started to fail below sea level along with what is interpreted as a sliding surface at 8 mbsl before it retrogressed backward on land.

Figure 93 Sequence of events if the landslide was initiated below sea level.

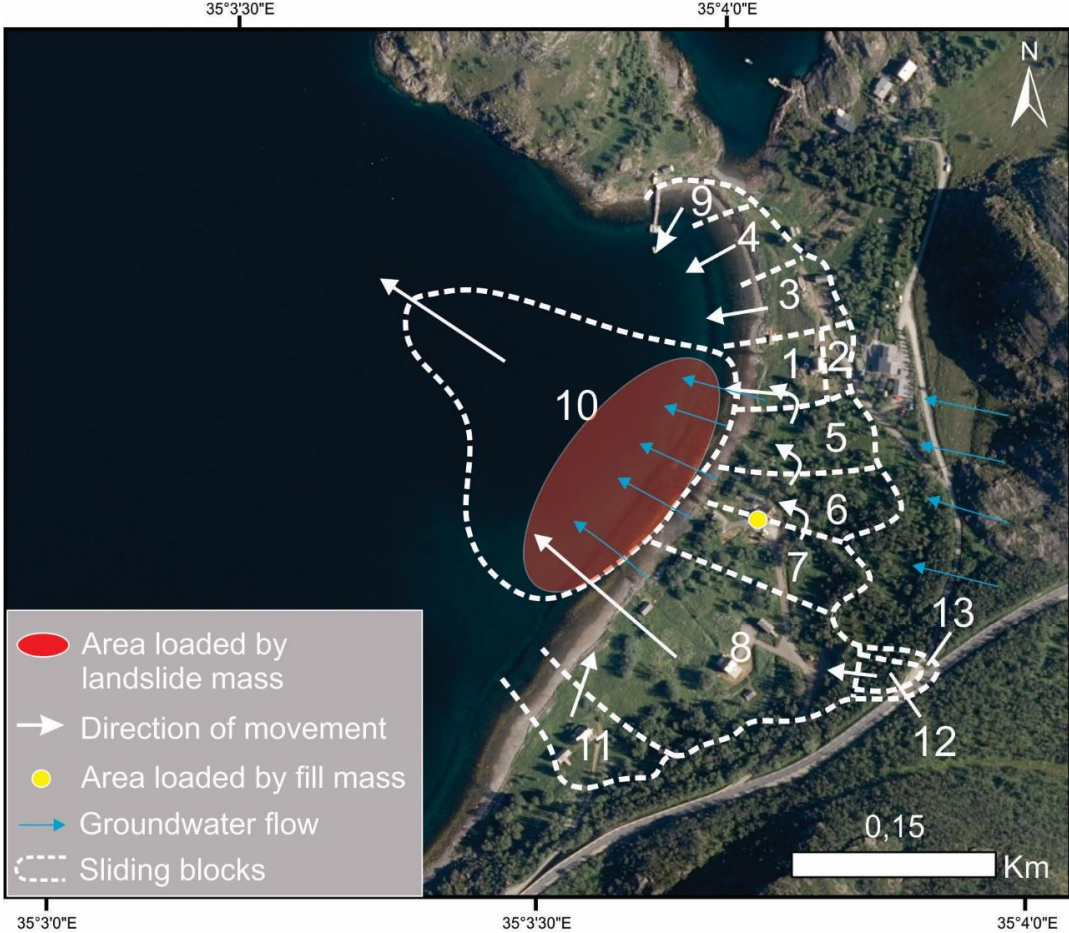
Another scenario is if the landslide was initiated on land in section C (Figure 94), where run 2 (Figure 88) is followed by run 1 (Figure 87). The initial slide would likely be a progressive slide along a sliding surface created by strain-softening and triggered by the increased amount of meltwater. The initial slide would then cause a retrogressive failure in blocks 2-9 (Figure 94) as each block loses support when the buttressing mass below fails. The series of failures on land causes a rapid loading of landslide mass on the seafloor that eventually triggers a slide below sea level (Red circle in Figure 94). Based on the sudden descending water level explained by the coast guard, the slide below water is likely to have been triggered before block 11 in section A failed, one hour after the landslide was initiated. When the slide below sea level failed, the already sensitive block 11 failed due to the loss of support in the bottom of the slope.

Figure 94 Sequence of events of the landslide was initiated on land.
