## An investigation into the causal factors of the Kråknes landslide

Torgrim Sandnes Master's thesis in Geology (GEO-39100), May 2021

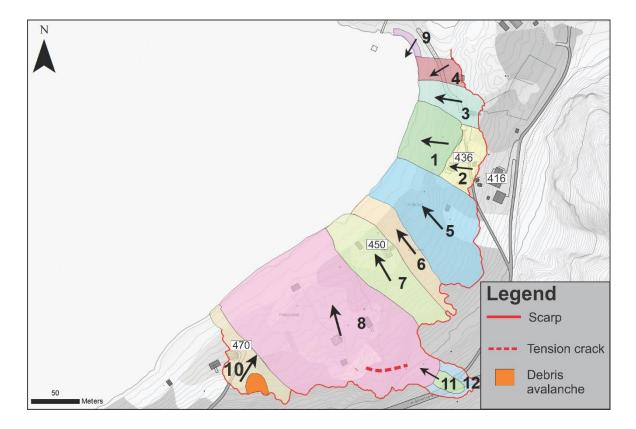
Figure 22: Proposed sequence of events for the Kråknes landslide. This map is based on video observations and reports from local residents.

After the temperatures had increased in the middle of May, local cabin owners staying at Kråknes between the 27<sup>th</sup> -29<sup>th</sup> of May stated that large amounts of water was observed on the fields and in the gutters around Kråknesveien 470 (Figure 22). Additionally, on the 29th of May, five days before the landslide, a smaller debris avalanche was reported above the cabin at Kråknesveien 470 (Figure 23 C/D). The landslide cut the water supply for one of the cabins, and was reported to the Flood and Landslide Warning Service. In the statement from the locals, it was emphasized that there was much water and clay on the ground in the area.

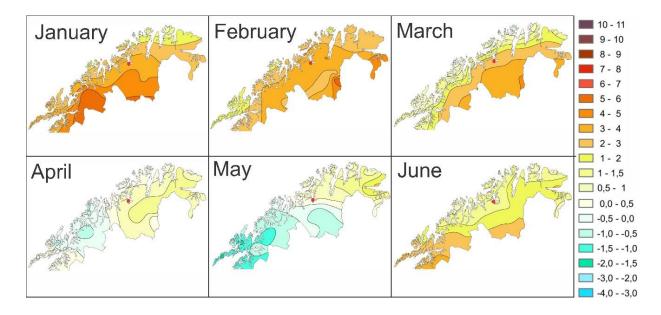
Figure 26: Temperature map for Troms and Finnmark. The location of Kråknes is represented by a red dot. Temperature (°C) is presented as the variation from the monthly normal. Adatpted from Grinde et al. 2020a,b,c,d,e,f).

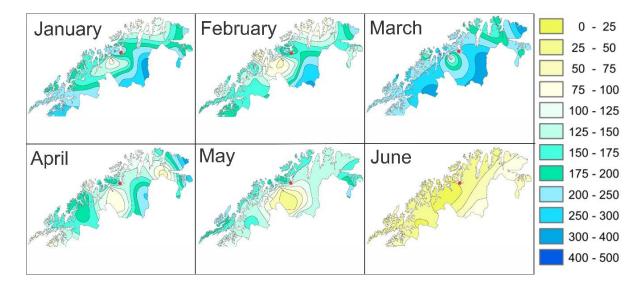
Figure 27: Precipitation map of Troms and Finnmark. The location of Kråknes is represented by a red dot. Precipitation (%) is presented as the variation from the monthly normal. Adapted from Grinde et al. 2020a,b,c,d,e,f).

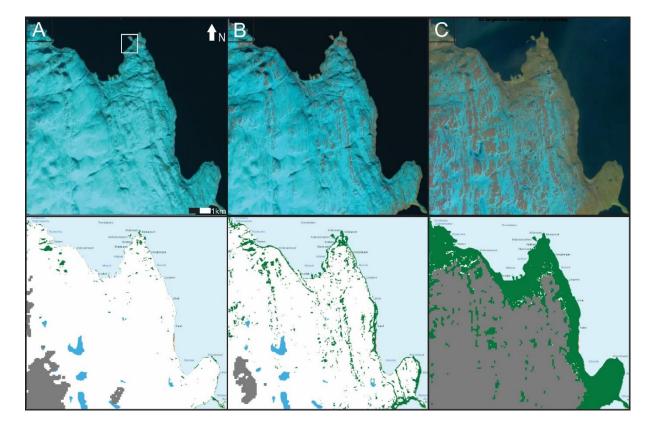
The heavy precipitation in January, February and March generated large volumes of snow in Troms and Finnmark. As a result, several gauging stations recorded snow depths close to an all-time high. As an example, the month of March 2020 had the most recorded snow, going back to 1958 (NVE, 2020). The combination of a thick snowpack and low temperatures resulted in the preservation of the snowpack, even into the warmer months of April and May (Grinde et al., 2020d). Snow covered most of Kråknes and the surrounding mountains until the end of May. It was not until the turn of the month that warmer temperatures led to a drastic decrease in snow cover, as observed in Figure 28.

Figure 28: Figure illustrating the snow-cover at Kråknes and the surrounding area at three different times. The snow-cover is demonstrated both by orthophoto and concurrent snow-cover model from Xgeo. In the model, white color illustrates snow cover, while green is bare ground. Dark grey color comes from cloud cover. A) Snow-cover at 02.05.2020. The location of Kråknes is illustrated by a white square. B) Snow-cover at 22.05.2020. C) Snow-cover at 05.06.202. Retrieved from Xgeo.no.

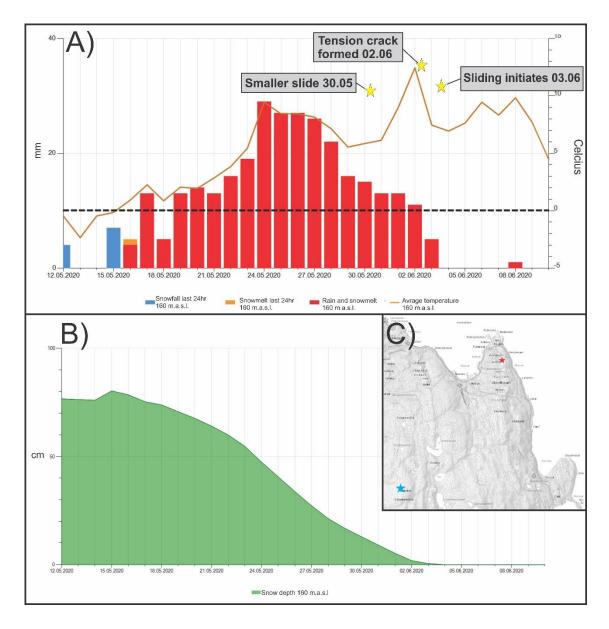
The snow depth at Kråknes measured 70-80 cm in the start of May (Figure 29B). It was not until the influx of warmer temperatures around the 23<sup>rd</sup> of May, that a more drastic increase in snow melt was observed (Figure 29A). As a result of the warmer weather, the snow-melt peaked during the 24-29<sup>th</sup> of May, reducing the snowpack from 55 to 20 cm (Figure 29B). Subsequently, a new period of warmer weather followed into the start of June, although snow-melt levels continued to drop due to the reduced snowpack. Hence, most of the snow at Kråknes had melted by the early days of June (Figure 28, Figure 29B).

Figure 29: A) Graph displaying the snowfall and snowmelt in relation to temperature between May 12th and June 8th. B) Graph of snow depth at Kråknes. C) Topographic map of the study area. Red star marks the location of the measurements. Blue star marks the location of Flintfjellet. (Kartverket, 2020). Source: Xgeo.no.

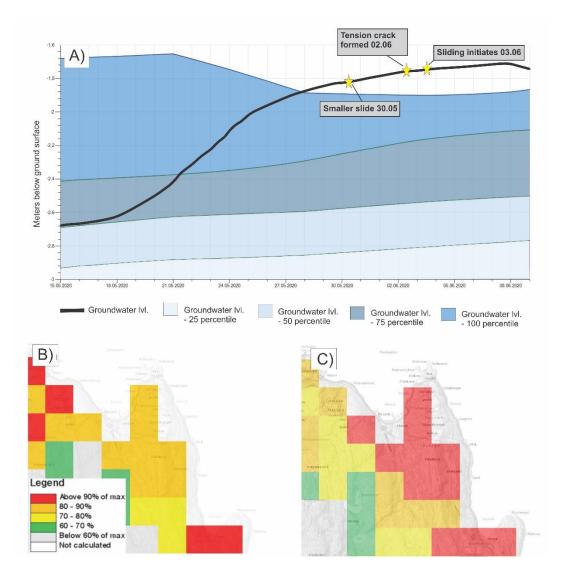
As temperatures rose and the snowpack started to melt during the middle of May, large volumes of water were released. This is reflected in the groundwater monitoring station at Lakselv, 70 km east of Kråknes (Figure 2B). The station at Lakselv is the closest monitoring station for Kråknes, and provides a useful proxy for groundwater level changes in the region. From the monitoring station, a considerable increase in groundwater level can be observed from the 18<sup>th</sup> of May (Figure 30A). This corresponds well with the increased temperature and snowmelt witnessed at Kråknes for the same time period (Figure 29A). As the groundwater level continued to rise during the end of May, it even exceeded the 100<sup>th</sup> percentile boundary, indicating exceptional circumstances (Figure 30A). These percentiles are calculated by comparing the registered groundwater level on the given day, to the groundwater level for the same day for previous years. This means that at the 50<sup>th</sup> percentile, we have the same amount of observations registered above and below. Subsequently, at the 100<sup>th</sup> percentile, all observations are equal to or less than the registered value. For Kråknes, a similar increase in groundwater level was observed. Here, the volume of groundwater was estimated to be 80-90% of the maximum on the 27<sup>th</sup> of May, and continued to increase to over 90 % of maximum to the 3<sup>rd</sup> of June (Figure 30 C/D). These maps show groundwater volume as a percent of the maximum value for the period 1981-2010 (Xgeo, 2020). In addition to the rise in groundwater levels, soil saturation levels also registered at an all-time high for this period.

Figure 30: A) Graph of the groundwater level at Lakselv. The percentiles are based on the data from 1957-2020 (Xgeo.no). Yellow stars indicate the timing of the smaller debris avalanche, tension crack and sliding initiation. B) Groundwater volume in % of maximum for 27.05.2020 (source: xGeo.no, 1 km<sup>2</sup> grids). C) Groundwater volume in % of maximum for 03.062020 2020 (source: xGeo.no, 1 km<sup>2</sup> grids).

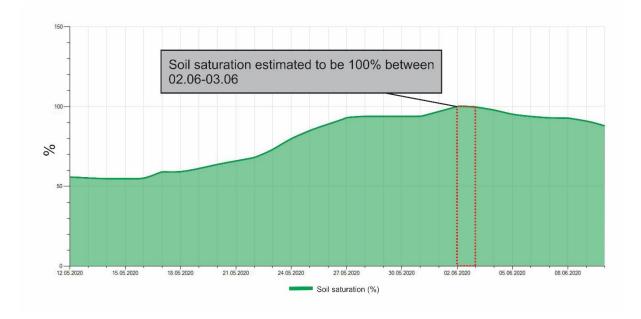
Soil saturation measurements from Kråknes revealed an increase from 55 to 100 percent from the 15<sup>th</sup> of May until the 1<sup>st</sup> of June (Figure 31). A similar increase in soil saturation was observed at Flintfjellet (775 masl), about 8 kilometers from Kråknes (Figure 29C), indicating that the temperatures at this time were sufficient to initiate snowmelt at higher altitude as well.

Figure 31: Graph of soil saturation (%) at Kråknes. Soil saturation was estimated to reach 100% on 02.06, the day before the landslide initiated. (Xgeo.no).

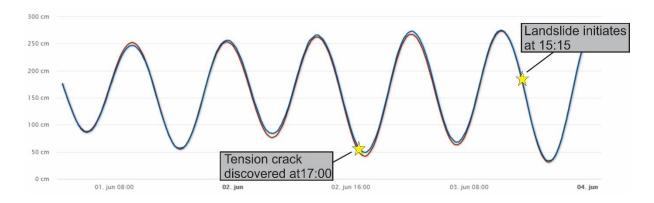
For Kråknes tide levels fluctuates between 45 and 260 cm above the sea chart datum in the days leading up to the event. On June 2<sup>nd</sup> at 17:00 tension cracks crossing Kråknesvegen 450 were observed by a local. At this time, the tide level was registered at 59 cm, corresponding to the value of "mean low water springs". For the initiation of the main sliding event on June 3<sup>rd</sup> at 15:15, the tide level was between high- and low tide. At this time the tide level registered at 171 cm, corresponding to the "mean sea level (1996-2014)", dropping around 60 cm/h (Figure 32).

Figure 32: Graph of the tides prior to the landslide. Blue line is the observed tide level from the nearest tide gauge, adjusted for Kråknes. Red line is the predicted tide. The tide level is referenced from the "sea chart datum". Data from https://kartverket.no/en/at-sea/se-havniva.

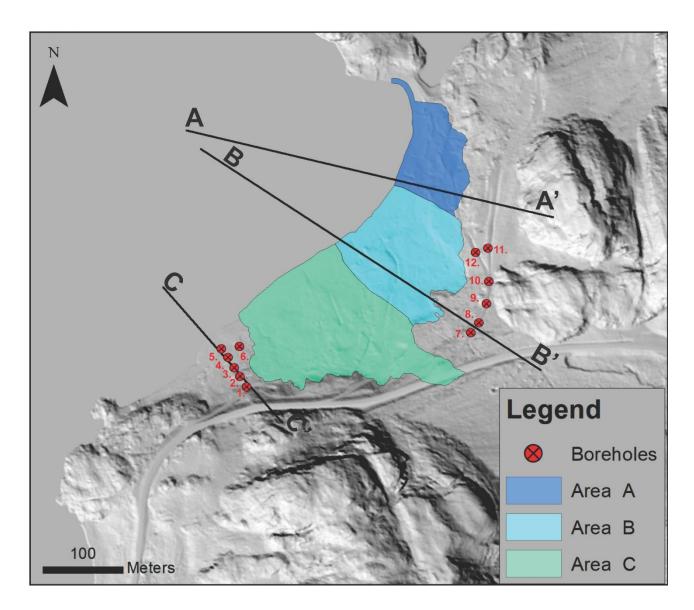
Figure 33: Hillshade relief map of the Kråknes. The landslide has been divided into three separate areas, depending on geomorphology and soil characteristics. Boreholes from ground investigations are marked on the map, in addition to profiles selected for slope reconstruction and stability modeling.

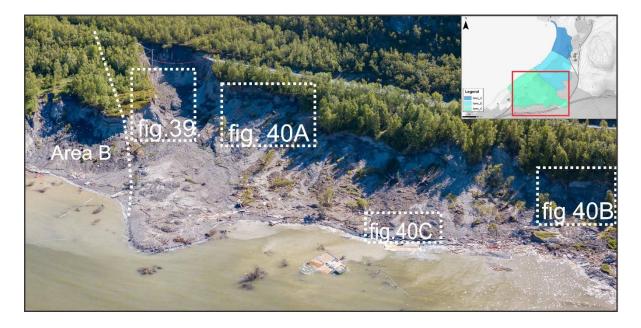
Area C is characterized by the thickest sediment package of the landslide area. This is also the area where the largest volume of mass has released during the landslide. Four localities will be focused on and presented from this area (Figure 38).

Figure 38: Overview photo from area C. White boxes illustrate the location of figures 39 and 40. Photo: Raymond Eilertsen .

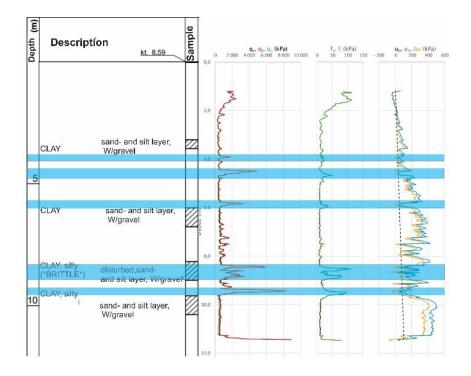
From BP2, five permeable layers were identified (Figure 43). These layers range from 10 to 30 cm in thickness, presumably consisting of a mixture of sand, silt and gravel. This is based on the sample classifications by Multiconsult, where one of the core samples overlap the location

of a permeable layer. From the samples collected, we can observe that the general composition of the soil at BP2 is predominantly clay and silt with smaller amounts of gravel. Lab tests reveal that the clay exhibits a sensitivity ( $s_t$ ) between 8 and 16, and remolded shear strength ranging from 0.8 to 1.3 kPa. However, the values satisfying the requirement for sensitive clay is only found between 8 and 9 meters depth (Appendix A). It can be observed that the location of sensitive clay overlaps a more permeable layer indicating a possible connection.

Figure 43: Figure showing the depth and description of samples collected in BP2. The graphs to the right are the corresponding CPTU-data, showing cone resistance  $(q_c)$ , sleeve friction  $(f_s)$  and pore pressure (u). Blue lines indicate more permeable layers. Figure adapted from Waldeland (2020).

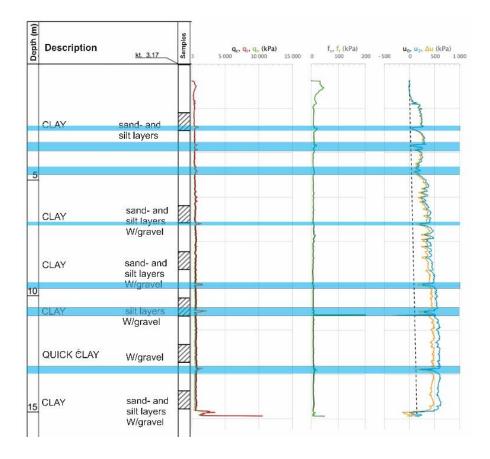
At BP4, the sediment thickness has increased by four meters compared to BP4. Along with the thicker sediment, more permeable layers have been identified, increasing from 5 to7 (Figure 44). Although the permeable layers have increased in numbers, it must be taken into account that the overall variation in the dataset for BP4 is far less than for BP2. This means that the values required for interpreting a layer as permeable in BP2 is higher than BP4, suggesting that some layers may have been excluded in BP2. Comparing to BP2, the values from the CPTU are more uniform, with  $q_c$  and  $f_s$  showing fewer spikes. It is also apparent that the permeable layers have become thinner (5-10 cm), indicating that these layers thin out in the down-slope direction.

Similarly as for BP2, soil samples were tested for sensitivity  $(s_t)$  and undrained shear strength  $(c_u)$ . These results combined with the CPTU-test show that sensitive- and quick clay is located between 8 and 15 meters in BP4. Although the data from the CPTU is valuable, the majority of the ground investigations at Kråknes were done by total sounding. As a result, the data from the total soundings must be taken into account when reconstructing the slope stratigraphy.

Figure 44: Figure showing the depth and description of samples collected in BP4. The graphs to the right are the corresponding CPTU-data, showing cone resistance  $(q_c)$ , sleeve friction  $(f_s)$  and pore pressure (u).Blue lines indicate more permeable layers. Figure adapted from Waldeland (2020).

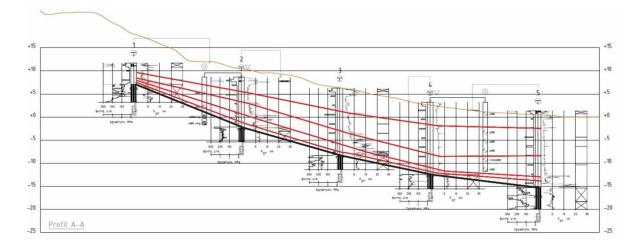
A schematic of the slope profile and locations of BP 1-5 are shown in Figure 45. Despite the fact that total sounding is more rudimentary than CPTU, it is possible to estimate the location of permeable layers by the increased penetration resistance and their concurrent location from CPTU-data. As a consequence, four layers where interpreted to follow the entire length of the slope, for BP 1-5 (Figure 45). From this, sedimentary layers were interpreted in respect to depositional environment, and the following profiles were constructed.

Figure 45: Profile of total soundings from BP 1-5. Slope geometry is represented by the yellow line, and elevation contours are listed on the y-axis. Red lines are drawn on to illustrate the location of permeable layers. The bedrock interface is represented by the black line. Adapted from (Waldeland, 2020).

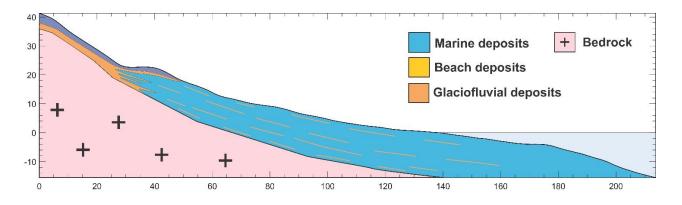
Figure 46: Profile C-C': Geological profile based on the CPTU- and total sounding data from BP 1-5.

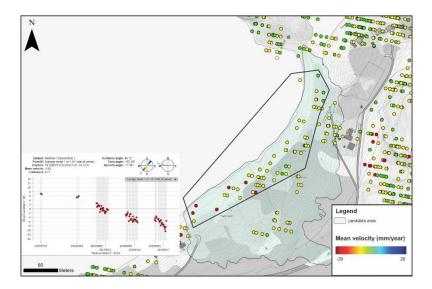
InSAR-data from Kråknes is presented in Figure 49. The data shows little overall displacement at Kråknes over the last five years, with an average displacement of 3-5 mm/yr. Apart from the average, single points have registered displacement up to 20 mm/yr in the SW corner of the landslide area. In general, the area exhibits poor data coverage, especially where there has been human activity. As such, there remains uncertainties related to their reliability of this data.

Figure 49: Topographic map of Kråknes with the landslide area overlaid (Kartverket, 2020). Colored dots represent InSAR reflector points. The diagram to the left displays the average displacement from 2015 to 2019, registered by the InSAR reflectors inside the black polygon (NGU, 2020b).

Apart from the sediment and bedrock at Kråknes, InSAR-data and seismic activity were also investigated for observations that could be attributed to the slope failure. The InSAR-data revealed an average displacement of 3-5 mm/yr at Kråknes, with some reflectors averaging close to 20 mm/yr (Figure 49). Due to the limited data for the area, and possible sources of error, little emphasis has been put on these observations. Similarly, seismic activity has been

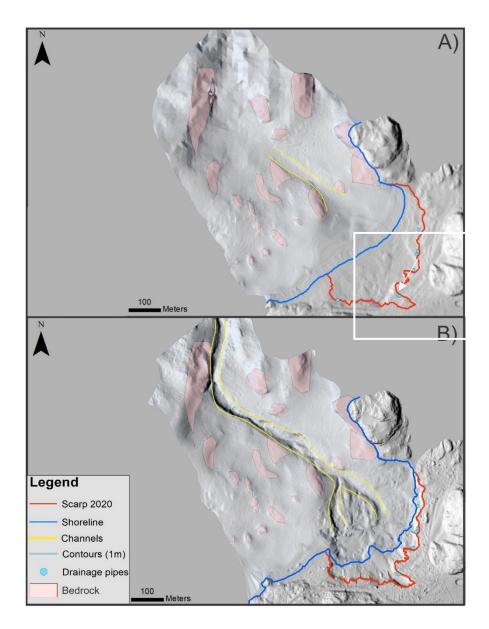
Figure 50: Maps based on LiDAR and bathymetry data, illustrating the subaqueous geomorphology from before and after the landslide. Scarp, shoreline (0 m), subsurface-channels and interpreted drainage pipes are marked on the maps. A) Map of the pre-slide geomorphology, white arrow indicates the location of the small bulges that were observed.

The seafloor from before the landslide had a varied and undulating topography. Steeper areas and protruding "lumps" have been interpreted to be exposed bedrock, while smooth surfaces are interpreted to be covered with sediment. Just outside of the NE part of the landslide, the topography forms a "bowl"-shape, marked by the white square (Figure 50A). Inside of the bowl, the seafloor bulges out in some areas, which could be due to exposed bedrock or remnants of smaller slides. Alternatively, the bulging could be caused by the mobilization of sediment caused by the drainage pipes identified earlier. Below the bowl, a channel is visible. This channel feeds out from the bottom of the bowl, and stretches out approximately 240 meters to the NW, with a depth ranging from 5 to 10 meters. Although it is difficult to predict what caused the channel to form, it can be suspected that a prehistoric sliding event may have played a part. This will be described in more detail in section 4.3.7.

After the landslide, most the bowl-shape was destroyed and replaced by a rougher and more gently dipping surface (Figure 50B), consistent with the morphology of a translational slide (Figure 12B). In addition, two smaller channels have appeared above the original channel, presumably as a result of the sediment flow during the landslide. The sediment from the landslide followed the old channel, consequently deepening and elongating it. In total, the channel increased from 240 to 650 meters in length, and from 5 to 10 meters in depth. This shows that the sediment flow had an erosional effect on the seafloor, proving that most of the sediment must have been deposited beyond the limits of the dataset (Figure 50B).

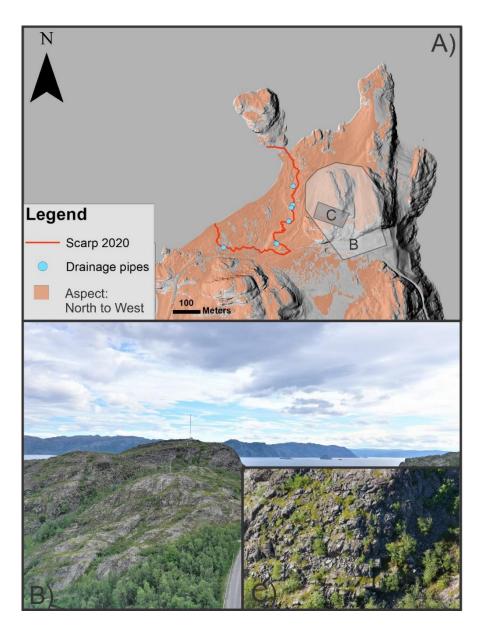
The large-scale bedrock structures at Kråknes have been mapped with Lidar, showing faults striking ENE-WSW to NE-SW, with a fall predominantly to the NW (Figure 4C). As observed from B/C, the bedrock is influenced by joints and fractures. Some of the more fractured areas (Figure 51C), generally correspond to the larger faults that were identified by LiDAR (Figure 4C). Given a well-developed network of faults, fractures and joints, groundwater flow could be facilitated into the landslide area.

In addition to faults and fractures, the aspect of the bedrock and ground surface can influence the transport of water. This can be compared with rain hitting the ridge of a roof, where water will be transported down the side of the roof of where it landed. As a consequence, the aspect of the ground surface can channel water into specific areas, and should therefore be considered when investigating the causalities of the landslide. Ground surfaces with aspects ranging from north to west are highlighted in Figure 51A. These aspects have been considered to be the most significant for channeling water towards the landslide area at Kråknes. The aspect map revealed that the mountains surrounding Kråknes demonstrate an aspect that will channel the water towards the landslide area. This is further supported by the observation of water exiting the scarp at the bedrock and soil interface, suggesting that groundwater follows the bedrock surface (Figure 35C, Figure 37B).

Figure 51: A) Hillshade topography illustrating the aspect of the bedrock and ground at Kråknes. Aspects between North and West have been highlighted (red) as they potentially channel water towards the landslide area. Locations of Figures B and C are shown as grey polygons. B) Drone photo of the bedrock at Kråknes. C) Close-up photo of the fractured bedrock found at Kråknes.

The surrounding bedrock is also interpreted to have played an important role in the destabilization of the slope. With water being one of the most effective catalysts for slope failure, it is important to evaluate all the possibilities where water can infiltrate the slope. For Kråknes, the bedrock is characterized by fractures and faults that are believed to have facilitated water flow into the landslide area (Figure 51C). The NW dip on the large-scale faults indicates that water could be transported into the area through these structures. Additionally, the overall aspect of the bedrock and ground surface is interpreted to acts as a relief, encouraging water to be guided into the landslide area (Figure 51A).

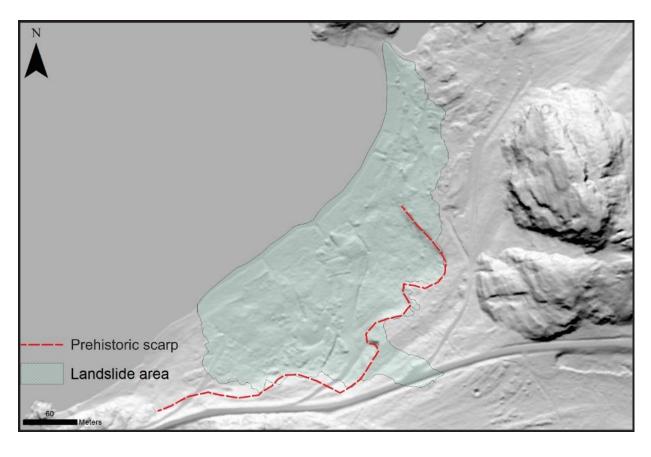
A prehistoric landslide scarp is identified in the pre-2020 landslide event lidar data (). The scarp follows a similar alignment to the current landslide scarp around the bay with an elevation of approximately 30 meters. The identification of a prehistoric scarp indicates that a landslide event has taken place at Kråknes in the past, and that the landslide in 2020 might be the most recent in a series of events. Due to the scarp not being dated, it is difficult to determine when the prehistoric landslide might have happened. However, the lack of raised beach ridges within the landslide area suggests that the scarp is relatively young (Figure 5B), and the event may have occurred in the last 1000 years, as supported by (Multiconsult, 2021).

Figure 53: Hillshade topography of Kråknes based on 1 metetr resolution digital elevation model (Source: Kartverket.no). Prehistoric scarp (red) overlain the landslide area from 2020.

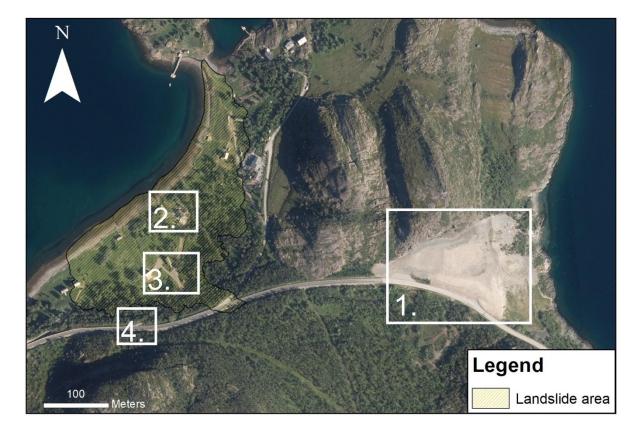
Figure 54: Overview map of human activities before the landslide. The numbers indicate the location of the different activities. 1) Landfill. 2) Ground work for cabin building. 3) Mass relocation. 4) Road work.

During the construction of the new E6 Alta Vest in 2015, a landfill was built on the eastern side of Kråknes (Figure 54). The landfill covers an area of approximately 230 x 150 meters, with an average thickness of around 6 meters. The landfill material consists mainly of silt, sand and gravel. Smaller lobes of material on the eastern side of the landfill suggest that material has released from the side of the landfill.

Four human activities have potentially influenced the stability of the site. The landfill at the eastern side of Kråknes was established in 2015 in accordance with the establishment of the new E6 (Figure 54). With the size and potential weight of the landfill, unstable conditions would be expected if the landfill was located in an area predisposed to instability. However, the location of the landfill is regarded as an unlikely to be a contributing factor as it is placed on the opposite side of the peninsula to Kråknes. It is also deposited directly on bedrock, removing the potential effect of subsidence of the ground underneath. As for water transport, the same argument is interpreted to be applicable, as water from the landfill will concern a different watershed.

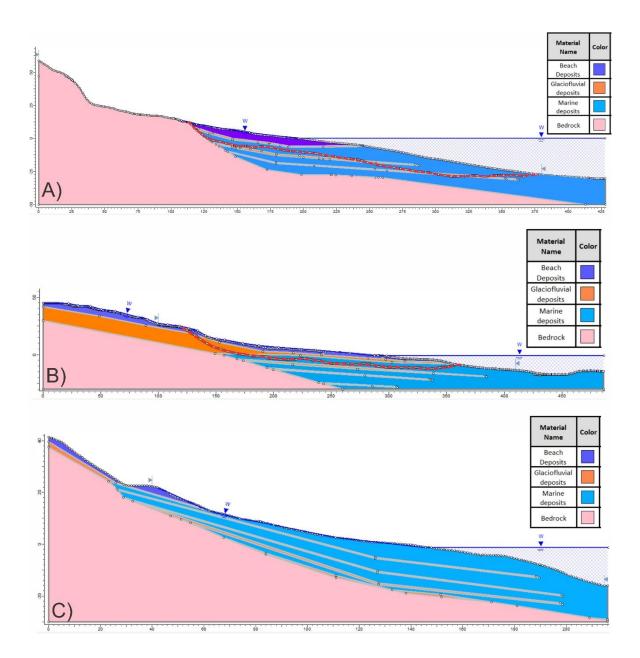
As a basis for the modeling results, the failure surface for profiles A-A' and B-B' have been added (Figure 59A/B). The failure surfaces are extracted from the post-slide LiDAR- and bathymetry data, and thus represents the actual failure surface from the field. For profile A-A', the failure surface measured 265 meters in length and approximately 10 meters in depth. Similarly, the failure surface for profile B-B' measured 250 meters in length and 10 meters in depth. This data will prove as a benchmark for the modeling results, which will be discussed in chapter 5.

Figure 59: Profiles used for stability modeling in Slide2. Failure surface (red) is based on the post-slide LiDAR- and bathymetry data. A) Profile A-A'. B) Profile B-B'. C) Profile C-C'.

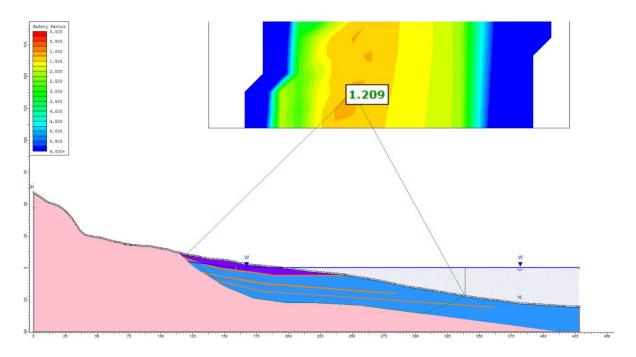
Low groundwater (GW) levels were simulated to determine the stability of the area in a "dry" state. This was done by lowering the groundwater table approximately 5 meters below the ground surface. For profile A-A' (Figure 60) this resulted in a FS = 1.209. The failure surface stretches a total length of 230 meters. For Profile B-B' (Figure 61), low GW levels gave a FS

Figure 60: Profile A-A'': Undrained total stress analysis using the grid-search method. No excess pore pressure (sea level 0 meters). FS = 1.209.

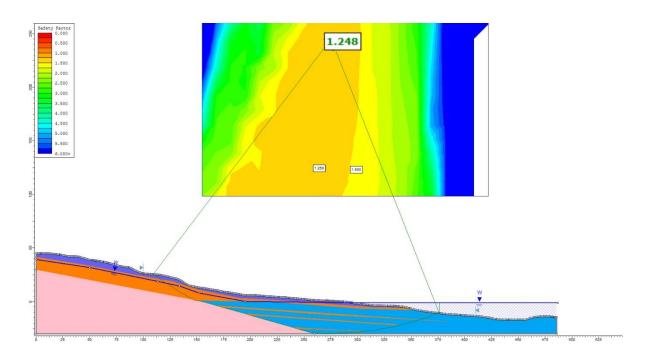
= 1.248, with a failure surface of 260 m. For profile C-C' (Figure 62), FS = 1.033 with a failure surface of 80 meters.

Figure 61: Profile B-B'': Undrained total stress analysis using the grid-search method. No excess pore pressure (sea level 0 meters). FS = 1.248.

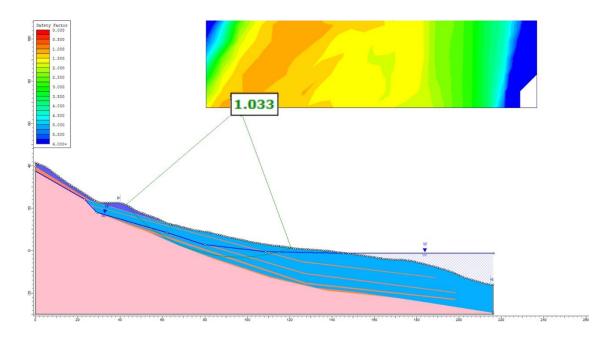
Figure 62: Profile C-C': Undrained total stress analysis using the grid-search method. No excess pore pressure (sea level 0 meters). FS = 1.033.

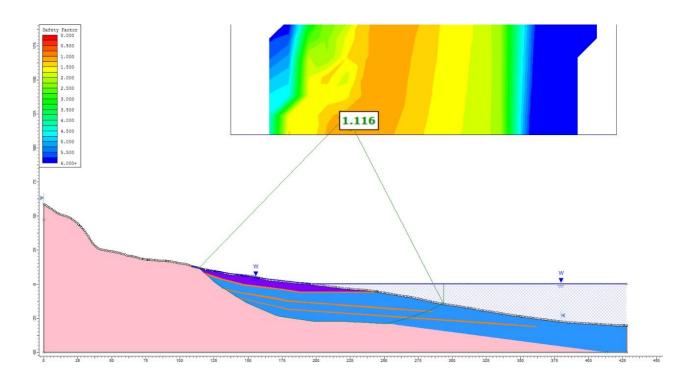
A high GW level was modeled to determine the stability of the area after the snow-melt event, when soil saturation levels reached 100%. Hence, the groundwater level was set at the surface of the slope, and pore pressure was modeled hydrostatically, which means that no excess pore pressure was included. As a result, FS = 1.116 was achieved for profile A-A' (Figure 63), with a failure surface of 175 meters. For profile B-B' (Figure 64), high groundwater levels achieved an FS = 1.030 and a failure surface of 115 meters. Lastly, profile C-C' (Figure 65) resulted in a failed situation with FS = 0.899, and a failure surface of 80 meters.

Figure 63: Profile A-A': Undrained total stress analysis using the grid-search method. No excess pore pressure (sea level 0 meter). FS =1.030

As the soil saturation and groundwater levels approached their maximum, the first signs of instability started to appear. Large amounts of surficial water and a small debris avalanche were reported at the end of May, shortly followed by the formation of a tension crack on the 2<sup>nd</sup> of June (Figure 23B). Given the high levels of groundwater and soil saturation, the unit weight of the soil would increase. This presumably led to an increase in the driving forces and pore pressure acting on the slope, consequently reducing the stability. This is also reflected by the slope stability modeling, where the factor of safety was reduced for all profiles when groundwater levels were increased (Figure 63,Figure 64,Figure 65). In addition, the timing of 85

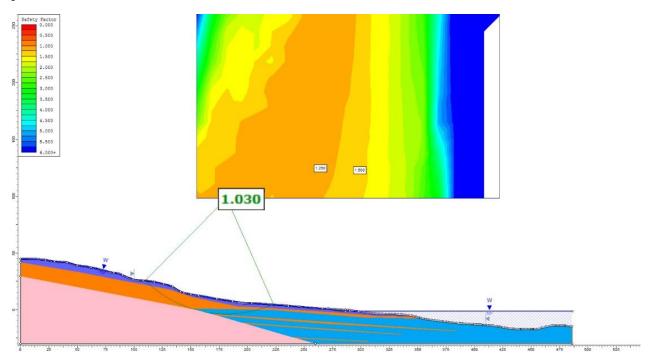
Figure 64: Profile B-: B': Undrained total stress analysis using the grid-search method. No excess pore pressure (sea level 0 meter). FS = 1.030.

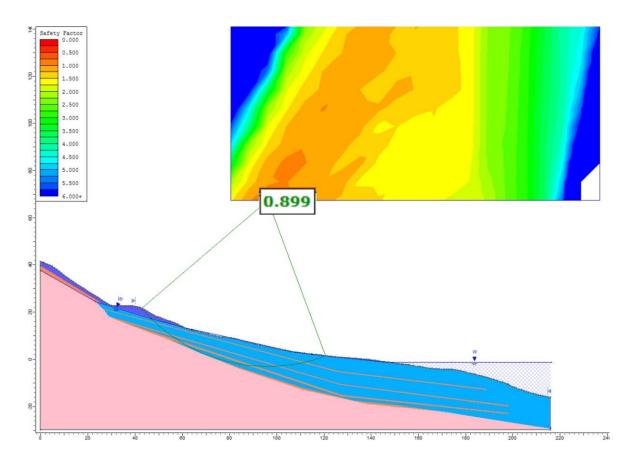
Figure 65: C-C': Undrained total stress analysis using grid-search method. No excess pore pressure (sea level 0 meter). FS = 0.899.

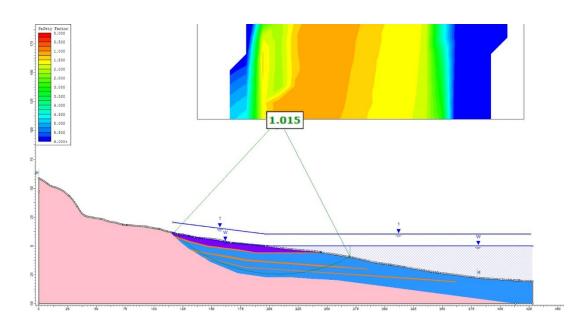
The excess pore resulted in two of the three profiles obtaining a factor of safety lower than 1, indicating unstable conditions. Profile B-B' (Figure 67) and C-C'(Figure 68) obtained values of FS = 0.433 and FS = 0.471, while profile A-A'(Figure 66) still registered as stable with FS

Figure 66: Profile A-A'': Undrained total stress analysis using the grid-search method. Glaciofluvial deposits (orange) are modeled with an excess pore pressure of  $\sim 100$  kPa (1) (sea level 0 m). FS =1.015.

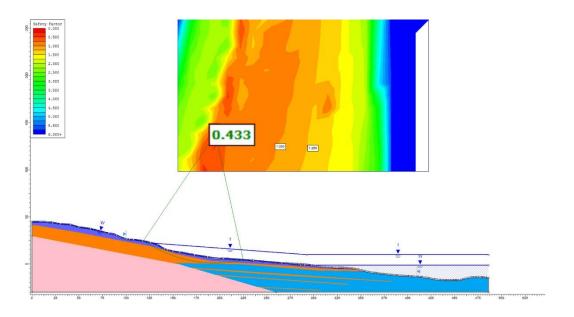
Figure 67: Profile B-B'': Undrained total stress analysis using the grid-search method. Glaciofluvial deposits (orange) are modeled with an excess pore pressure of ~100 kPa (1) (sea level 0 m). FS =0.433.

this area. The excess pore pressure would be created by the difference in hydraulic head between the glaciofluvial deposits, and surrounding marine deposits. Studies by Pierson (1983) show that if drainage pipes are parallel to the fall of the slope, excess pore pressure could develop and potentially trigger a landslide. As a result, the influence of the drainage pipes in combination with excess pore pressure is regarded as one of the potential triggers for the landslide at Kråknes. The modeling results support this theory, with the factor of safety dropping drastically for profile B-B' and C-C' with the addition of excess pore pressure on the glaciofluvial deposits (Figure 67, Figure 68). The validity of these results will be discussed in more detail later on.

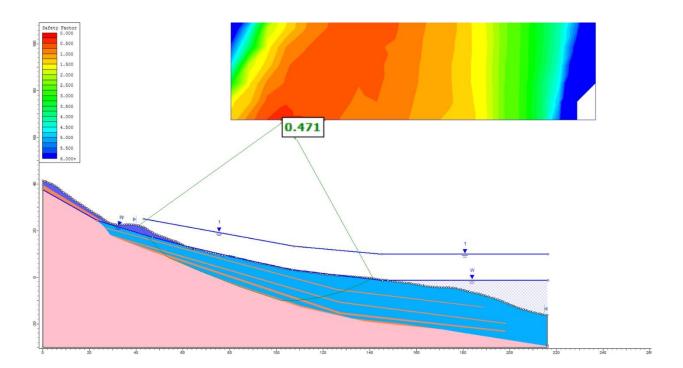
Figure 68: C-C': Undrained total stress analysis using the grid-search method. Glaciofluvial deposits (orange) are modeled with an excess pore pressure of ~100 kPa (1) (sea level 0 m). FS =0.471.

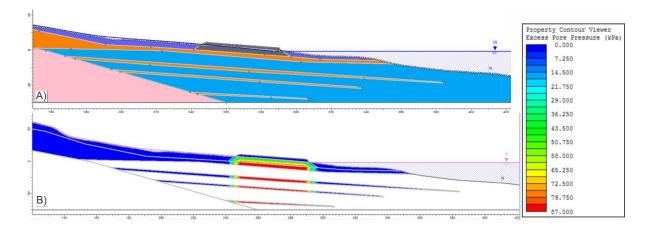
Modeling was performed for high GW levels, under similar conditions as shown in Figure 64 (FS = 1.030). The weight of the fill material was modeled to influence the pore pressure for the underlying glaciofluvial deposits (Figure 69A). As a result, the fill added an excess pore pressure of 87 kPa, lowering the stability by 3.2 % and producing an unstable situation (FS = 0.997 < 1.0) (Figure 70). The length of the failure surface was approximately 120 meters, similar to the one produced for high GW levels (Figure 64).

Figure 69: Profile: B-B':A) Close-up of the fill material (black) modeled at the approximate location of the cabin. The weight of the fill material was modeled to apply excess pore pressure on the underlying glaciofluvial deposits (orange). B) Profile displaying the pore pressure at the same area as A). The fill material applied an excess pore pressure up to 87 kPa on the glaciofluvial deposits. The remainder of the materials were modeled with hydrostatic pore pressure (blue) or as undrained/no pore pressure (white).

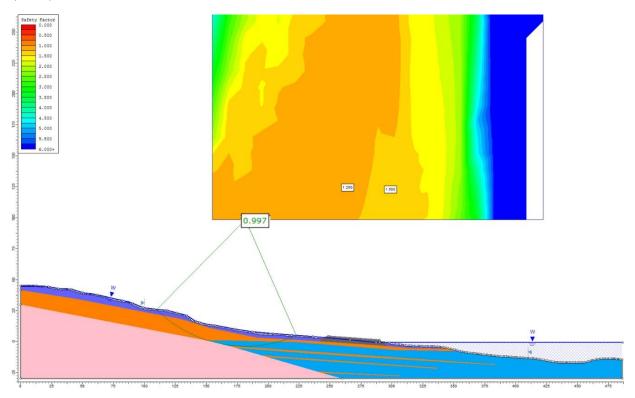
Figure 70: Profile B-B': Undrained total stress analysis using the grid-search method. FS = 0.997 with the added weight of fill material.

During construction, approximately 1000-1200  $\text{m}^3$  of fill was deposited on the slope. This is a large enough load that a reduction in stability would be expected. The modeling supports this, with the factor of safety dropping from 1.030 without the load to 0.997 with the load. In general, a load would be considered a contributory factor as natural conditions have to be prone to instability for human activity to trigger a landslide (Hansen 2013).

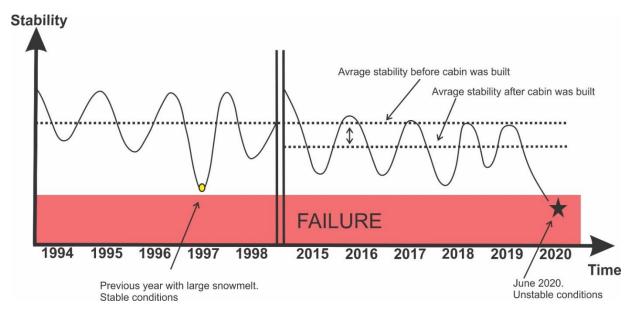
With the assumption of a progressive flake-type failure mechanism, several factors indicate an initial low stability for Kråknes prior to the landslide. Given that extreme periods of snowmelt or rainfall likely has led to similar soil saturation levels before, the rapid snowmelt event cannot be given full accountability for triggering the landslide. The same argument is applicable for the ground conditions, where there is little data justifying an abrupt deterioration of the stability in the last 20-30 years. As a result, it is interpreted that human activities, specifically the loading of the fill associated with the cabin building is responsible for lowering the average stability sufficiently for the landslide to be triggered on June 3<sup>rd</sup>, 2020 (Figure 71).

Figure 70: Principal schematic of the stability at Kråknes, before and after the cabin was built. Adapted from (Multiconsult, 2021).
