ISOPE Proceedings — Experimental investigation of deicing with seawater

ABSTRACT

TEST OF SEAWATER DEICING

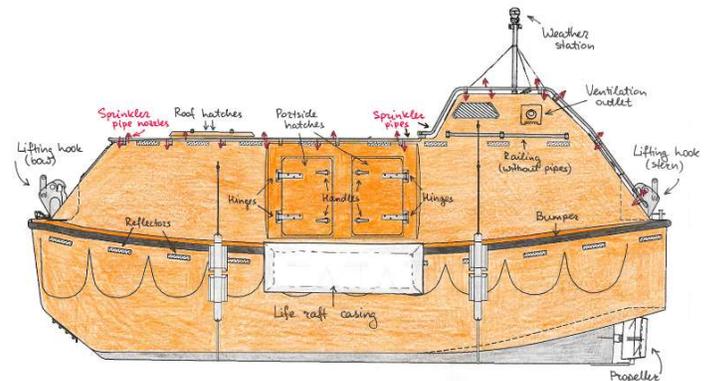
Fig. 1 External general arrangement of the Miriam 8.5 lifeboat from Viking Norsafe.

The seawater deicing test was performed on a small vessel, a Viking Norsafe Miriam 8.5 lifeboat with a capacity for 55 passengers, on the 6th of January 2023. The fire sprinkler system is designed to cover and flush the entire surface of the lifeboat with a film or layer of seawater when the boat is waterborne. A self-priming sprinkler pump located directly on the main ship diesel engine provides sea water through the boat internal piping to a manifold mounted externally on the canopy. The water is then distributed through sprinkler rails which are fitted with spray nozzles that disperse the seawater from the top of the steering tower and lifeboat canopy, see Fig. 1. The downward and upward blue arrows on the sprinkler pipes in Fig. 1 mark the position of the sprinkle nozzles facing to and from the observer, respectively. Fig. 2 and Fig. 3 show the lifeboat before the deicing procedure.

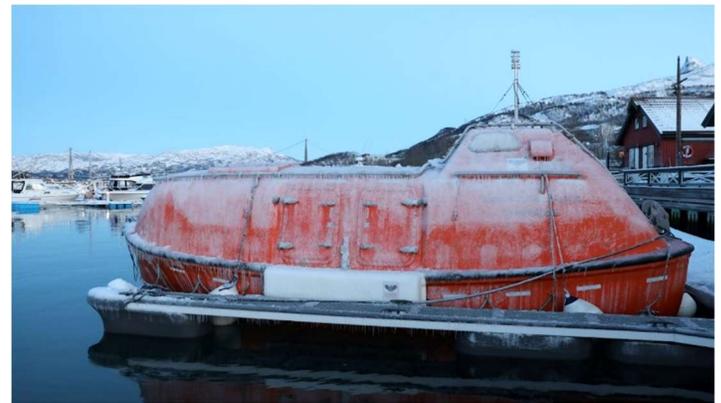
Fig. 2 Ice applied on the portside of the lifeboat.

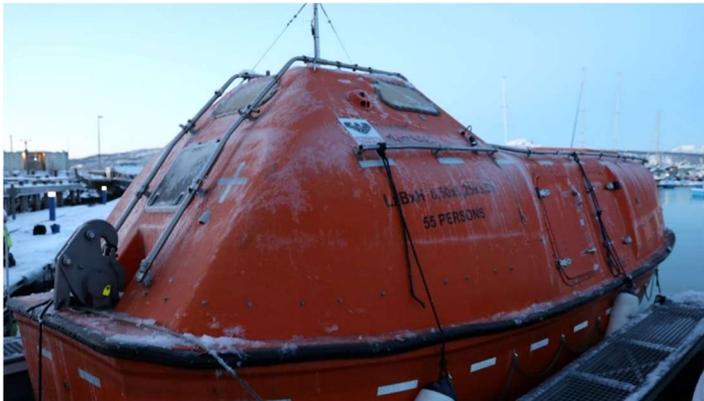
Fig. 3 Ice applied on the starboard side and stern.

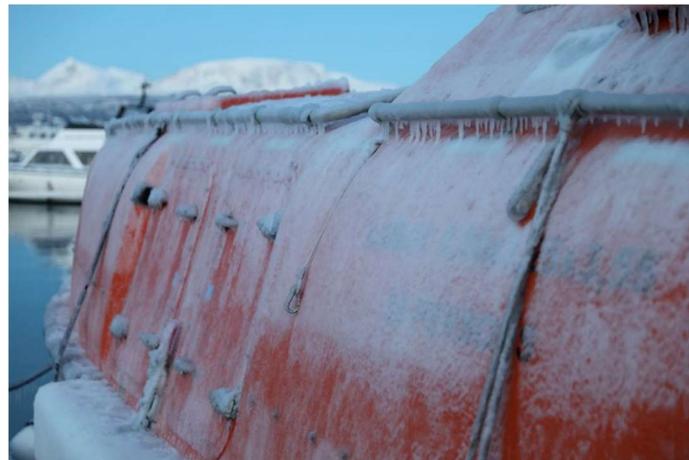
Fig. 4 Details from portside ice cover prior to test.

As visually observed, spraying of seawater resulted in quasi-even icing on the top part of the boat side, above the bumper, and on the roof. At a close look, the ice had a rough, uneven surface, and trapped air bubbles resulted in non-transparent patches, see Fig. 4.

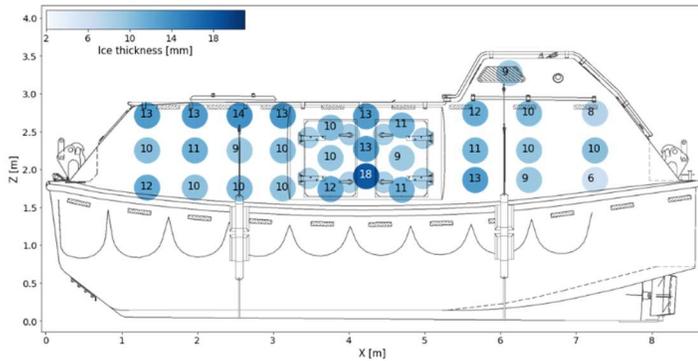
Ice thickness on the port side and the boat's roof is graphically depicted in Fig. 5 and Fig. 6, respectively, where the locations of the circles correspond to the measurement points, and their color and annotations reflect the measured values in centimeters. On the side of the boat, ice thickness was nearly uniform in the range between 6 and 18 mm, with an average of 11 mm and slightly higher values in the top row of the front part and between the hatches. The highest thickness was measured at the bottom between the hatches, likely due to ice accumulation near the chain holding the life raft casing. On the roof ice thickness was higher than on the wall, with an average of 13 mm, and featured a pronounced difference between the port side (values up to 21 mm) and starboard side (5-10 mm). This gradient is caused by applying spray from the port side, with only a small number of droplets reaching the other side. Both the four bridge windows and the four windows had a relatively thin ice layer between 5 and 9 mm. Ice cover on the starboard side of the boat, due to the absence of direct spray, was too thin to be measured with precision.

Fig. 5 Measured ice thickness on the portside.

Prior to deicing, the ice-cover on the boat was mapped by manually measuring ice thickness at selected locations with a caliper through predrilled holes in the ice cover, see Fig. 5 and Fig. 6. The experiment and measurements were documented with video and photos by multiple GoPro cameras.

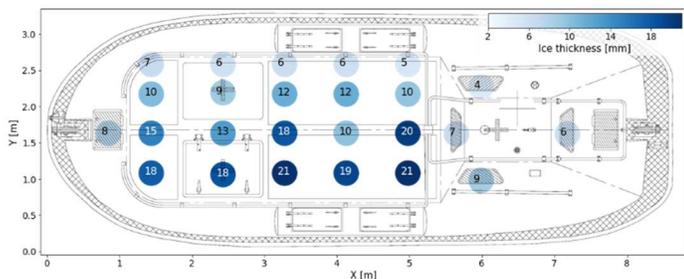
Fig. 6 Measured ice thickness on the roof.

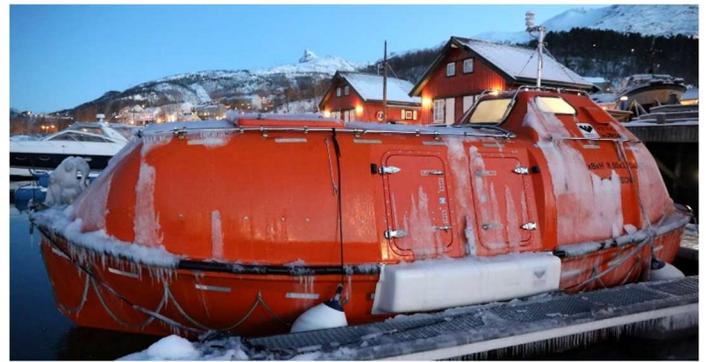
Fig. 7 Portside after the deicing procedure.

12 minutes, where the engine operated at 50 % capacity, and 20 minutes, where the system was run at 75 % capacity. Fig. 7 and Fig. 8 show the remaining ice on the vessel.

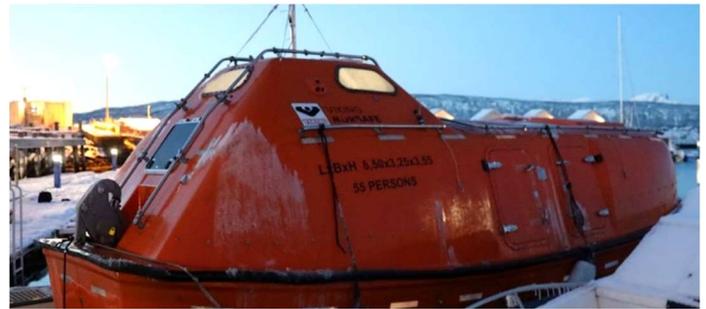
Fig. 8 Starboard and stern after the deicing procedure.

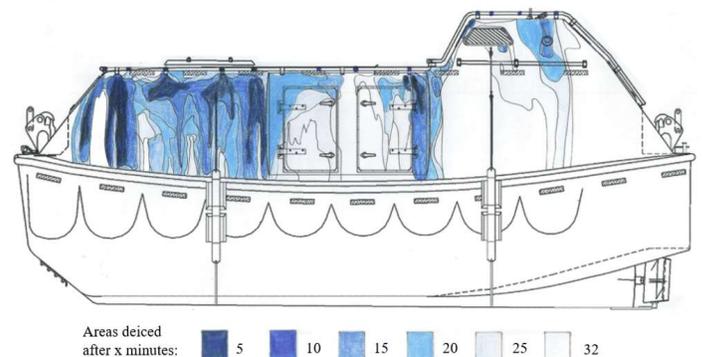
Fig. 9 illustrates the deicing progression and shows de-iced areas with five-minute increments from dark to light color. The remaining 2 minutes of runtime were added to the last timestep. Areas in direct contact with spray from the nozzles were generally deiced within five minutes (dark blue). Some locations with nozzles located above did not melt at the same phase. This could be caused by the fact that the initial ice thickness was greater or by blockages. Blockages could not be detected from videos. The relatively quick local deicing could be designed to target priority areas. The ice layer removed from the vessel had settled for approximately 24 hours. During a voyage under icing conditions, it is reasonable to expect an earlier deicing effort. Newly formed ice requires less energy to remove, and the amount of remaining ice after deicing would be lower.

Fig. 9 Deiced areas in time intervals from dark to light color, i.e., the darkest patches correspond to the areas deiced in the first 5 minutes of

the test.

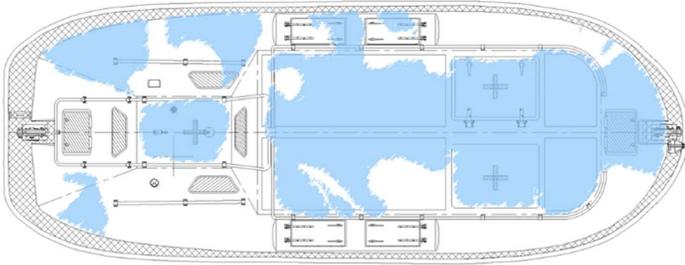
Fig. 10 Ice remaining on the roof after the deicing procedure (in blue).

On the horizontal surfaces, such as the roof of the lifeboat, the initial ice thickness was approximately 6 - 21 mm, and most of the top was not deiced after the exercise. Several factors caused the remaining ice thickness, in addition to the thicker initial ice layer. Fire rails were located at the side of the roof and not across the center, and fewer nozzles were directed toward the top compared to the side areas. The ice on the sides of the boat was melted by run-off from the roof, in addition to nozzles directed at the side surface. The ice accumulated on the vessel's sides could be removed in larger pieces by gravity, in contrast to the areas on the top where the ice needed to melt before running off the sides. One concern with ice on ships is the overall stability and weight of the ice. Even if the roof was not fully deiced, the overall weight on the top was reduced as the ice thickness was diminished.

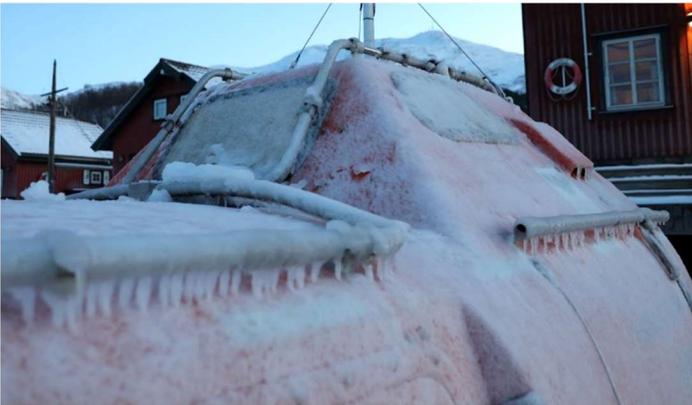
Fig. 11 Steering tower with the windows and the air inlet (on the right) before deicing.

High-priority locations such as windows and air inlets were successfully deiced during the procedure, see Fig. 11 and Fig. 12. Some ice remained on the escape hatches, but the soft ice could be easily removed, and the opening function of the doors and hatches was maintained. In general, the remaining ice on the lifeboat topside had a reduced thickness and was easy to remove manually, and sprinkling could be combined with other deicing efforts. However, the time spent deicing indicates that an upper limit of the ice layer thickness exists, above which the method is not practical. Topside equipment near the front towing hook/painter connection, was not sufficiently deiced, i.e., the attachment point for the tow rope.

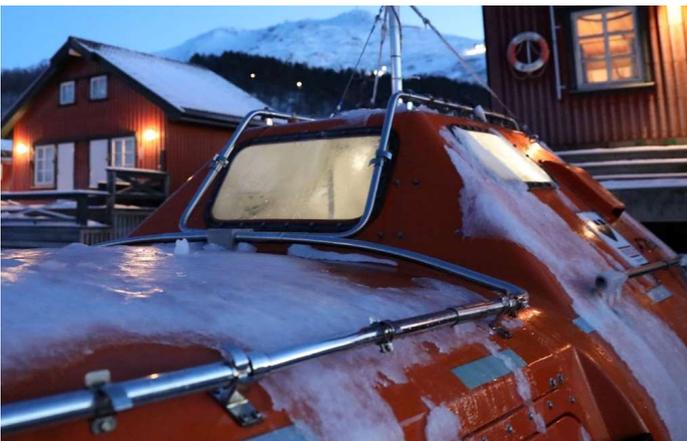
Fig. 12 Steering tower with the windows and the air inlet (on the right) after deicing.

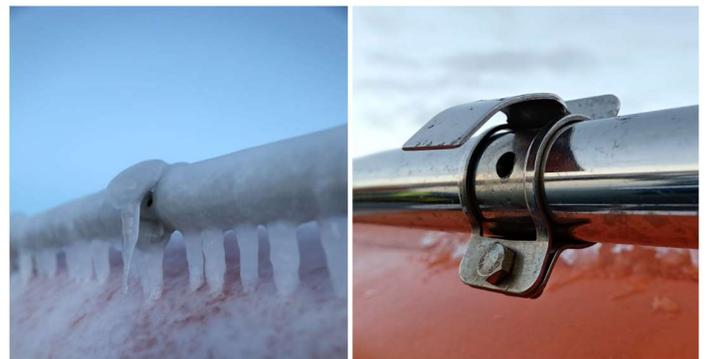
The nozzle design influences functionality when the vessel is exposed to sea spray icing. The fire system on the lifeboat is pipelines where holes allow water spray to exit. The water is reflected towards the vessel's surface by a metal sheet. The metal sheet largely protected the pipeline from clogging during icing. Seawater spray was applied manually, and another direction of oncoming spray could have been less favorable for this design, e.g., spray coming upwards from the sea. The design should be tested during icing from sea-spray in natural conditions. Clogged fire sprinklers might result in a fire hazard.

Fig. 13 Sprinkler nozzle with and without ice.

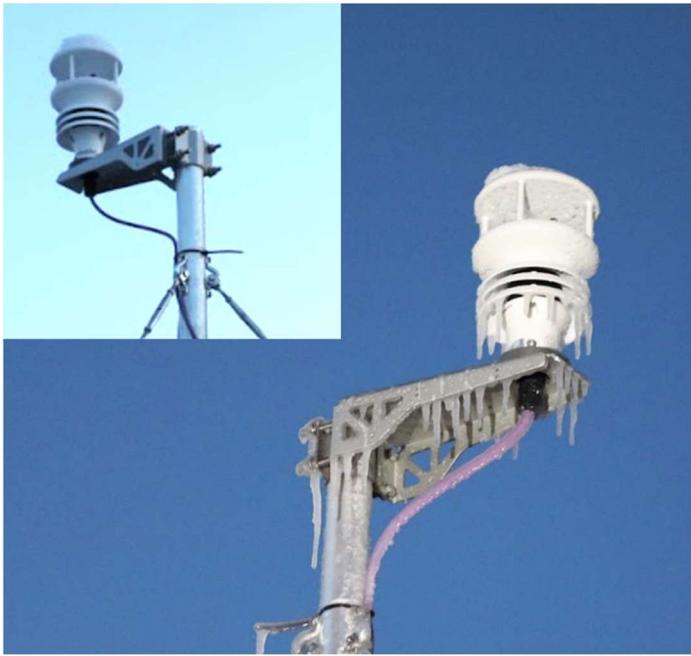
Ice accumulation during deicing. Fig. 14 shows the weather station mounted on the roof of the lifeboat before (upper left) and after (lower right) the deicing procedure. Droplets of the deicing spray reached the weather station and caused icing. Deicing can cause ice accumulation in adjacent areas where the water flux is low.

Fig. 14 Weather station mounted on the steering tower before (left) and after (right) the deicing procedure.
